XIX ANIDIS Conference, Seismic Engineering in Italy

## Modal characterization and NDTs of a historical church in Noto

In this work, we analyzed as case-study the Madonna del Carmine Church, located in Noto, Sicily. The city of Noto, placed in the southeastern part of Sicily, is characterized by a high seismic hazard with relevant historical events. Noto was completely destroyed by the catastrophic earthquake occurred in January 1693, that affected the old city and caused over 60,000 victims (Piatanesi and Tinti, 1998). After such event, the new city was build a few miles downstream from the beginning of the 1700. The Madonna del Carmine Church is believed to have been built between the 1730-1750. Further on, other relevant seismic sequences rumbled through the new city of Noto in 1727, 1780, 1818 and 1848, possibly damaging the structure in some of its parts. Some interventions were carried out in time too, modifying the original structure, and with the construction of other buildings in continuity with three of the main sides of the structure. The church has been subject to an experimental campaign based both on NDTs and SDTs to evaluate the main geometrical features, the connec

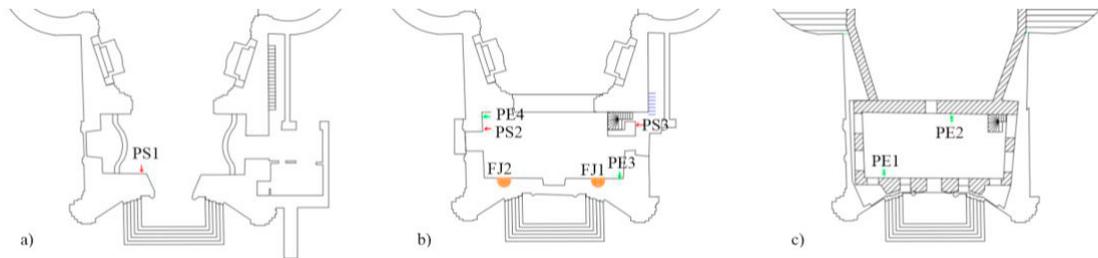
A set of complementary SDTs and NDTs were carried out, other than visual inspections to characterize the quality of the masonry. The main tests were: flat jacket tests (FJ), both single and double, pulse velocity tests (PS), and endoscopies (PE). Some masonry cores, together with the extraction of mortars from the joints were also carried out to reconstruct their composition and evaluate the presence of possible deterioration mechanisms. Figure 4 shows the location of the tests carried out.

Fig. 4: Positions of the flat jacket (FJ) tests, pulse velocity (PS) and endoscopies (PE).

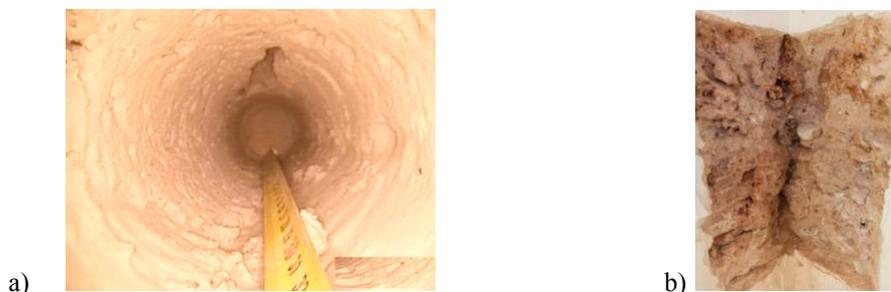
Five cores were extracted from the façade and their transverse walls to identify the type, homogeneity and quality of the masonry. Cores have different height, varying from 400 to 800 mm, depending on their location. After a first thickness of 35–40 mm of plaster, almost a homogeneous layer of biocalcarene stones was detected (Figure 6a); however, almost in all cases, at about 30–40 cm from the external face, a reduction of the porosity and compactness was visible.

Three other openings were created to evaluate the level of connections among the walls, especially between the façade and the transverse ones. In these corners of the structure, masonry was not homogeneous, there was an absence of any courses or bands, and only some small squared-shape blocks could be recognized (see Figure 6b), avoiding their function as a key. Accordingly, the connections among the walls cannot be completely ensured.

Fig. 6: Inspection of a core from the façade (a) and inspection at a corner between the façade and the transverse wall (b).

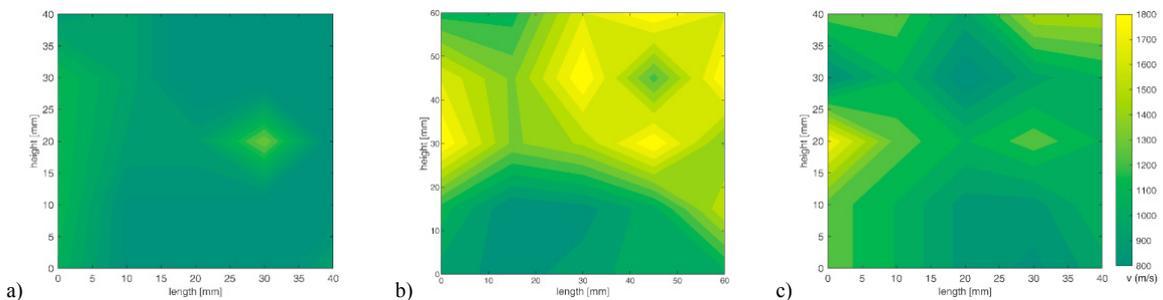
Due to limited accessibility to both sides of the walls pulse velocity test were carried out in limited portions of the masonry being on 40x40 cm and 60x60 cm. A 5x5 base grid with 10 cm and 15 cm spacing (respectively for 40x40 cm and 60x60 cm investigated portions) was used for the pulse input and recording. The results showed pulse velocities mainly in the range of 800-1200 m/s with peaks up to 1800 m/s in line with a poor to medium quality masonry. Results are graphically shown in Figure 7.

Fig. 7: Pulse velocity test results. PS1 (a), PS2 (b) and PS3 (c).
