UNIVERSITÀ  
DEGLI STUDI  
DI PADOVA

**AN INTEGRATED APPROACH FOR RESTORATION AND  
CONSERVATION OF CULTURAL HERITAGE STRUCTURES: HISTORY,  
MATERIALS AND STRUCTURAL BEHAVIOUR. THE ARSENAL OF  
VENICE**

**Dottorando:** Giulia Bettiol

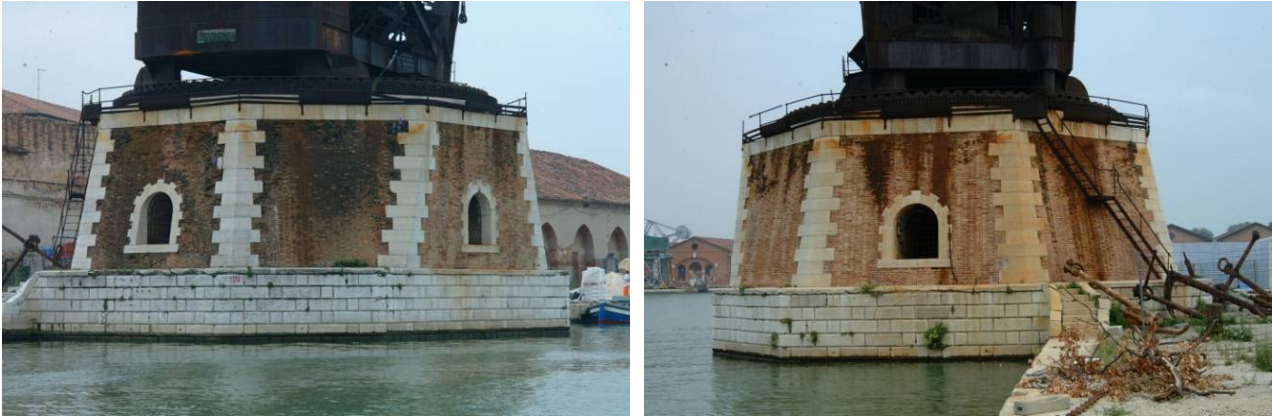
The degradation differs more between the four sides facing north-east and the four sides facing south-west (Fig. 5.4.24). This difference is evident by looking at the wall and its color. The faces that show a bright coloration, typical of masonry, are the most degraded ones in the southwest, that have a deep erosion, both in bricks and in mortar, while the faces in the north-east are brown, almost black, and the surfaces are well preserved, despite their major disruptions.

Fig. 5.4.24: On the left the north east side of the basement, on the right the south west side of the basement

Probably the winds inside Darsena Nuova blow strongly from the south. Their action accelerated the deterioration process, promoting the penetration of rainwater, increasing the wet/dry cycles and producing a surface erosion by removing material, so as to make them almost smooth (Fig. 5.4.25).

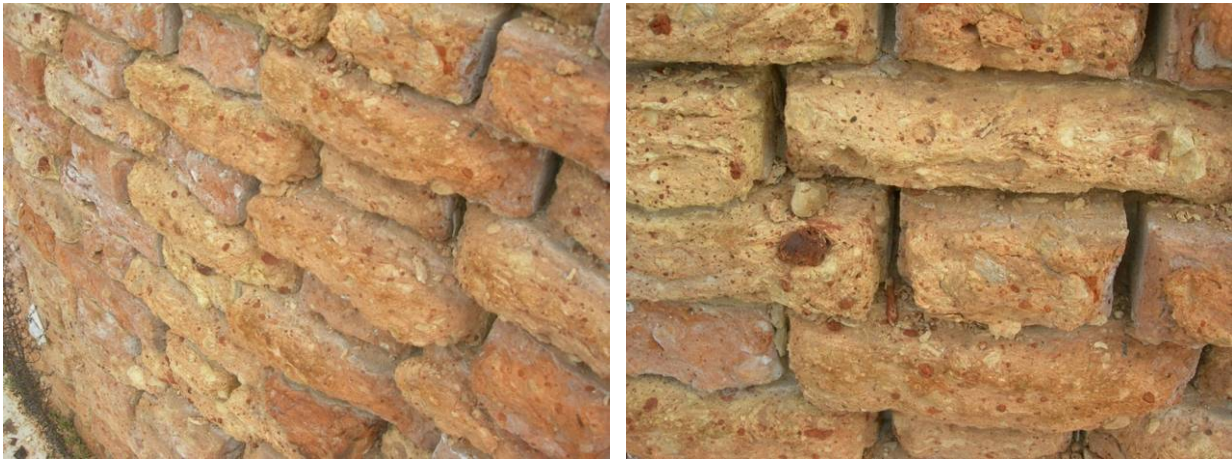
Fig. 5.4.25: Eroded surface's detail

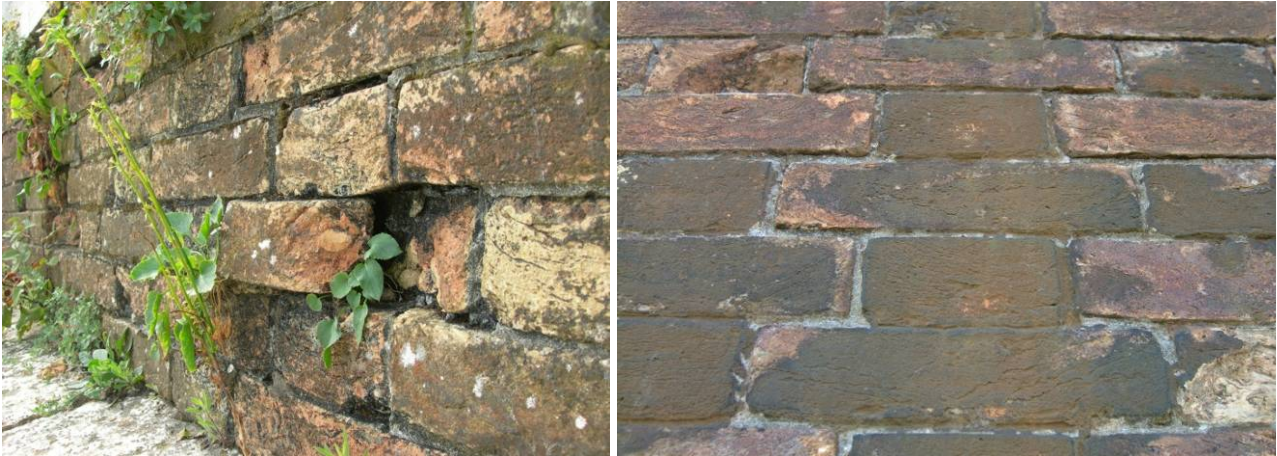
The brightest orange spots (Fig. 5.4.28) are those in which the action of the wind does not permit the combination of iron oxides with other elements, removing them continually. Generally the layer below the deposits, unless there was a strong action of atmospheric agents, is not degraded and in particular it seems to be consistent with the surface. The patina of rust, continually replenished, creates a layer of sacrifice to protect the underlying surface preserving the faces' masonry. The very dark areas denote the formation of black crust caused by atmospheric particles rich in pollutants, which includes the exhaust fumes produced by the crane itself or by the vessels within the Arsenal, that laid on the surface of the material and that were smoothed by air humidity, slightly increased by the poor sunshine. The particles are very consistent to the substrate, the underlying surface is not flaked and there are no layers of plaster.

Fig. 5.4.28: Different types of stains

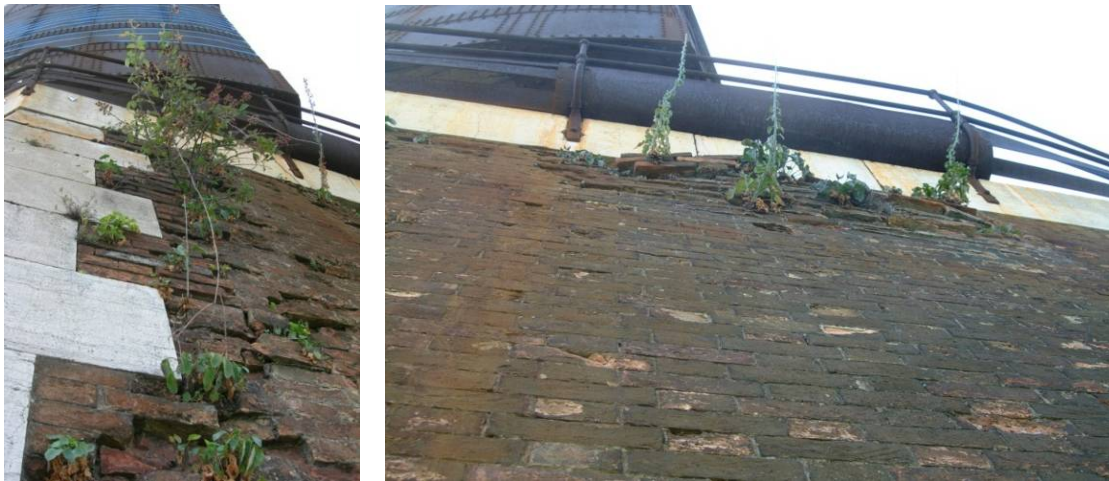
On the other hand the northeastern faces have some areas where large portions of bricks are missing. These are mainly concentrated at the top of the edge between the northwestern faces, accompanied by a vertical fracture and a disconnection of the masonry and its subsequent expulsion (Fig. 5.4.29).

Fig. 5.4.29: Masonry's disconnections

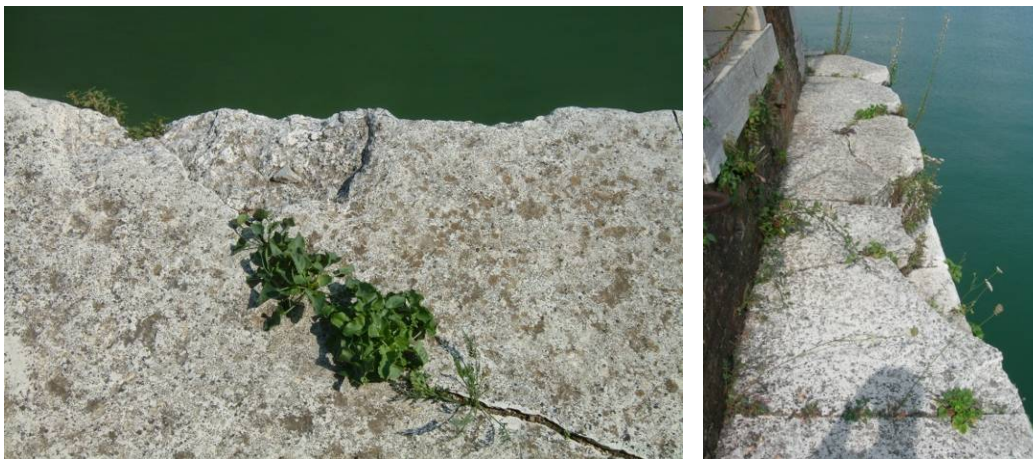
The biological patina (Fig. 5.4.31) is widespread and it consists of several biodeteriogens, mostly lichens, present on the surface of the plates above the podium. In the area near the surface of the water a widespread and homogeneous band of seaweed is present. The degradation of the various micro-organisms, including microscopic algae, is of a chemical type (release of pigments) and of microclimate type (relative humidity increase on the surface), so that it holds water, which we know is a vehicle for pollutant and the cause of countless chemical reactions.

Fig. 5.4.31: Degradation cause by biological patina

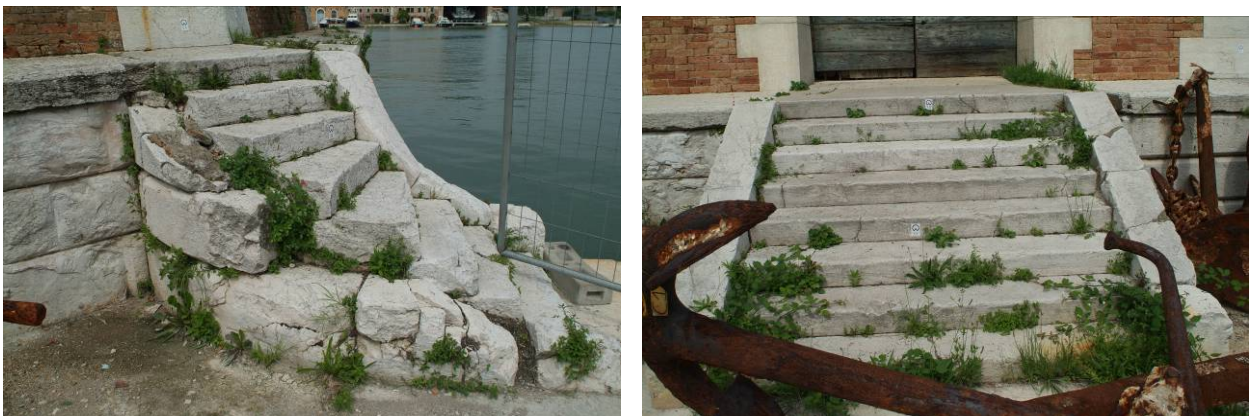
The blocks of Istrian stone presenting the worst disconnections (Fig. 5.4.32) are the ones forming the three stairs leading to the basement below the podium where the mortar lost its cohesion.

Fig. 5.4.32: The two side stairs with disconnected blocks and missing parts

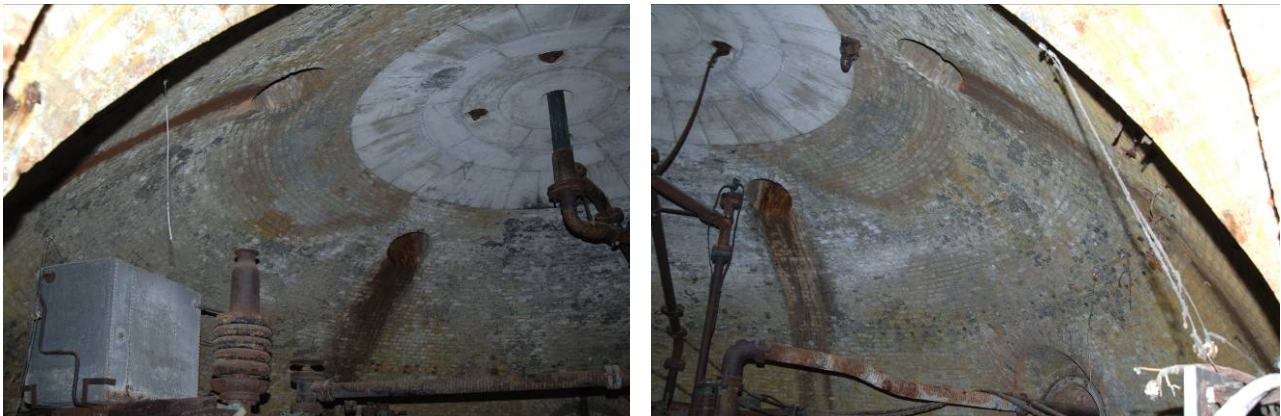
The high humidity carried in the air deposits then released on the surfaces, keeping constantly wet the faces of the bricks. Layers of salt efflorescence formed where they are not covered by washed rust (Fig. 5.4.34).

Fig. 5.4.34: Internal surface of the vault showing the light spots covered by efflorescence and the dark ones covered by oxides.

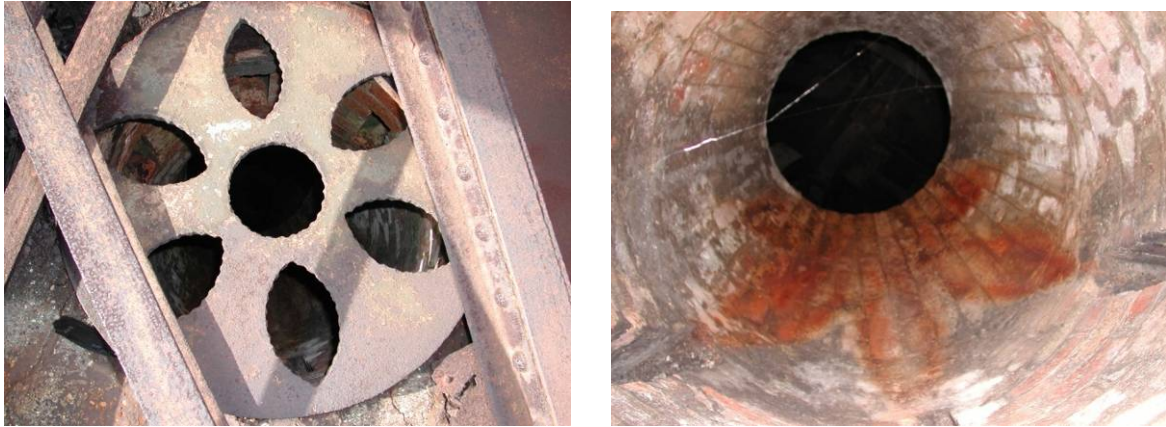
Oxides derived in part from corrosion of machinery and partly from the corrosion of the elements above the basement which penetrate by the 4 cylindrical holes made on the vault to expel the fumes of the machines. These holes (Fig. 5.4.35) were closed from the outside by circular iron plates with holes to avoid falling of foreign bodies. The steam coming out of these, during the crane operation, has certainly contributed to its corrosion.

Fig. 5.4.35: The basement's holes from which the superficial whasing products enter

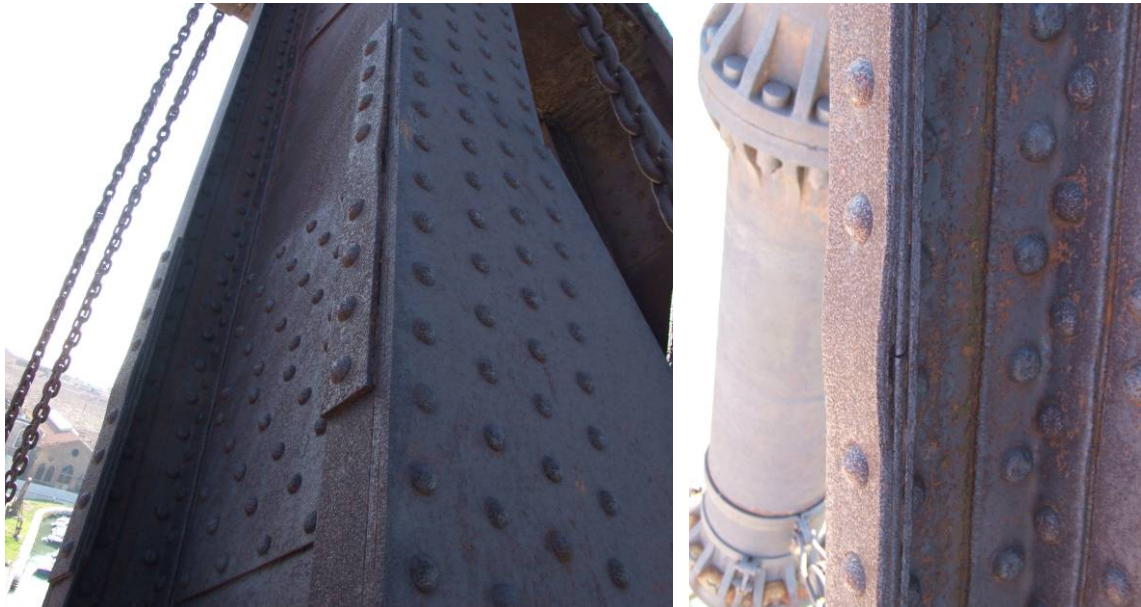
Fig. 5.4.38: Evident open cracks where the rivet pitch is wider and where there are joints.

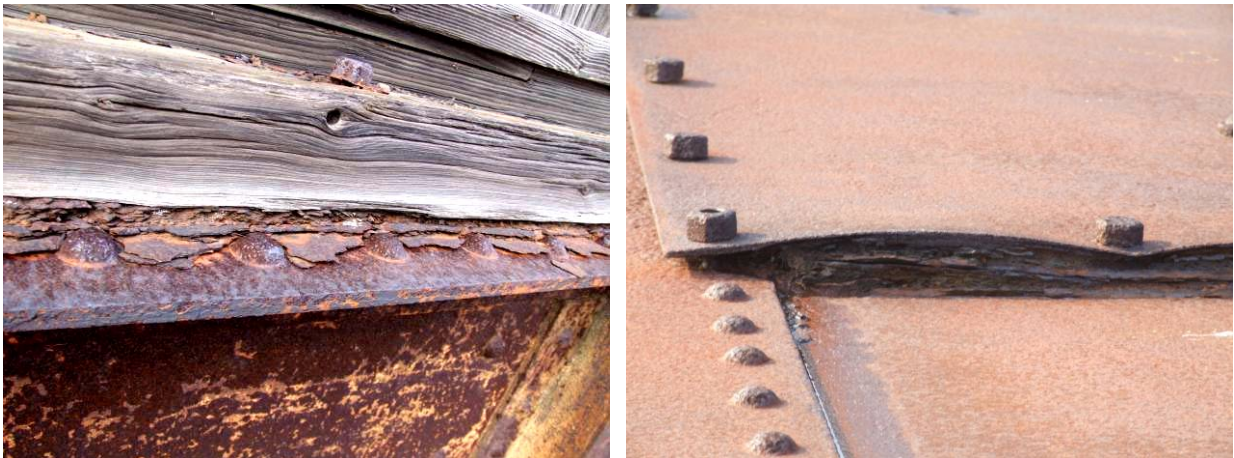
Fig. 5.4.40: Examples of puddle iron parts exfoliation

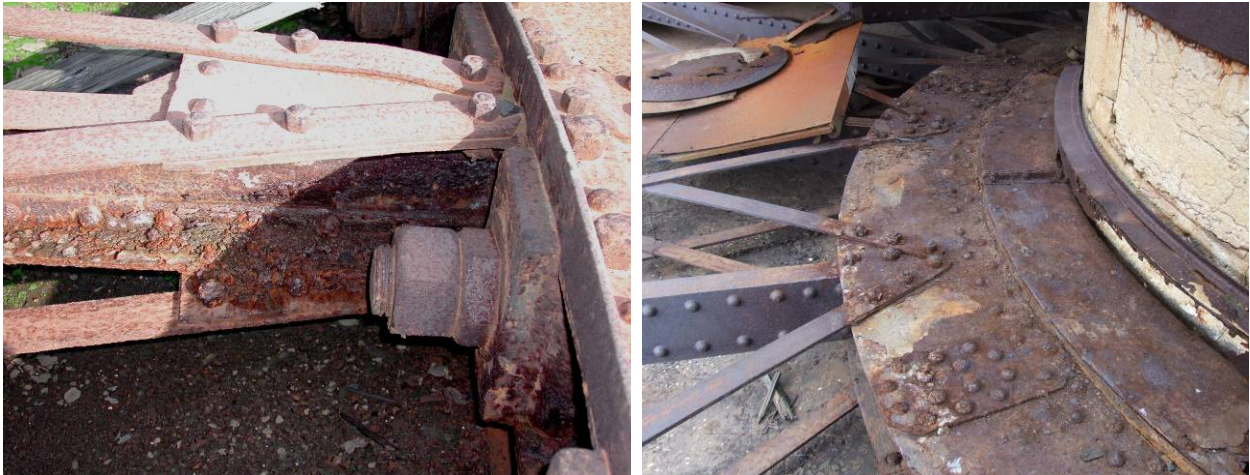
Fig. 5.4.42: slewing ring's corrosion

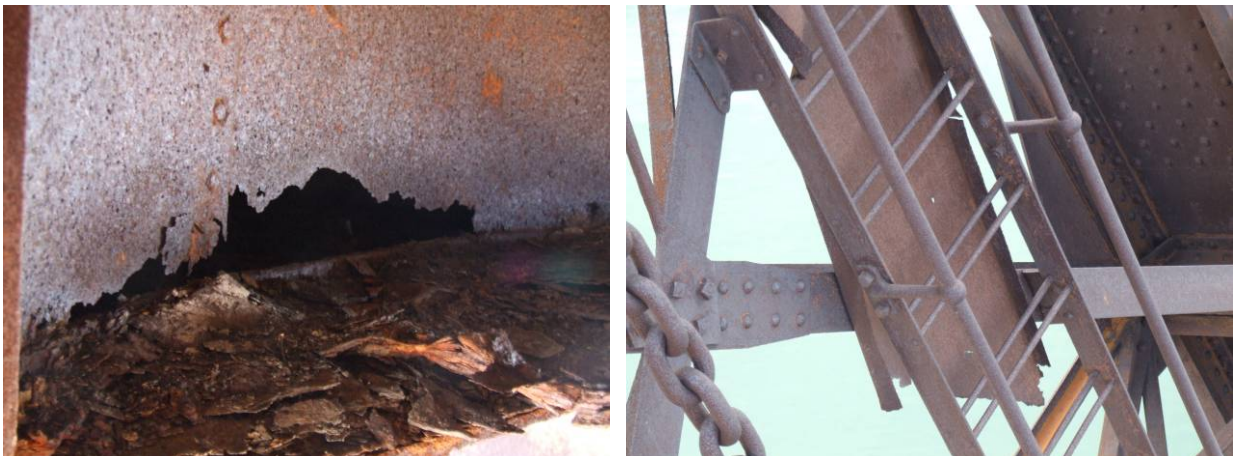
Fig. 5.4.43: Sheets corrosion

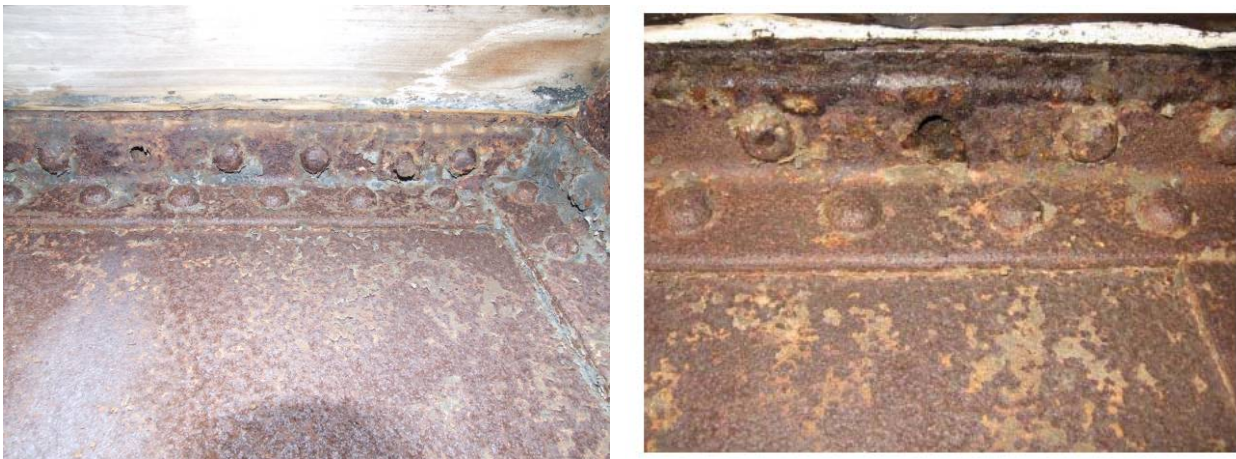
Fig. 5.4.45: Missing rivets

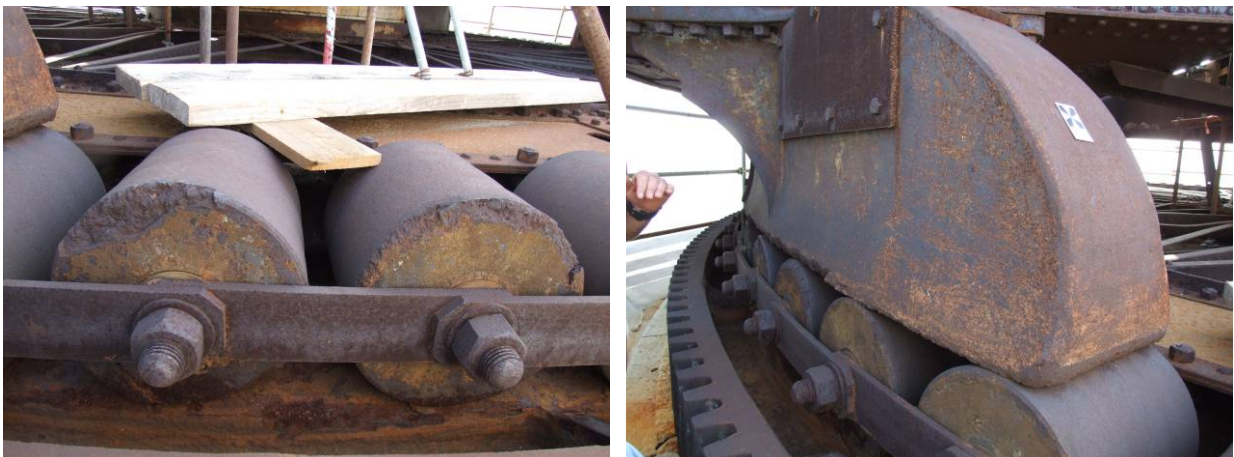
Fig. 5.4.48: Ware in rollers edges and in sliding blocks

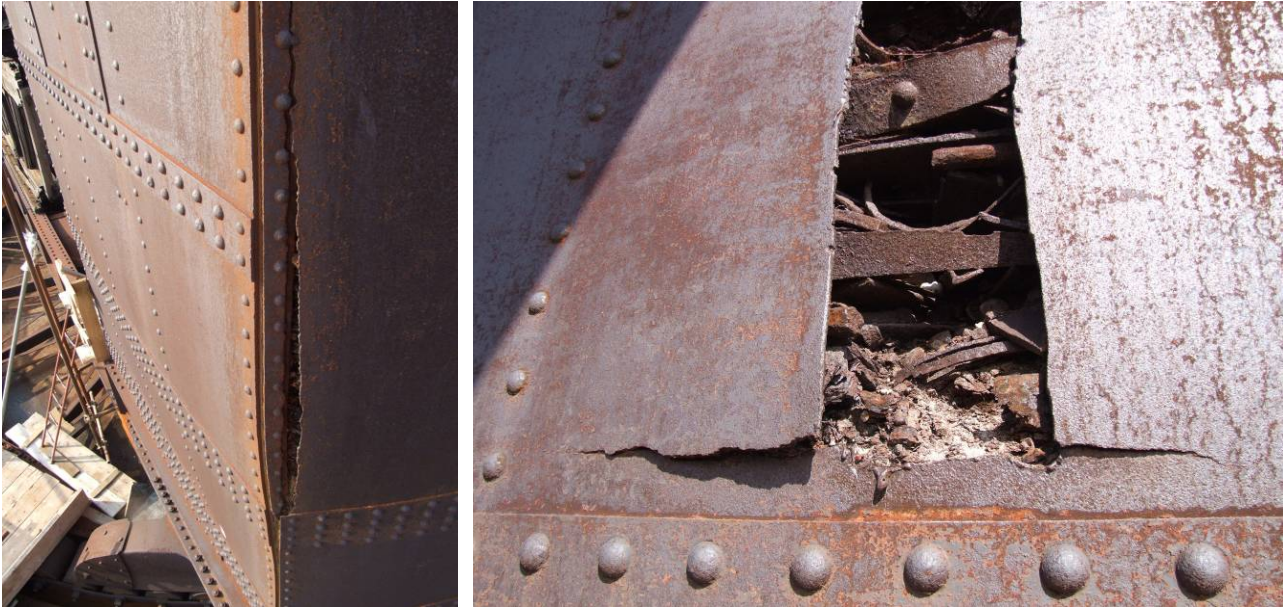
Fig. 5.4.51: Crack on the rear of the counterweight and in particular on one of the inspection holes present in the box

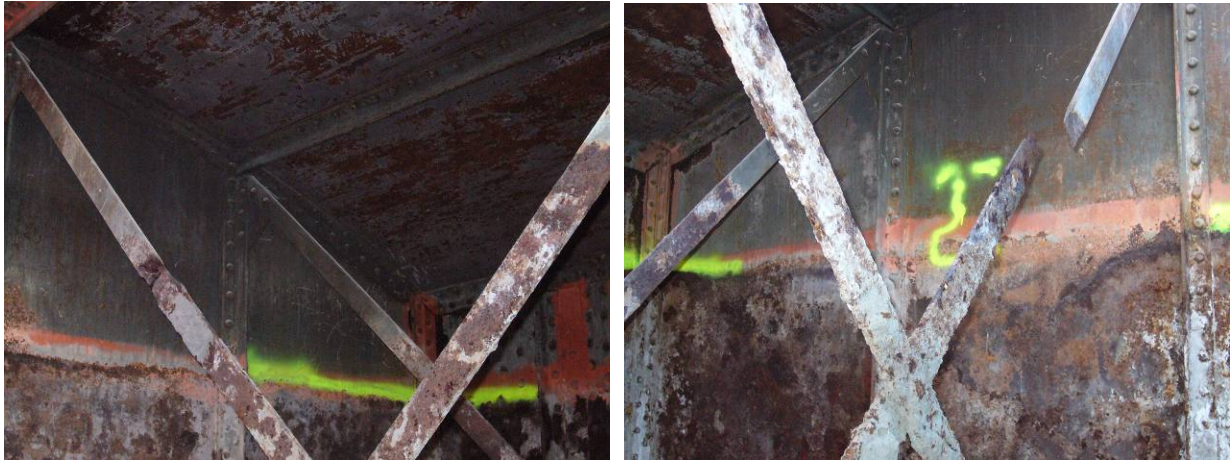
Fig. 5.7.11: bracing cross with cracks due to excessive tensile stress

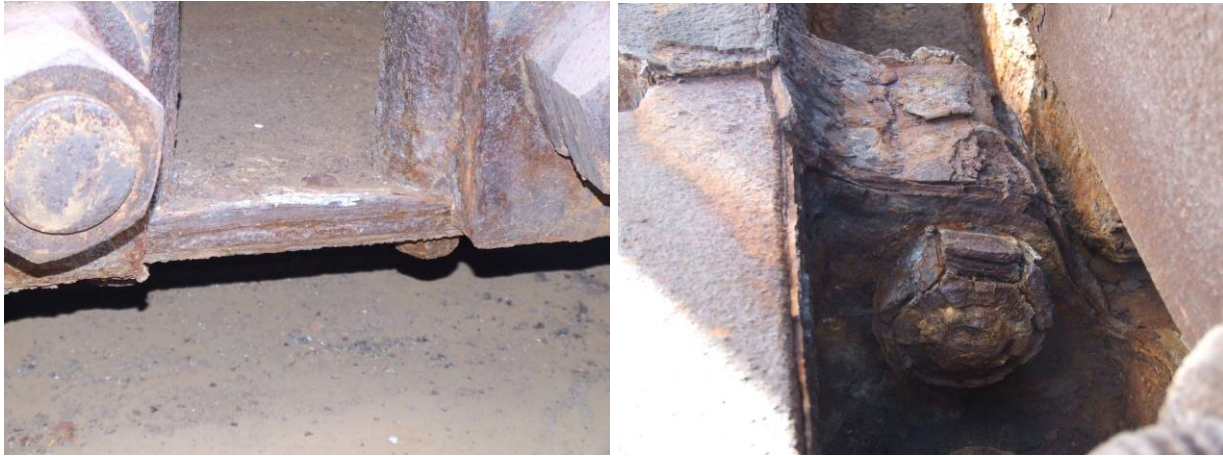
Fig. 5.8.13: Details of the metal elements degradation

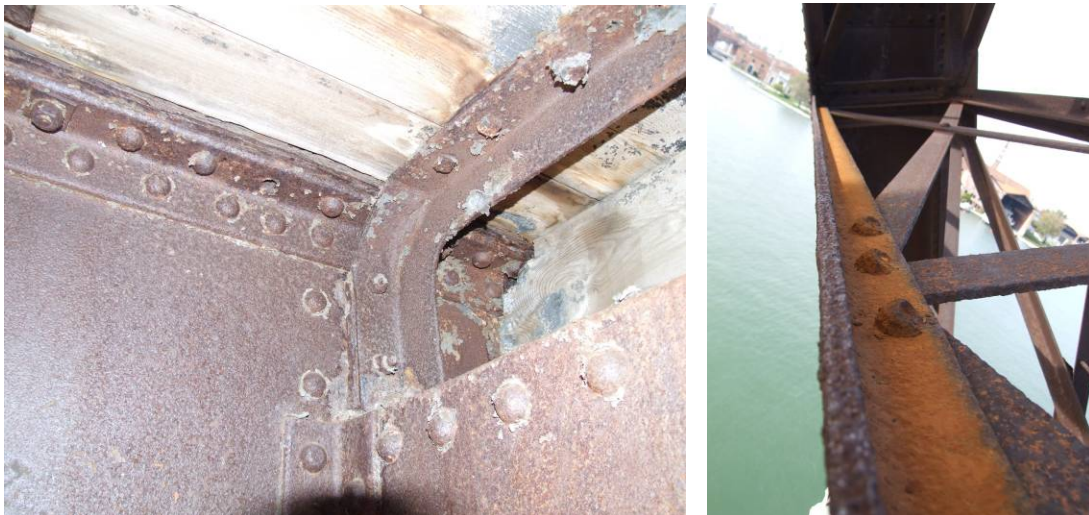
Fig. 5.8.14: Details of missing or degraded rivets

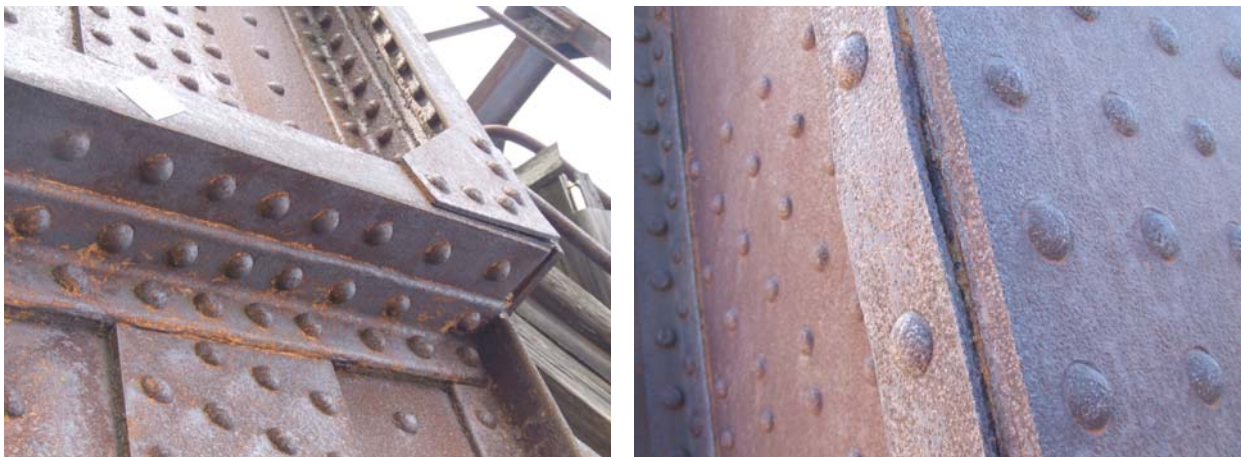
Fig. 5.8.17: Separation between the cracks of the profiles

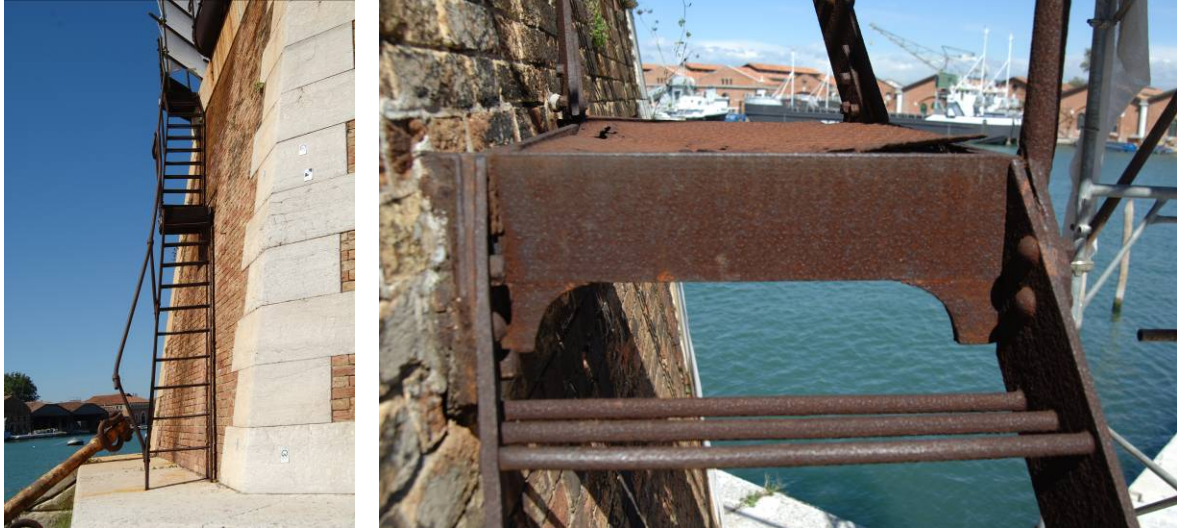
Fig. 5.8.18: Stairs and landings degradation

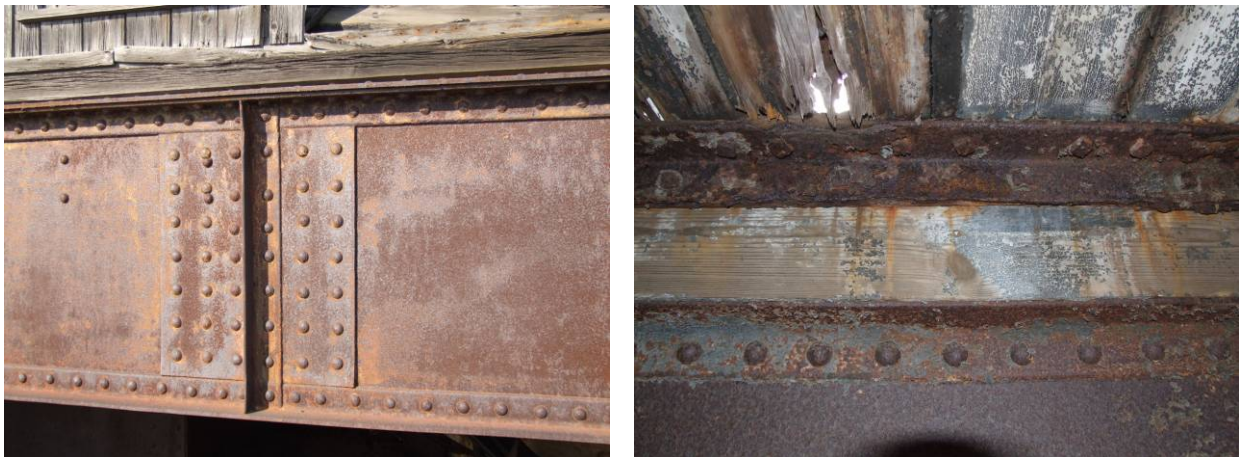
Fig. 5.8.19: Detail of unrecoverable wooden beams

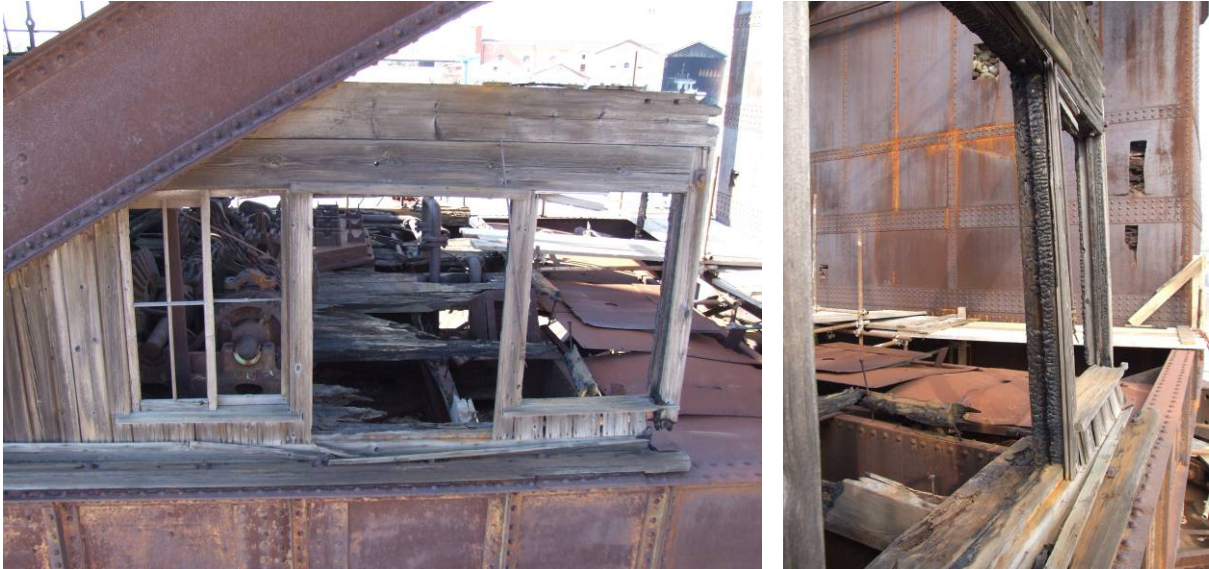
Fig. 5.8.20: Conditions of the cabin after the fire

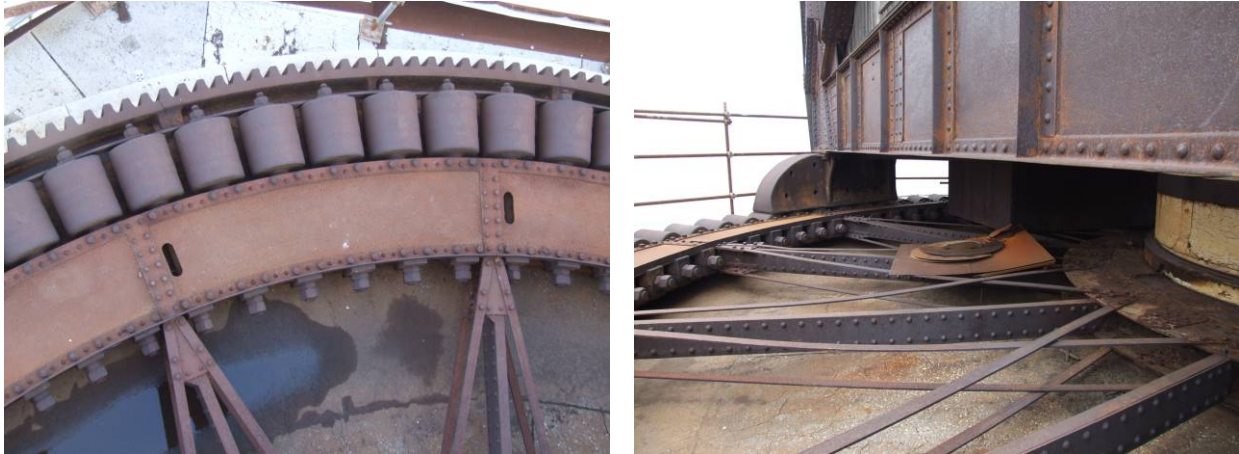
Fig. 5.8.28: Backwater problems at the top of the vault
