The effect of heterogeneities and small cavities on levee failures: The case study of the Panaro levee breach (Italy) on 6 December 2020

Francesca Ceccato 💿 | Paolo Simonini

Department of Civil Environmental and Architectural Engineering (DICEA), University of Padua, Padua, Italy

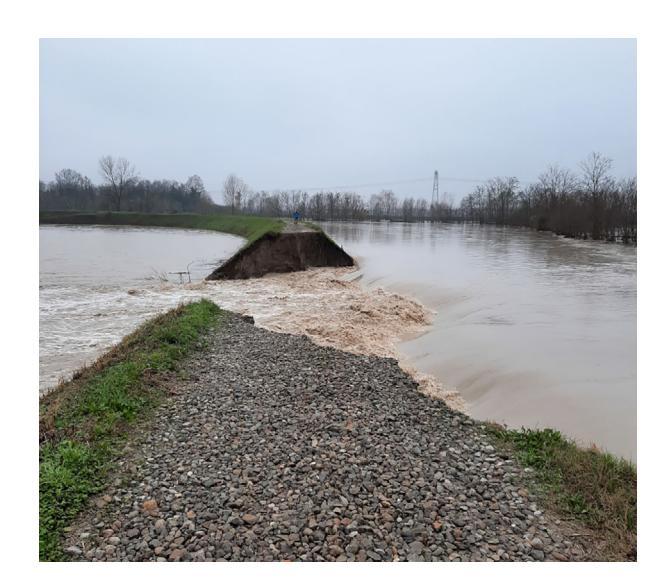
missing. However, it is clear that the water level was much lower than the levee crest (about 1.5 m), as shown in Figure 2. Previous evaluations of the safety factor, as connected to overflowing and seepage in undisturbed levees, did not suggest significant risks at this location (Fiorentini, Moretti, & Orlandini, 2016). However, as reported above, this levee failed when river-flow was significantly less than the design limit as also occurred in 2014 along the Secchia and Panaro Rivers (Orlandini et al., 2015).

FIGURE 2 Photo of the breach at 8:40 on 6 December.

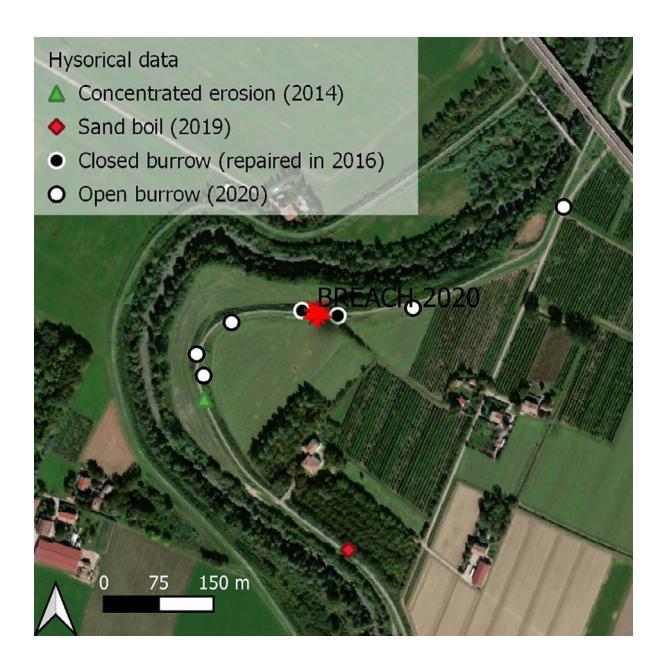
In the last decade, two erosion phenomena were observed very close to the new breach (Figure 3): (i) sand boils were observed in 2019 and kept under control with sandbags rings and (ii) concentrated erosion due to animal burrow was observed in 2014, leading to a 3 m settlement of the crest rapidly repaired preventing breach opening (Orlandini et al., 2015).

Near the location of the breach, two animal burrows were detected and repaired in 2016 by tamping backfill soil into the holes due to economic restrictions (Figure 3). However, the dens can be very long and with complex structures (Borgatti et al., 2017; Fischer and Dunand, 2016), therefore, complete repair of the cavity

FIGURE 3 Historical and field observation near the breach (Google Satellite 8 September 2022. https://mt1.google.com/vt/ lyrs=s&x={x}&y={y}&z={z})

system using this method may be difficult and it is possible that part of the tunnel was still present. Despite the effort paid by the regional authority to control the population of burrowing animals, in recent years, their number has probably increased, as suggested by several sightings of badgers, foxes, porcupines, and nutria. Furthermore, five open burrows were detected a few days after the breach (Figure 3) and rapidly repaired.

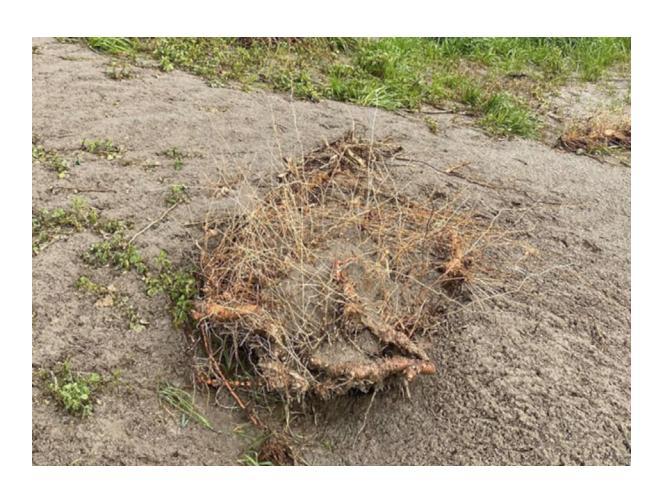
FIGURE 5 Rhizomes of Adundo Donax found in the crevasse spillway.

the rhizomes were still present and one could speculate that they could be partially rotten leaving a cavity.

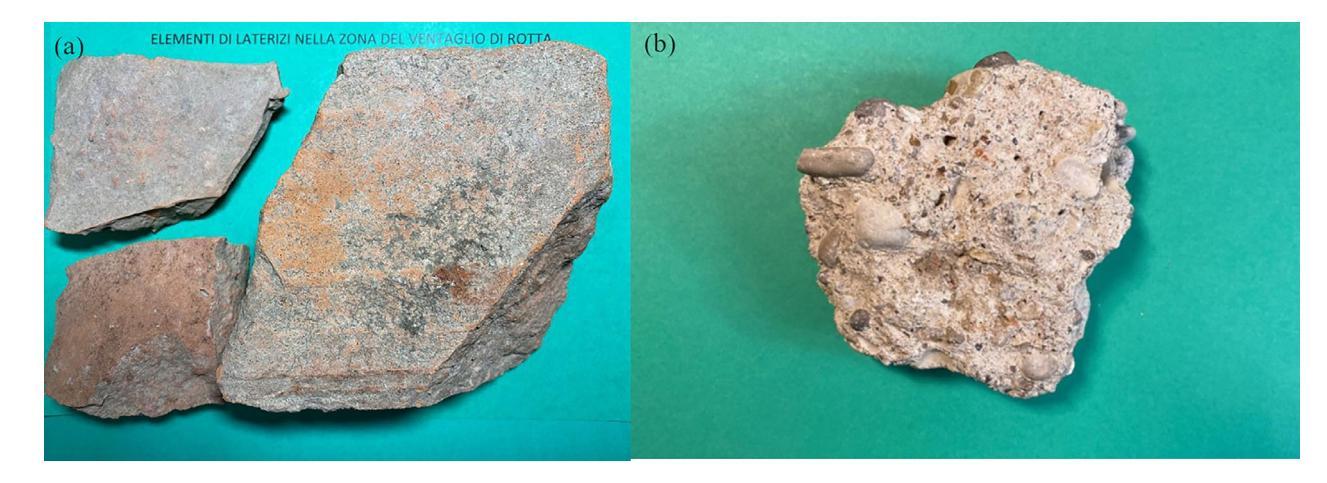
Peculiar elements were found in the crevasse spillway, that is, 518 pieces of ancient bricks and concrete blocks dated back to the late 19th century (Figure 4) and rizhomes of Arundo Donax (giant cane; Figure 5). The relatively small amount of bricks suggests the possible presence of an old buried structure in the levee, but no documentation was found. Arundo Donax is a tall perennial cane belonging to reed species, it can grow in a variety of soils, but prefers wet-drained soils. Aerial photos confirmed the presence of this vegetation until 2012, then it was removed during maintenance works, but some of

FIGURE 4 Material found in the crevasse spillway: (a) lateritic pieces and (b) concrete pieces dated 19th century

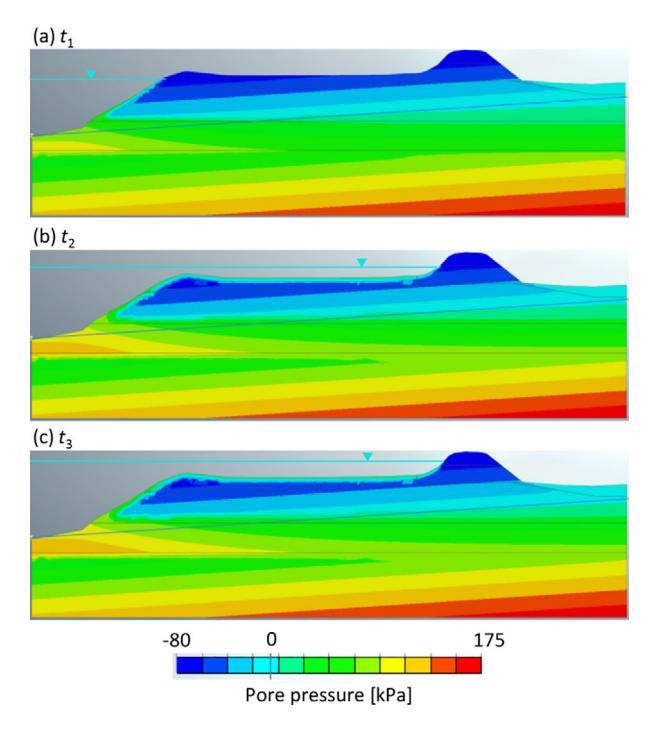
FIGURE 13 Pore pressure distribution at different time instants (negative pressures are matric suctions)

Figure 13 shows the pore pressure distribution at different time instants indicated in Figure 12. It can be noted that due to the low permeability of the unsaturated silty sand and the short duration of the flood, the wetting front does not penetrate significantly inside the levee body. Significant pore pressure changes occur only on the waterside slope, with limited consequences on the overall embankment stability. Indeed, the FS of the slope, calculated with SRM, is equal to 2.9 throughout the simulation. The embankment core tends to remain largely unaffected by changes in river water levels, due to its soil retention characteristics. This behavior is in agreement with monitoring data on similar embankments on the Secchia river (Rocchi et al., 2020).

These results show that macro instability is very unlikely because FS is significantly greater than one. The wetting front does not reach the outer surface; thus, piping cannot be triggered; furthermore, this internal erosion mechanism manifests with sand boils and usually progresses slowly, but this failure occurred very rapidly apparently without any sign. We can conclude that this levee, assumed homogeneous, should have been safe during the considered event and the observed failure can only be explained assuming the presence of a local defect.

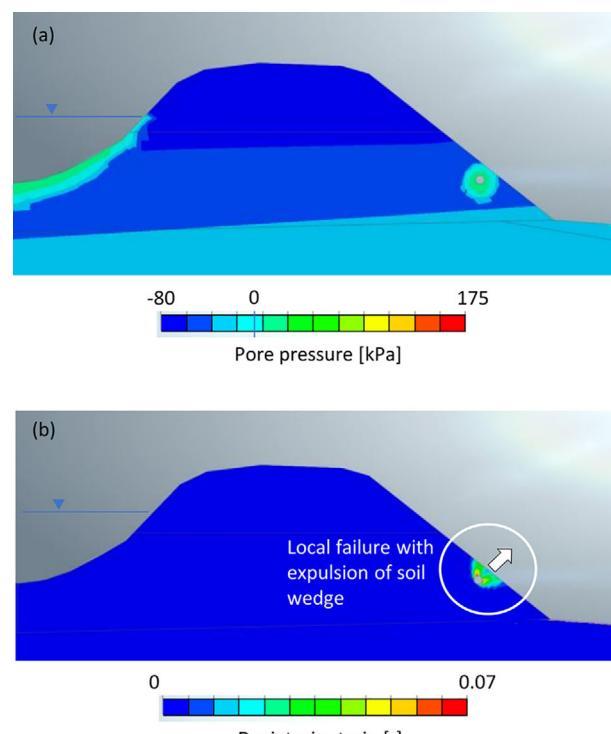
FIGURE 14 Model results for damaged levee: (a) pore pressure and (b) deviatoric strain at t_3

Figure 14 shows the pressures and deviatoric strains at t_3 . Numerical convergence could not be achieved after this point, meaning that the levee is failing. The deviatoric strain highlights the development of two failure

surfaces that depart from the boundary of the cavity to the slope surface; they delimit a soil wedge that is expulsed by the increasing pressure load inside the cavity. This superficial local failure can start a concentrated erosion leading very rapidly to the opening of the breach, as illustrated in Figure 15.

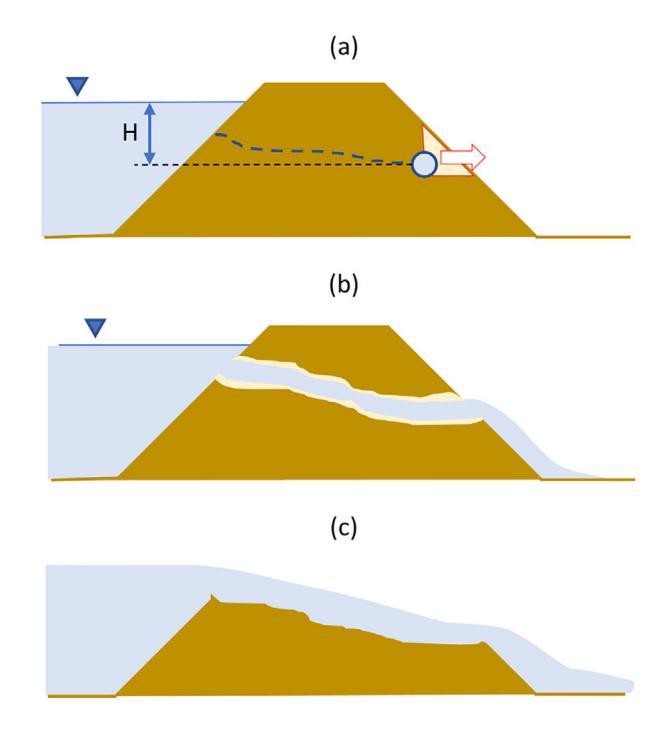
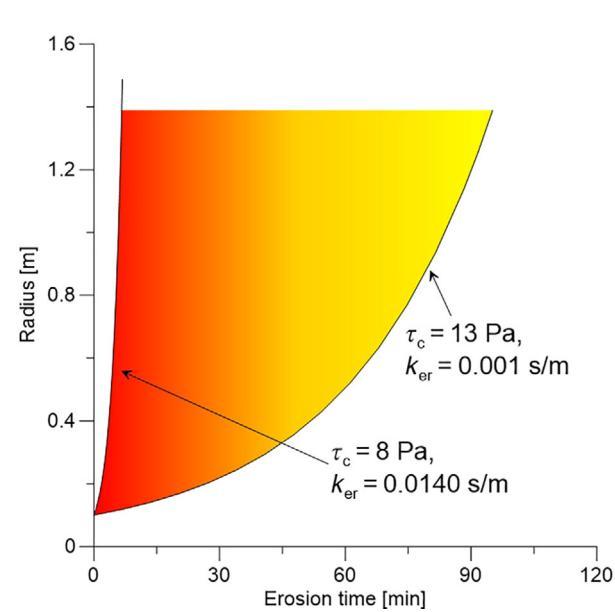
FIGURE 15 Hypothesized failure mechanism: (a) failure of the soil wedge, (b) progression of concentrated erosion, and (c) opening of the breach.

When the contact shear stress generated by the flow through the pipe exceeds the critical soil shear stress τ_c , particles are eroded and the size of the conduct increases leading to failure.

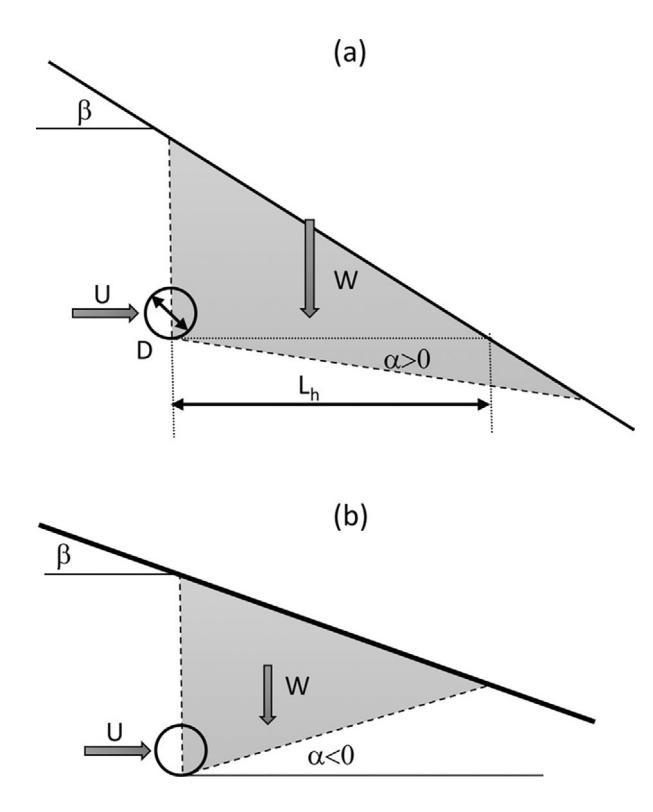
We assume the presence of a cavity with diameter D located at a distance $L_{\rm h}$ from the outer slope, that is inclined at an angle β (Figure 17). This cavity is in communication with the river, thus the internal pressure increases with the hydraulic level ($p = \gamma_{\rm w}H$), but no additional assumptions on the size and path are added. The Mohr-Coulomb failure criterion is used, and the soil shear strength parameters are φ and *c*. A 2D wedge stability is considered as shown in Figure 17, the base of the wedge is inclined of an angle α , which is assumed positive clockwise in Figure 17. If $\alpha > 0$, the FS can be expressed as Equation 4, where the wedge weight and the pressure load are unstabilizing forces as shown in Figure 17a.

FIGURE 17 Simplified failure mechanism of the landside slope.

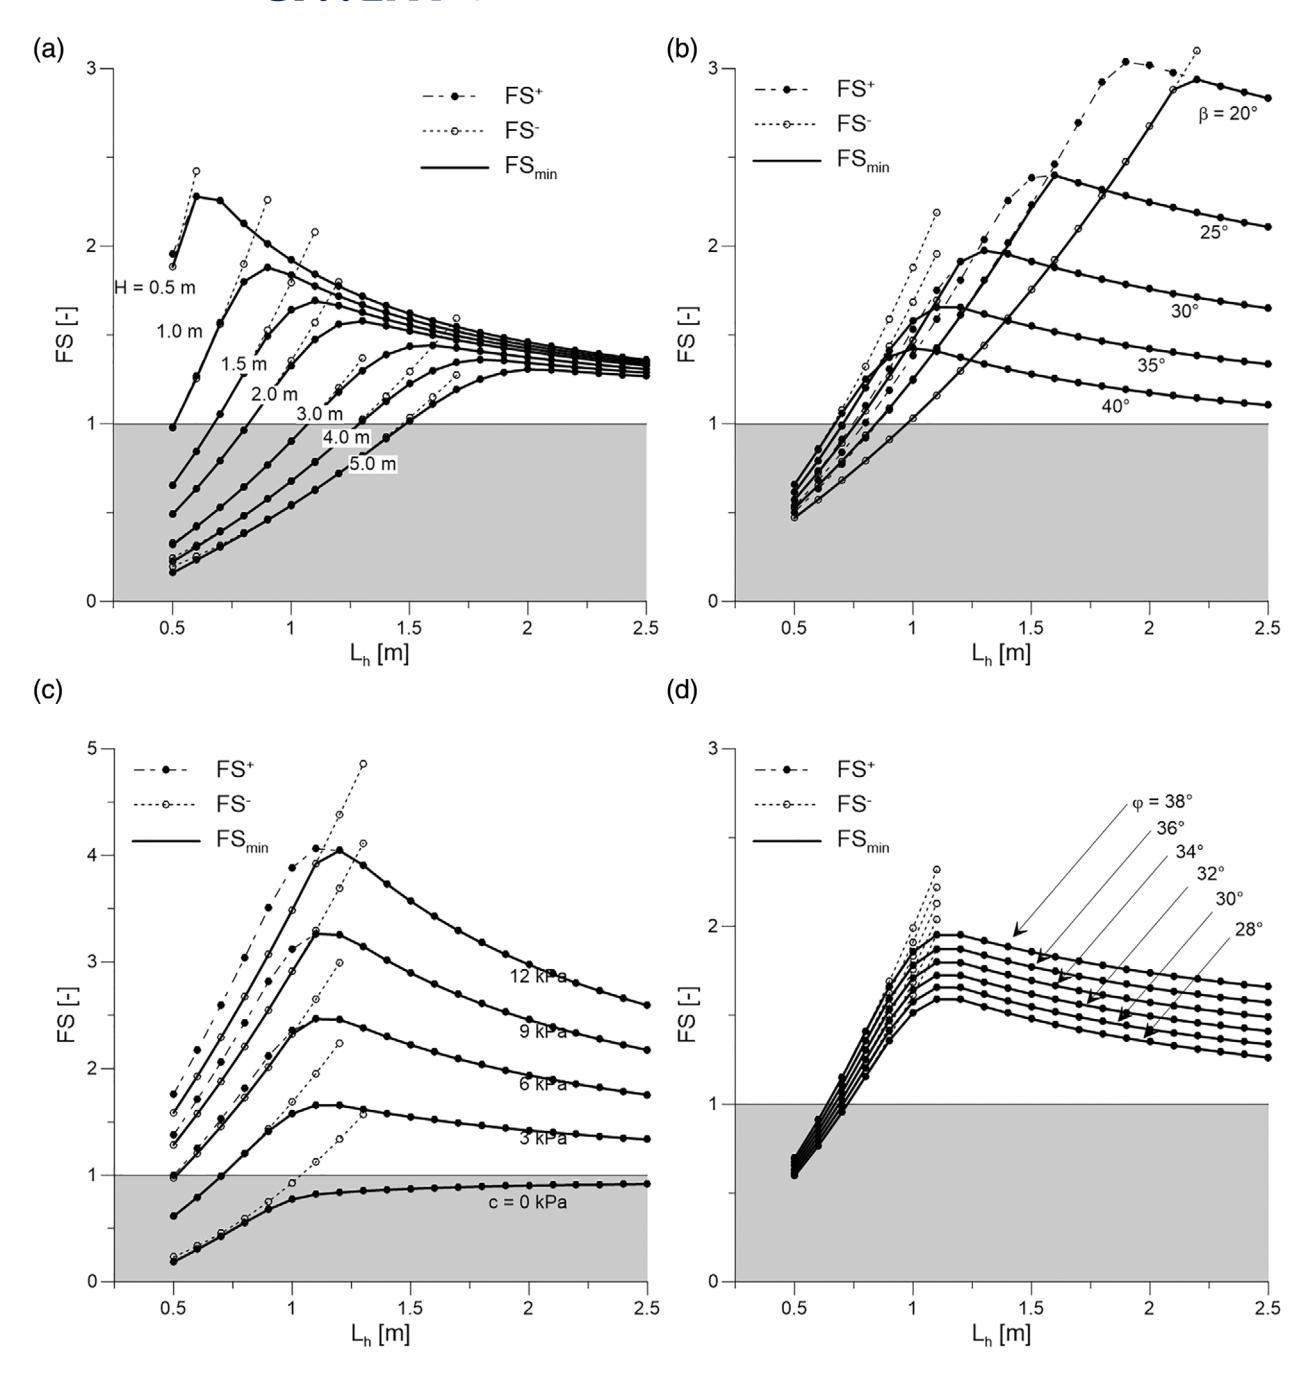
Figure 19 shows the effect of φ , c, β , and *H* on FS as function of $L_{\rm h}$. As expected, the FS decreases with the increase of *H* (Figure 19a). For small values of $L_{\rm h}$, FS decreases with the decrease of β and $\alpha_{\rm min} < 0$ is usually observed; in contrast, for large values of $L_{\rm h}$, FS decreases with the increase of β and $\alpha_{\rm min} > 0$ is obtained. The friction angle has a limited impact, while the cohesion significantly modifies FS. Evaluating this parameter is not

FIGURE 19 Factor of safety (FS) as function of L_h (if not otherwise specified H = 1.6 m, D = 0.25 m, $\gamma = 18$ kN/m³, c = 3 kPa, $\varphi = 30^\circ$, $\beta = 35^\circ$): (a) effect of hydraulic head, (b) effect of slope inclination, (c) effect of cohesion, and (d) effect of friction angle.

Reasonable parameters for the considered case study are H = 1.6 m, D = 0.25 m, $\gamma = 18$ kN/m³, c = 3 kPa, $\varphi = 31^{\circ}$, and $\beta = 35^{\circ}$, that provide FS = 1 for $L_{\rm h} = 0.7$ m. This further supports the hypothesis that a cavity, buried at shallow depth, could be the cause of failure.
