Proceedings of the
joint international event
9th ARQUEOLÒGICA
2.0 & 3rd GEORES,
Valencia (Spain).
26–28 April 2021

AN INTEGRATED APPROACH AIMED AT THE PROTECTION OF CULTURAL HERITAGE: FROM THE GEOMATIC SURVEY TO HBIM AND AR REPRESENTATION OF VILLA PISANI (STRA, ITALY)

Michele Monego^{a,b}, Simone Maioli^c, Matteo Salvalaggio^{a,*}

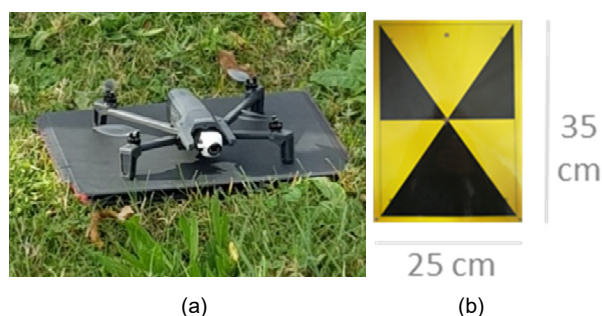
Figure 2: Aerial photogrammetric survey: a) Parrot Anafi drone; b) control point.

For scaling and georeferencing the survey 20 planar targets (Fig. 2b) were positioned on the ground around the building and measured by GNSS acquisition with RTK technic. The distribution of the GCPs only on the ground (and not on the façades or roof) represents a clear limit for an optimal control of the resulting model. However, it is not possible to access the roof area with a reasonable safety margin if not with a considerable use of means and time.

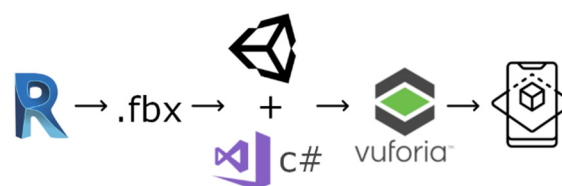
Figure 4: AR app development process.

Vuforia was used for the development of the apps, an advanced AR building engine that inside Unity provides an intuitive platform for creating augmented reality apps for Android and iOS platforms (Fig. 4). In practice, the Augmented Reality (AR) application permits, through the camera of a compatible device and the recognition of a predetermined target, to view the model of the Villa in correspondence of the target surface. In addition to visualization, the app makes possible to interact with the model.

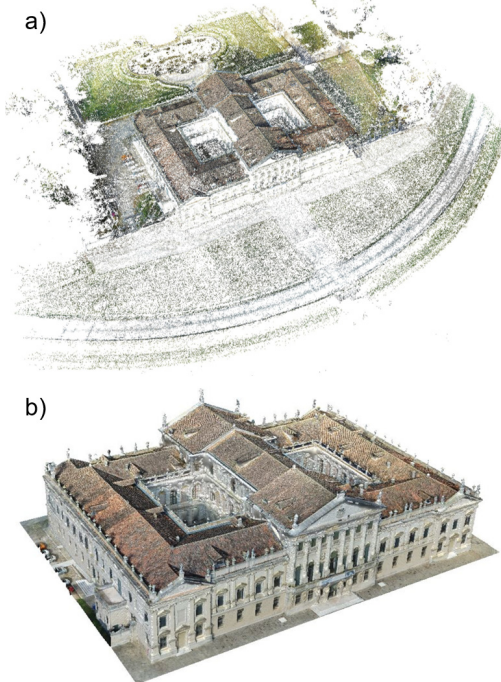
Figure 5: Processing of images (Agisoft Metashape): a) Sparse cloud of Villa Pisani from SfM; b) Textured mesh surface model.

The processing of the 782 images started with the aerotriangulation phase and brought to the extraction of a sparse cloud consisting of 747,631 tie points (Fig. 5a). A more specific area around the building was selected for the further processing that produced a dense cloud of 114,948,462 points and a triangular mesh model of 26,183,087 (Fig. 5b). The high density of points is a necessary feature to get an adequate model, which can be used for the detection, for example, of small anomalies in the roof surface. In order to validate the geometrical accuracy of the result, a set of GCP (Ground Control Points) have been measured and introduced in the processing phase. These targets provided the georeferencing of the data and the error evaluation. The coordinate reference system is the Italian national projection system Gauss-Boaga (west fuse), classified with code EPSG: 3003 - Monte Mario Italy (zone 1).

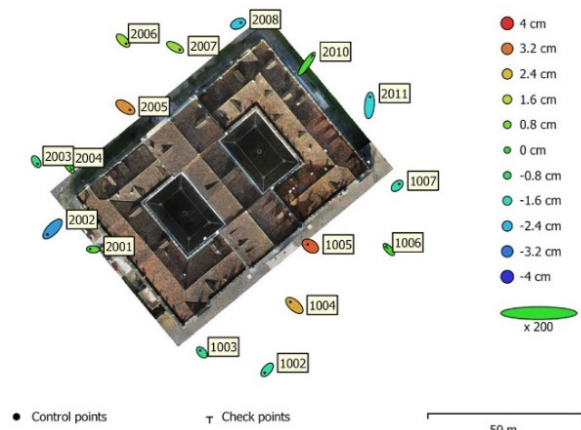
Figure 6: GCP locations and error estimates.

In this case the GCP are divided in Control Points, the targets that were used also for scaling and georeferencing the model, and Check Points that are the markers used only for the error verification. The RMSE values are shown in Table 2 while the graphical representation can be observed in Figure 6.

Setting	Control Points	Check Points
Number of points	13	3
X error (cm)	1.0	1.3
Y error (cm)	1.1	1.9
Z error (cm)	2.0	0.3
XY error (cm)	1.5	2.3
Total error (cm)	2.5	2.3

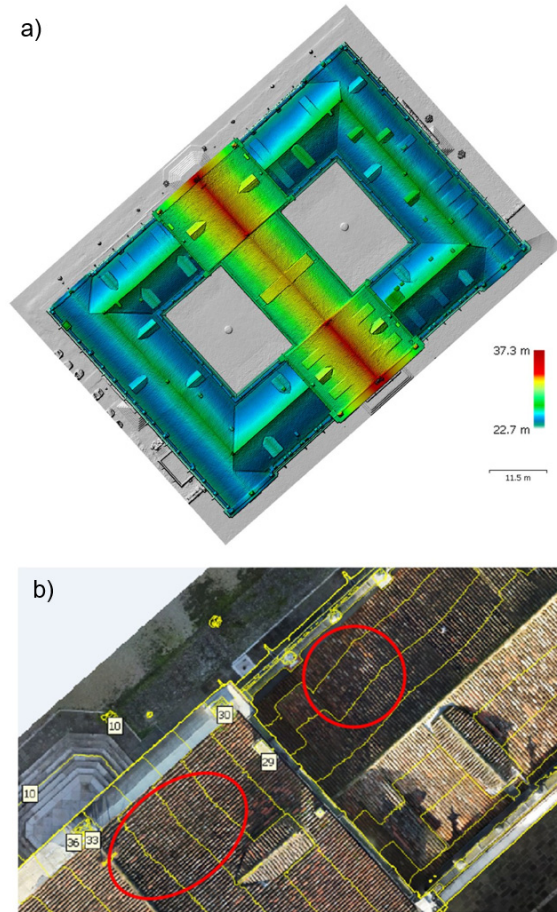
Figure 7: Products extracted from the 3D model: a) DEM with height colour scale of the roof part; b) Orthophoto with contour lines (interval of 1 m) with an example of two anomalies that could imply more detailed in-site inspections.

A further product extracted from the 3D model was a DEM (1.2 cm/pix) that allowed some observations focused on the health status of the roof coverage. While the inspection of the conservation status of the tiles could be done through a visual check of the single high-resolution images taken by the drone, a deeper view of the structure was made possible by morphological analysis. First, a height map was created for the DEM searching for a customized colour scale with a customized palette that permits highlighting the geometry of the roof pitches as shown in Figure 7a.

Besides this, a set of contour lines with interval of 10 cm and 1 m was produced from the DEM and so the capacity of detecting the morphological anomalies was improved (Fig. 7b). In some parts of the roof small differences in the continuity of the colour or the lines were evident and could be considered as surface displacement caused by underlying deformations. Of course, the age, the materials and a physiological adjustment of the structure must be considered as factors in the global evaluations. The area that was identified as possibly subject to

problems will be directly investigated with site inspections and targeted diagnostics on the roof beam structure.

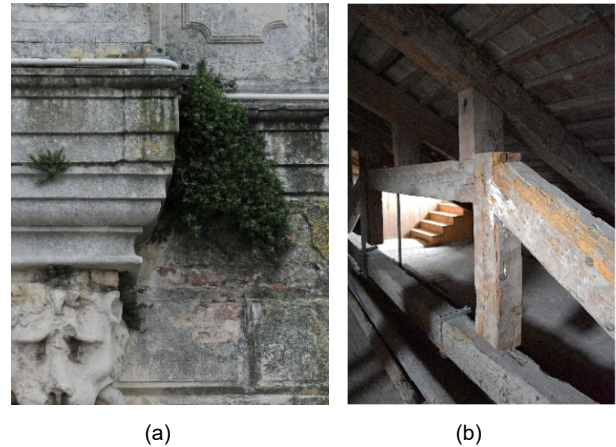
Figure 8: Detailed analysis of Villa Pisani external surfaces: a) Southern façade decay detail; b) roof system detail.

The large amount of data elaborated provided the base for the performance of a detailed analysis of Villa Pisani external surfaces. First, a map of the decay phenomena and crack patterns was prepared, which revealed the effects of weathering. Plaster and stone covers, in some cases, are powdered leaving the underneath structural masonry vulnerable to deterioration (Fig. 8a), especially near the foundations. Some deposits of vegetal and inorganic patina were detected, as well as black spot and pouring, due to stagnating water and humidity.

Furthermore, the processing of on-site data allowed to perform a primary detection of the displacements and strains occurred and occurring in the main structural parts (e.g. walls and roofs). In particular, the analysis of Figure 7 permitted to assess the health of timber roof systems, made of truss beams and purlins. The anomalies detected provided the focus of the investigation plan on that parts, whose timber components are being investigated (Fig. 8b).

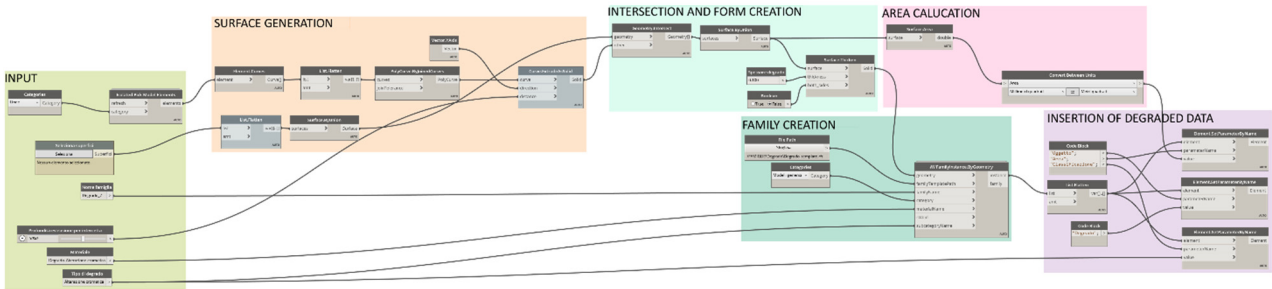
Figure 10: Dynamo code for the execution of the degradation mapping in Revit.

In the Revit environment, it is not easy to manage these operations and thus it was necessary to use the tool Dynamo visual programming, integrated within the program. First, through the observation of the building 3-D configuration and the photographic documentation, the state of conservation was investigated, detecting the

different forms of degradation and mapping them into CAD environment as closed areas. Following, the areas were imported into the Revit software. These were converted into real BIM objects thanks to the use of a script developed in Dynamo (Fig. 10). The script first proceeds by asking the user to select the surface on which the degrade should be placed and the thickness to assign to it. After that, it is necessary to select the closed areas (consisting of model lines) that correspond to a specific type of deterioration. Given these input values, the selected area is extruded until its intersection with the surface. This creates a geometry and a subsequent generic family.

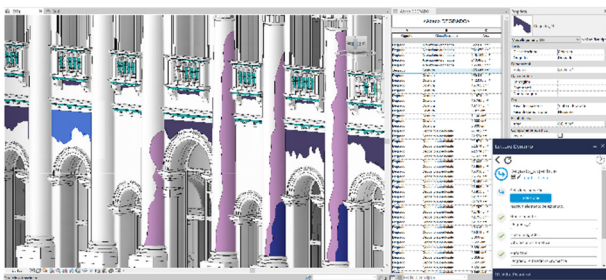
Figure 11: Mapped decay in the Revit environment.

Once the degradation modelling and related information have been obtained, it will be possible to create the schedule including all the information necessary for adequate description and quantification (Fig. 11).

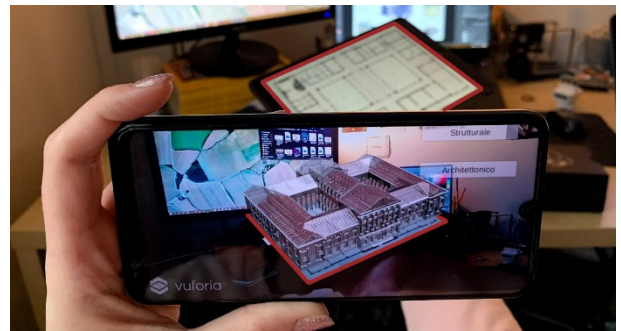
Figure 12: A view of the structural model through the AR app.

visualization in order to select and highlight separately the 3D architectural or structural components (Fig. 12). In this way, professionals in the field such as architects and engineers can use the app as an open-source dissemination tool and integration to paper documents.
