# Physical vulnerability to dynamic flooding: Vulnerability curves and vulnerability indices

Dynamic flooding  
Vulnerability curves  
Vulnerability indices  
Degree of loss  
European Alps

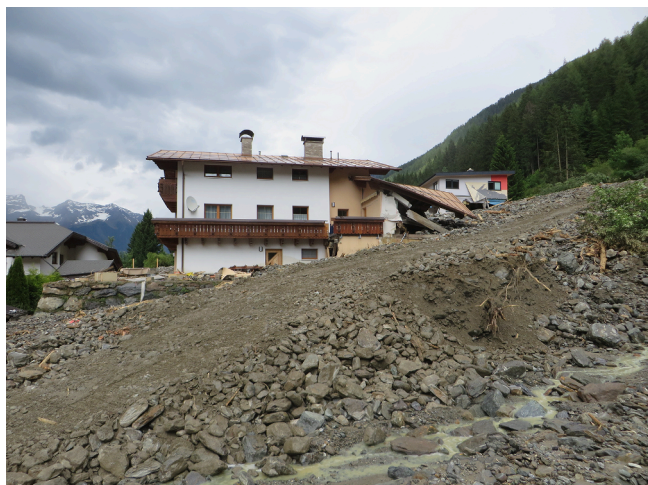
Fig. 2. Damaged buildings in Schallerbach (Tyrol, Austria). The building is located on the slope and, for this reason the deposit height is very high at the back side of the building in comparison with the deposit height observed in the opposite side. (Source: Austrian Service for Torrent and Avalanche Control, with permission).

Furthermore, some of the indicators (e.g. height of openings and height of the surrounding wall) are directly related to the observed process intensity. Process intensity is often proxied by the deposition height (Fuchs et al., 2007; Totschnig and Fuchs, 2013), neglecting any other information on process intensities such as the flow velocity and pressure (Gall et al., 2009; Mazzorana et al., 2013; Milanesi et al., 2018; Sturm et al., 2018a; Chow et al. 2018). Information regarding the process intensity is usually collected also from photographic documentation (Papathoma-Köhle et al., 2012). Nevertheless, the assessment is not straightforward since in mountain environments buildings are often located on a slope, meaning that the deposition height may vary around the building (Fig. 2).

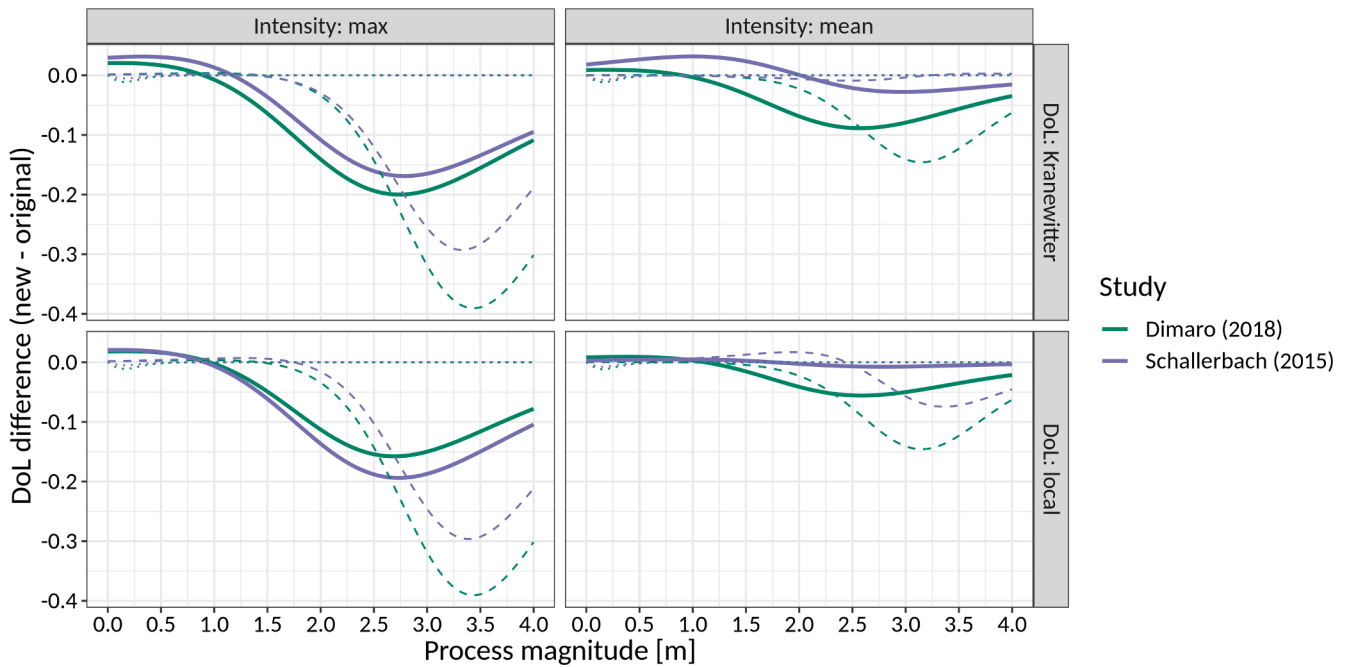
**Fig. 5.** Figure shows the difference between the original Beta model (vulnerability curve) and the vulnerability relation for the case studies of Dimaro and Schallerbach. The solid lines indicate the difference in mean damage of the underlying Beta distribution as a result of different process intensities (deposit height). The dashed lines show the difference in probability of an undamaged building, and the dotted lines show the difference in the probability of a building being completely destroyed.

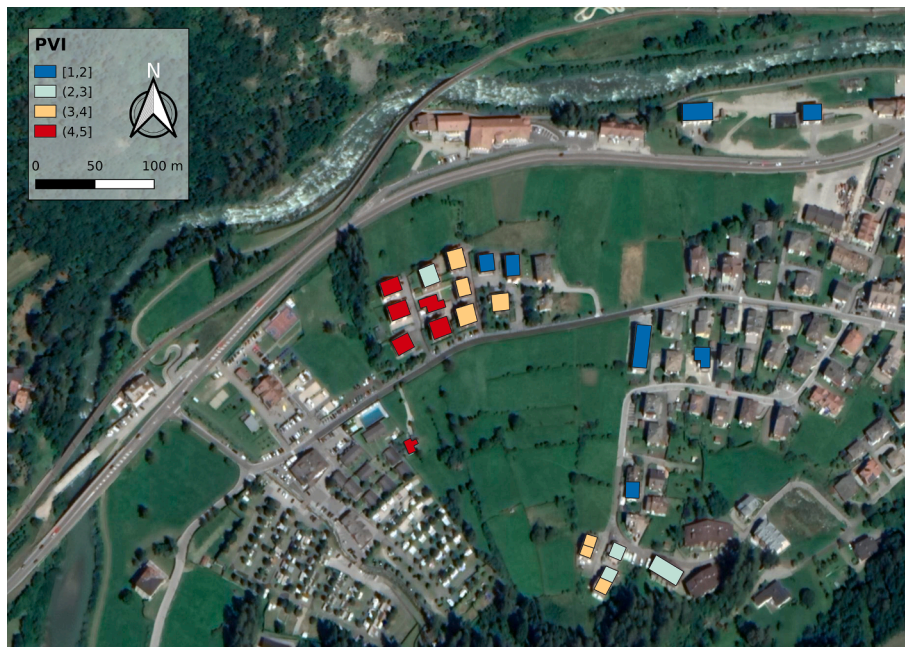
**Fig. 6.** Spatial distribution of the PVI (four vulnerability classes: very low (blue), low (light blue), high (orange), and very high (red)) in Dimaro.

According to equation (1), the physical vulnerability index was calculated for the 24 reviewed buildings with the subsequent results. The spatial distribution of the PVI is shown in Fig. 6. The PVI per building is shown in Appendix A.

The validation of the PVI in Dimaro is based on the comparison between the PVI of the buildings and the observed degree of loss during the 2018 event. From the distribution of the PVI it becomes evident that there is a cluster of buildings with high PVI in the east part of the village. Buildings with lower PVI are mostly located in the lower part of the valley, and buildings with higher PVI are located in proximity to depositions of the 2018 event. Nevertheless, some buildings located on higher ground close to the forest have a low PVI (blue colour) because they may also be protected by the vegetation around them. In the highly-exposed cluster of buildings, a building with lower PVI (orange colour) is surrounded and probably also protected by some buildings with higher PVI (red colour). Such so-called shielding effects of buildings to neighbouring structures in mountain areas have been also recently reported from laboratory studies by Sturm et al. (2018a, b).

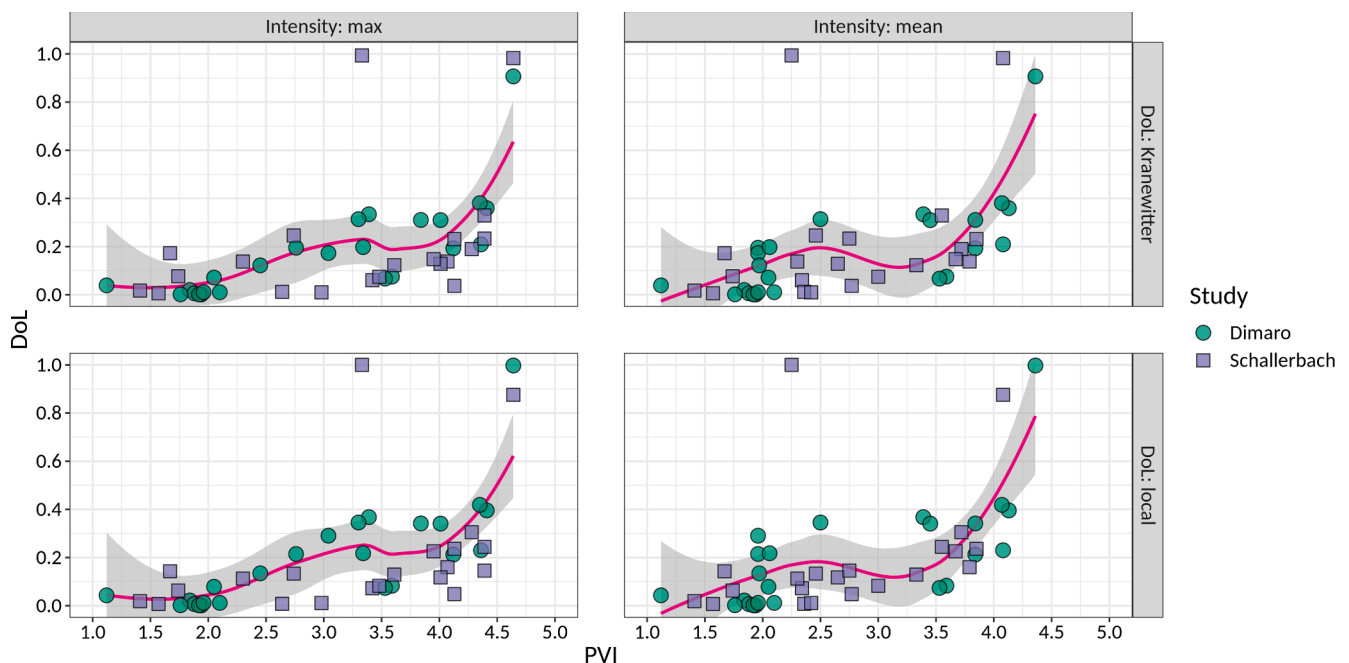
Fig. 8. Panels showing the PVI calculated considering maximum (left) and mean (right) intensity and local degree of loss (lower) or degree of loss (DoL) calculated after Kranewitter (2017) (upper).

The relationship between the PVI and the degree of loss is demonstrated in Fig. 8 by four panels. The left panels show the PVI for the maximum process intensity and the right panels show the PVI for the mean intensity. In all plots, it becomes evident that buildings that have experienced a low degree of loss have been also assigned a very low PVI.

In turn, with an increasing PVI the degree of loss is also increasing in all four panels, which is consistent with the overall expectation. Similar to the vulnerability curves, the key variable here is the process intensity, which is also mirrored in equation (1) accordingly by a high weighting factor. Moreover, the insignificant influence of different methods to calculate the degree of loss on the overall result is evident.

From all these observations it can be assumed that when the maximum process intensity is considered, the PVI performs better than when the mean intensity is considered, which is in line with the fact that the original weighting was established using maximum process intensity as a basis. However, as far as the degree of loss is considered, the differences are minimal.

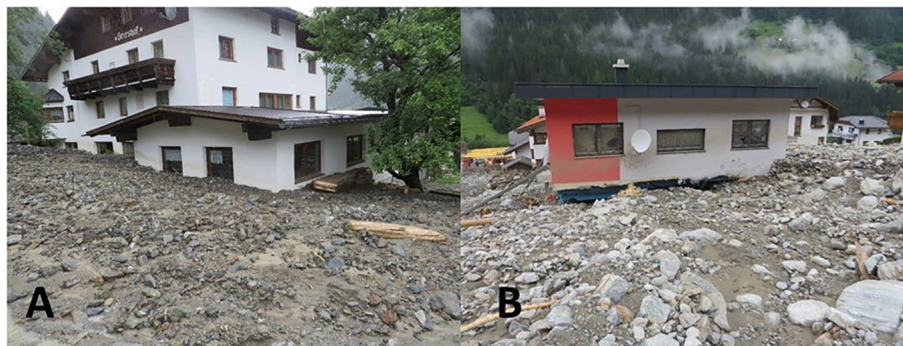
Fig. 9. Two buildings that experienced the highest degree of loss (approximately 1) in the Schallerbach case study (Source: WLV).
