The paper was published in the proceedings of the 13th International Symposium on Landslides and was edited by Miguel Angel Cabrera, Luis Felipe Prada-Sarmiento and Juan Montero. The conference was originally scheduled to be held in Cartagena, Colombia in June 2020, but due to the SARS-CoV-2 pandemic, it was held online from February 22nd to February 26th 2021.

Passive “floating” composite anchors for the gradual stabilization of a landslide

L. Brezzi¹, D. Pasa¹, A. Bisson², L. Marini³, S. Cola¹

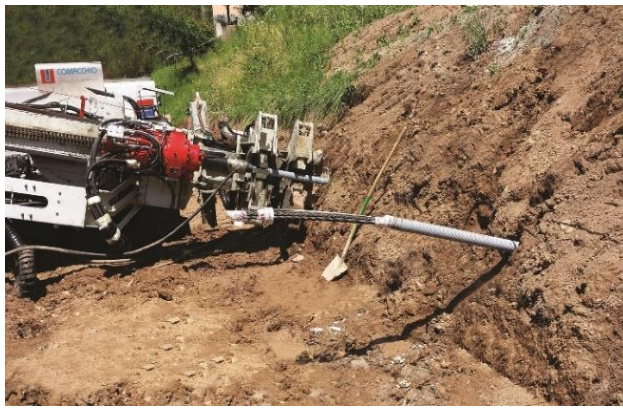
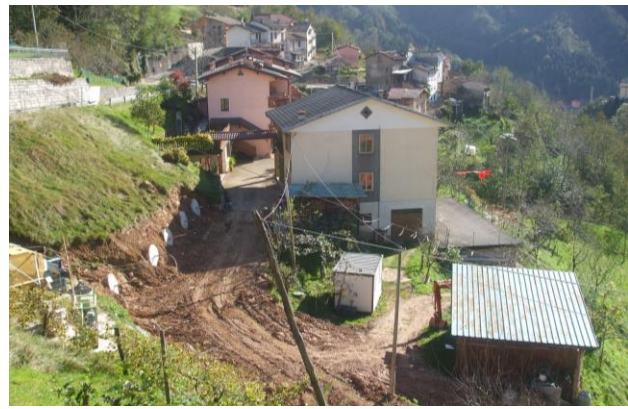
Figure 5. Installation of composite anchors at Cischele landslide (2014): (a) Bar and strands already infixed; (b) External concrete plates of alignment B visible at the ground surface near the house and below the road.

From June to December 2014 a first group of 32 composite anchors were set up (Fig.5). They are 40-50 m long and formed by a 76 mm bar coupled with 7x0.6" pre-tensioned strands. The pre-tension is limited to 250 kN per anchor to obtain the *partially active* configuration. Thanks to the presence of inner tendons, the nominal tensile strength of anchors increases from 1160 to 2840 kN with an increment of cost less than 20% with respect to the self-drilling bar alone.

The head of each anchor was connected with a prefabricated frustoconical reinforced concrete slab, with an outer diameter of 1.5 m (Fig.5). The reinforcements were arranged in three rows (alignments A, B and C) with horizontal spacing of 5 m: two rows in the Northern portion of the landslide, below the road, and one in the Southern portion, downstream of the housing (Fig.3).

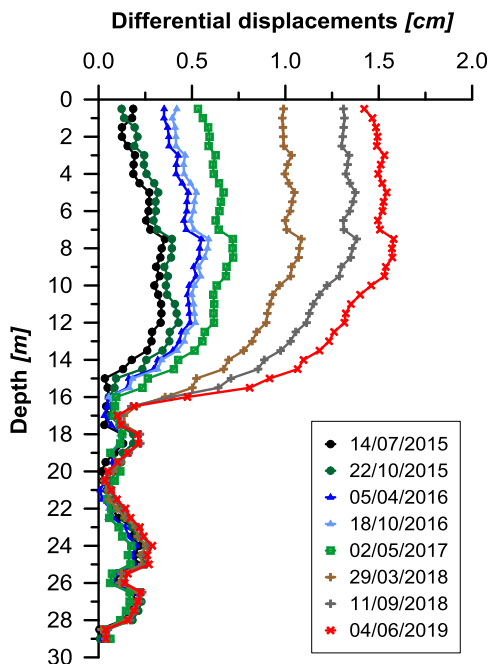
Figure 6. Vertical profile of landslide displacements recorded at inclinometer B from 2015 to now.

The displacement profiles measured at inclinometer B (Fig. 6) evidences that the landslide is still active, and it experiments some accelerations in occurrence of rain events. Nonetheless, the accumulated displacements are small, especially considering the increment related to the extreme rain event of November 2018.

It seems possible to conclude that the landslide is partially stabilized but not completely arrested. Moreover, some in progress damages are evident on the building in the Northern part of the slope. Consequently, the administration is now planning a supplementary installation of anchors, but in order to choose the optimal anchor configuration a 3D Finite Element model of the slope is previously realized.

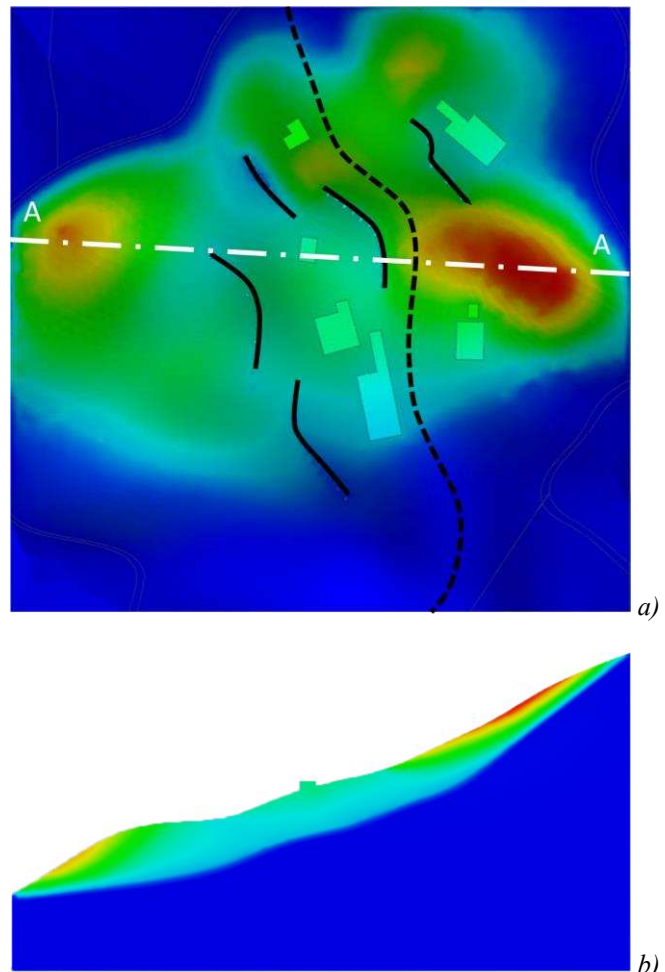
Figure 9. (a) Contour plot of the total displacements and (b) A-A section detail (*case 3*, WT = -10 m and FS = 1.25).

In an SRM analysis, the displacement entity corresponding to the critical SRF has not a real meaning, but their map allows to evaluate the areas more susceptible to instability and to compare their extension in various conditions. Figure 9b presents the displacements distribution on the most critical section resulted for the *case 3* with WT at -10 m and FS = 1.25 (the section is also indicated in Figure 9a). It is evident that the installation of the new group of anchors stabilizes the central portion of the landslide, i.e. the zona close to the road, but two unstable areas remain in the upper and lower parts of the section, where the reinforcement effect is minor. For a complete stabilization of the slope, it will need at least other 8-10 anchors respect those planned by the administration.
