Landslides (2021) 18:2143–2158
 DOI 10.1007/s10346-021-01638-0
 Received: 7 April 2020
 Accepted: 29 January 2021
 Published online: 24 February 2021
 © The Author(s) 2021

Innovative passive reinforcements for the gradual stabilization of a landslide according with the observational method

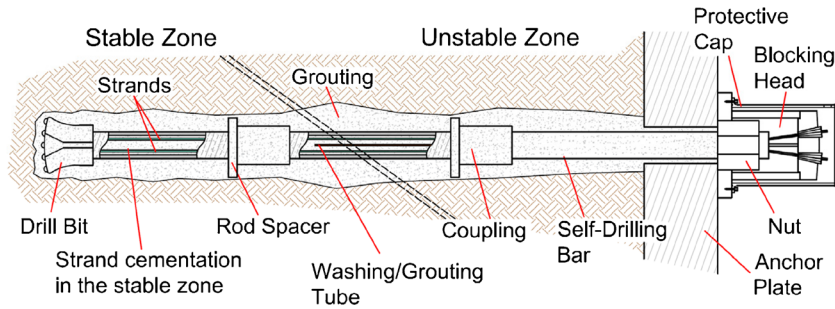
Fig. 1 Scheme of a composite anchor

A composite anchor consists of a traditional carbon steel self-drilling bar with one or more harmonic steel tendons inserted and cemented inside the central cavity of the bar. The system is completed by an external plate for locking the bar and a protective cover for the tendon head (Fig. 1).

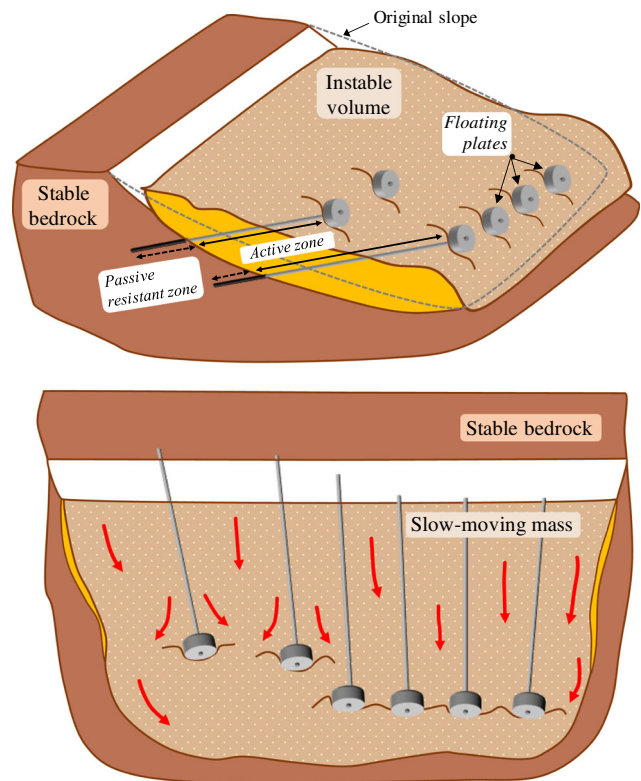
Fig. 2 Working scheme of the “floating anchor” technique with composite bars and external slab

The most important feature is that the slabs, having appropriate shape and size, are not connected to each other, as depicted in Fig. 2, condition for which the anchors are defined as *floating*. If some slope movements occur, axial forces in the passive reinforcements develop because of the shear stresses transmitted by the slow-moving mass at the bars along the soil-grout interface: these axial forces contrast part of the forces inducing instability and can reduce the landslide evolution process until it completely stops. Since the axial head force at the connection with an external slab is

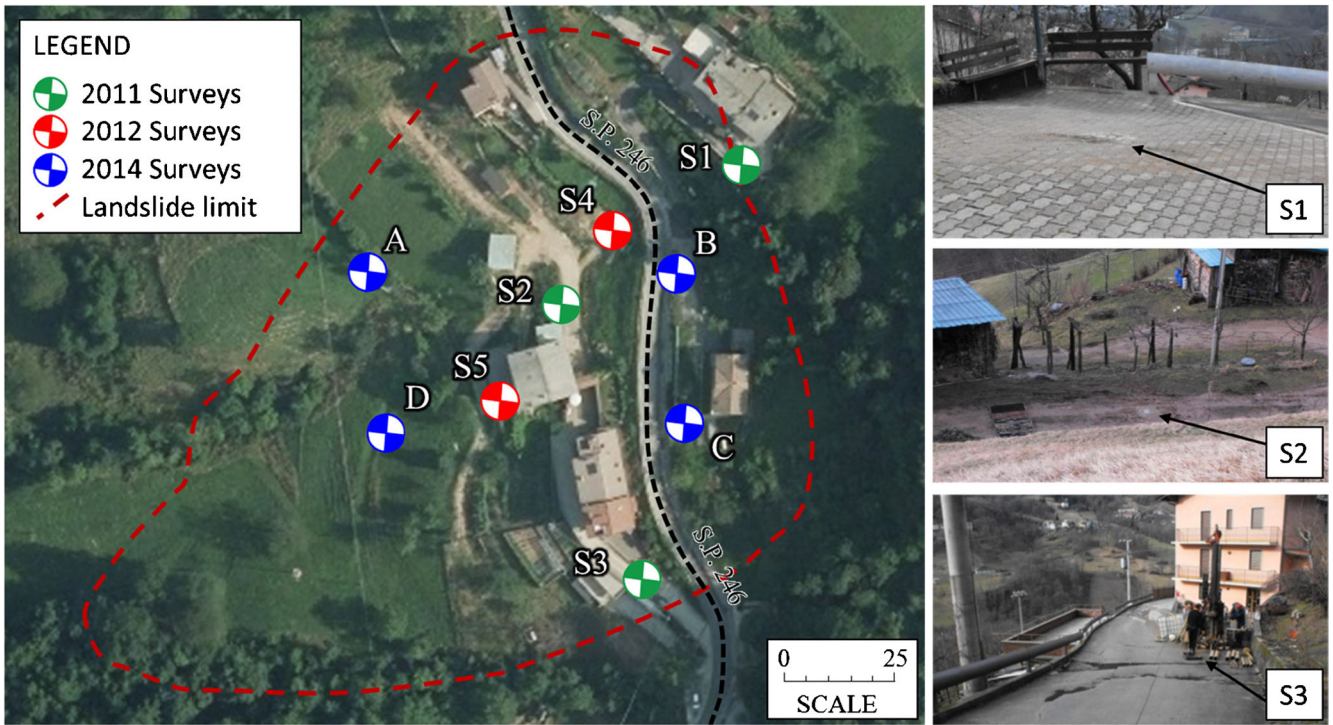
Fig. 3 Cischele landslide orthophoto, with indication of in situ borehole's locations and the landslide limits

In order to better characterize the stratigraphic profile of the area, several continuous core surveys were carried out. In particular (Fig. 3):

- Three surveys in 2011 (S1, S2, S3), (green circles);
- Two surveys in 2012 (S4, S5), (red circles);
- Four surveys in 2014 (A, B, C, D), (blue circles).

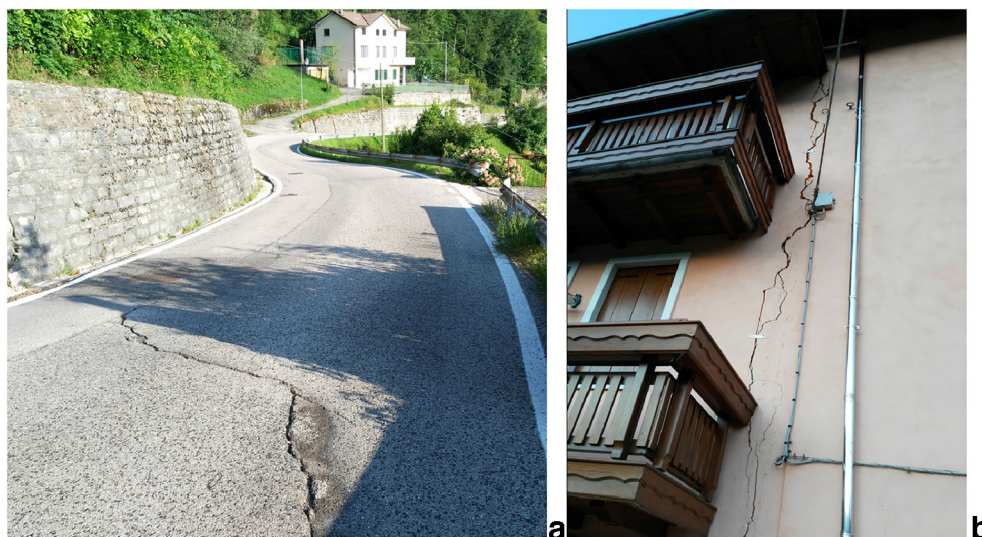
Fig. 4 Some damages caused by the Cischele landslides on: (a) the main road; (b) a house

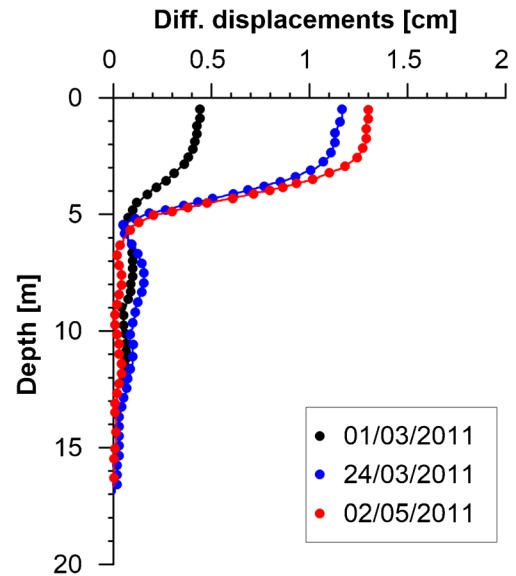
Fig. 5 Inclinometer surveys in CK2 (S3) location (reference date 26/01/2011)

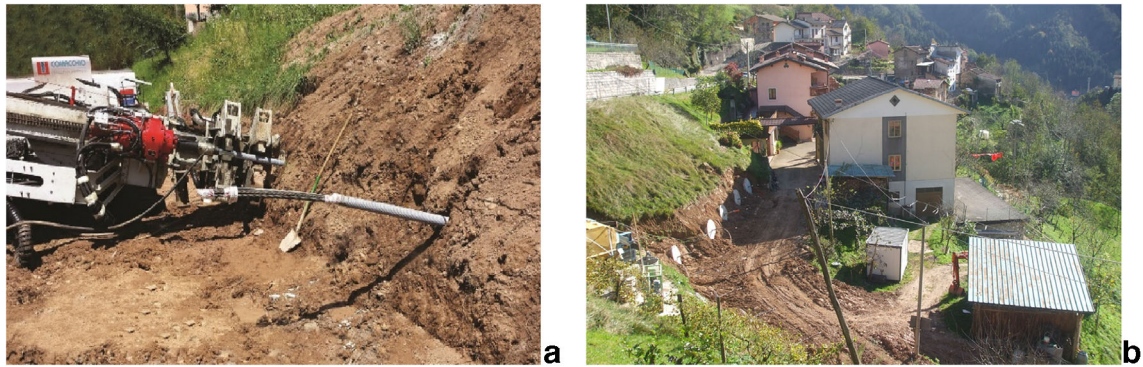
Fig. 6 Installation of composite anchors at Cischele landslide (2014): (a) Bar and strands already infixed; (b) external concrete plates of alignment B, visible at the ground surface near the house and below the road

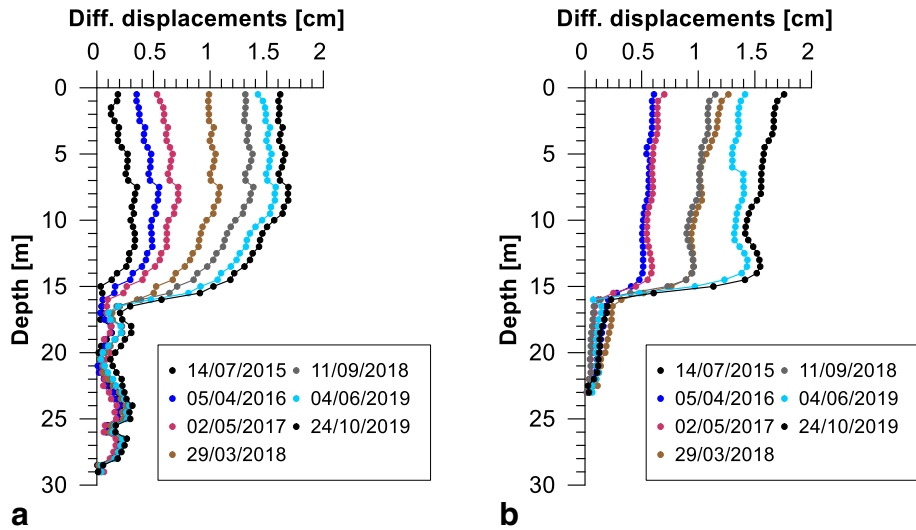
Fig. 8 Inclinometer surveys at locations: (a) B; (b) D (reference date 10/03/2015)

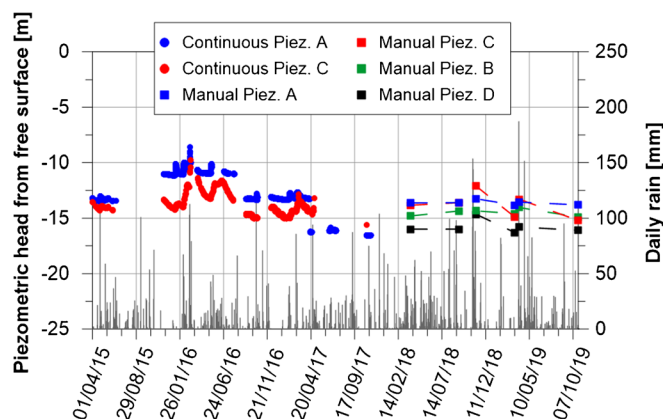
Fig. 9 Piezometer surveys at A, C, B, and D locations

Figure 9 shows that the water level at location C is generally 1–2 m deeper with respect to location A, but the water table oscillations in both the holes range around 5 m, underlining a strong correlation with the precipitation. These recent measures confirmed what was already observed in 2010. The instability in the Cischele landslide can be defined as a slow translational movement, strongly dependent on the interstitial pressures inside the instable body. The occurrence of heavy precipitations suddenly increases the water level, thus increasing the pore pressure, decreasing the shear soil resistance, and causing an acceleration of the slope displacements.

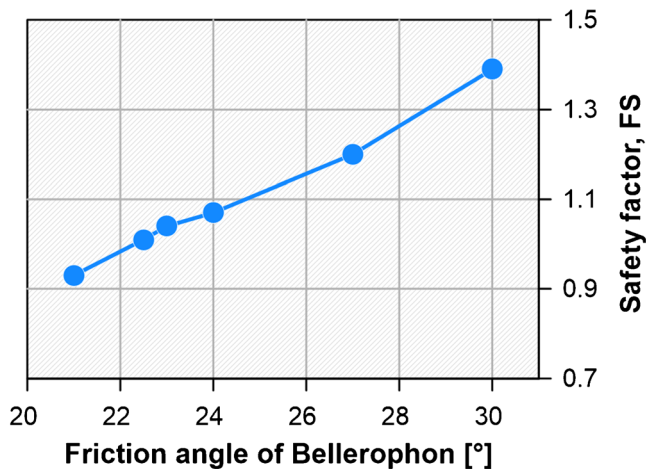
Fig. 11 Effect of the limestone friction angle on FS

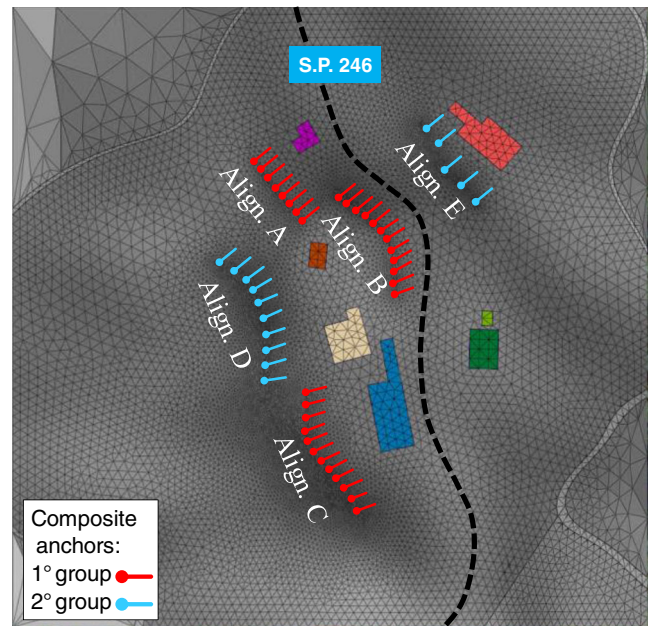
Fig. 12 FEM model geometry and mesh with positions of the two groups of anchors

Three different intervention situations are investigated, as indicated in Fig. 12:

- without any intervention (case 1);
- with the anchors already realized (case 2);
- with a hypothetical second group of anchors added to the 1° group already realized (case 3).

The first group of reinforcements are those realized in 2014, e.g., the 32 anchors arranged in three alignments (A, B, and C), while the hypothetical second group of 15 tie rods (not realized) is

considered distributed along two lines (alignments D and E). The quantity and numbering of anchors in each alignment are:

- Alignment A: no. 8 anchors (from 1 to 8);
- Alignment B: no. 12 anchors (from 9 to 20);
- Alignment C: no. 12 anchors (from 21 to 32);
- Alignment D: no. 10 anchors (from 33 to 42);
- Alignment E: no. 5 anchors (from 43 to 47).

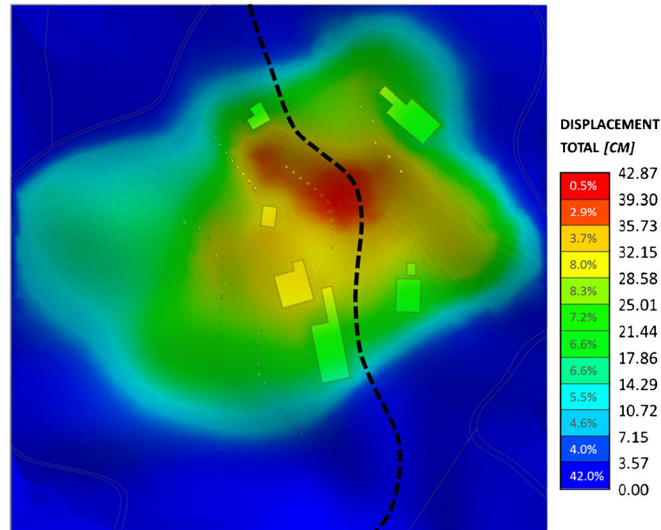
Fig. 13 Contour plot of the total displacements for case 1 in NLS-WLR analysis conditions, imposing WT = -7.5 m

It is possible to note that without interventions, the slope becomes unstable when the water table rises to -5 m of depth, according with the calibration previously performed. Indeed, significant deformations were observed when the water table reached the minimum in situ observed depth, around 7-8 m from the ground surface (Fig. 13).

The maximum movement observed in the original slope when the WT arrives to -7.5 m exceeds 40 cm (Fig. 13). The zone of maximum displacement is located immediately downstream of the road S.P. 246 in the central part of the slope. Moreover, the distribution of displacements shows important variability in space, justifying the large fissures observed on site. The displacements corresponding to the same WT for case 2 and case 3 are reported

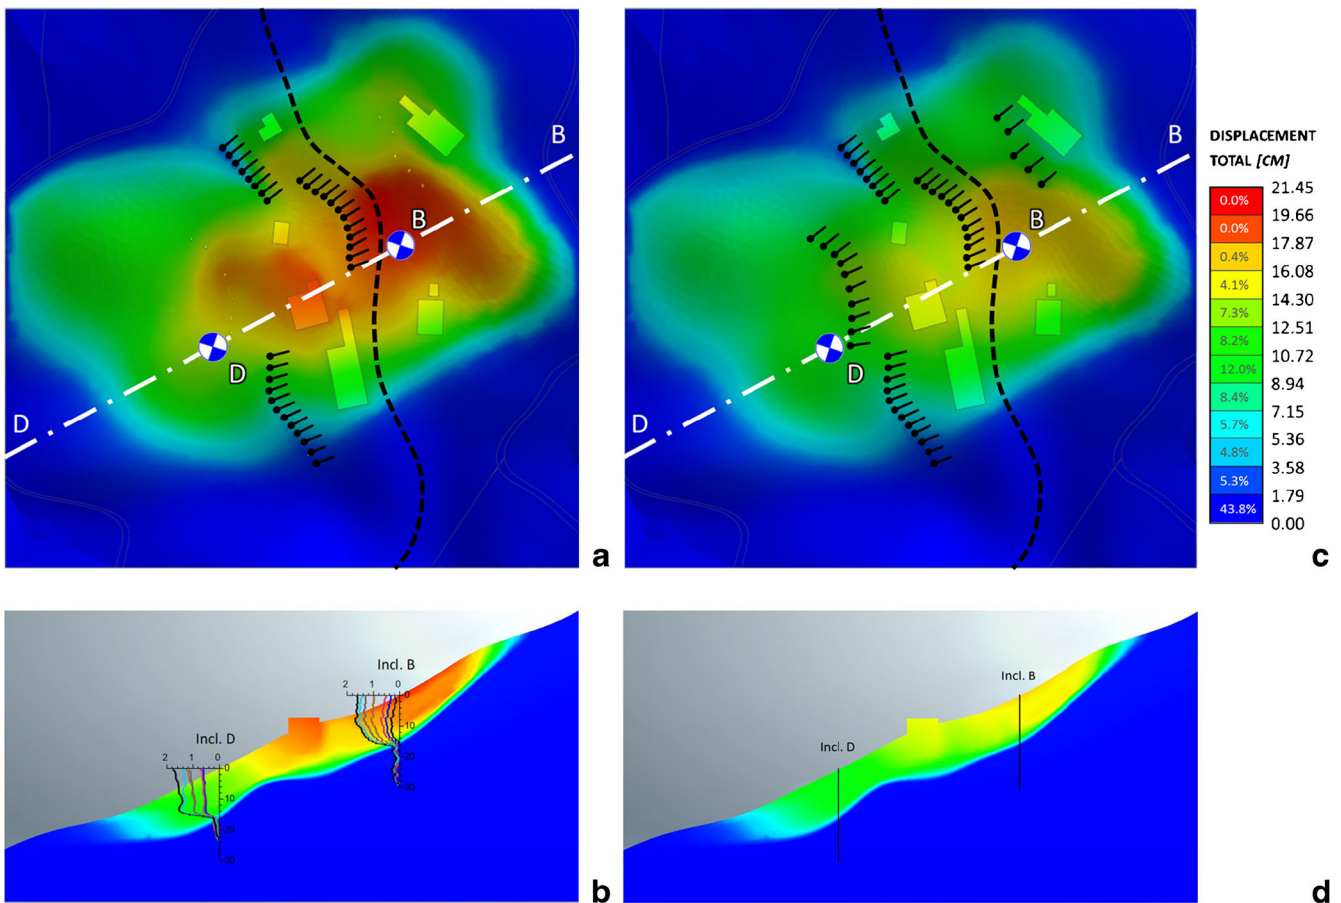
Fig. 14 Contour plot of the total displacements in NLS-WLR analysis conditions, imposing WT = -7.5 m for (a) map view and (b) section B-D case 2; and (c) map view and (d) section B-D case 3. The contour range is different from that of Fig. 13

in Fig. 14 using an enlarged color scale respect that is used in Fig. 13 to better visualize the space distribution of displacements, which are strongly reduced. In fact, by the comparison of analyses with the same water conditions, it is evident that the entity of displacements significantly reduces with the anchor installation and moving from case 2 to case 3, reaching maximum values of less than 22 cm and 17 cm, respectively.

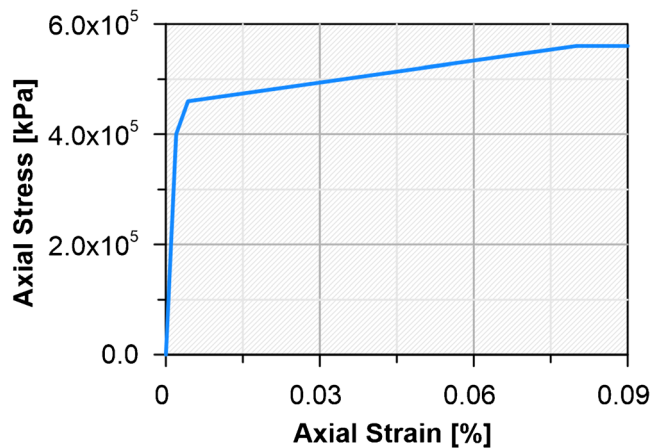
Fig. 15 Anchor's constitutive law

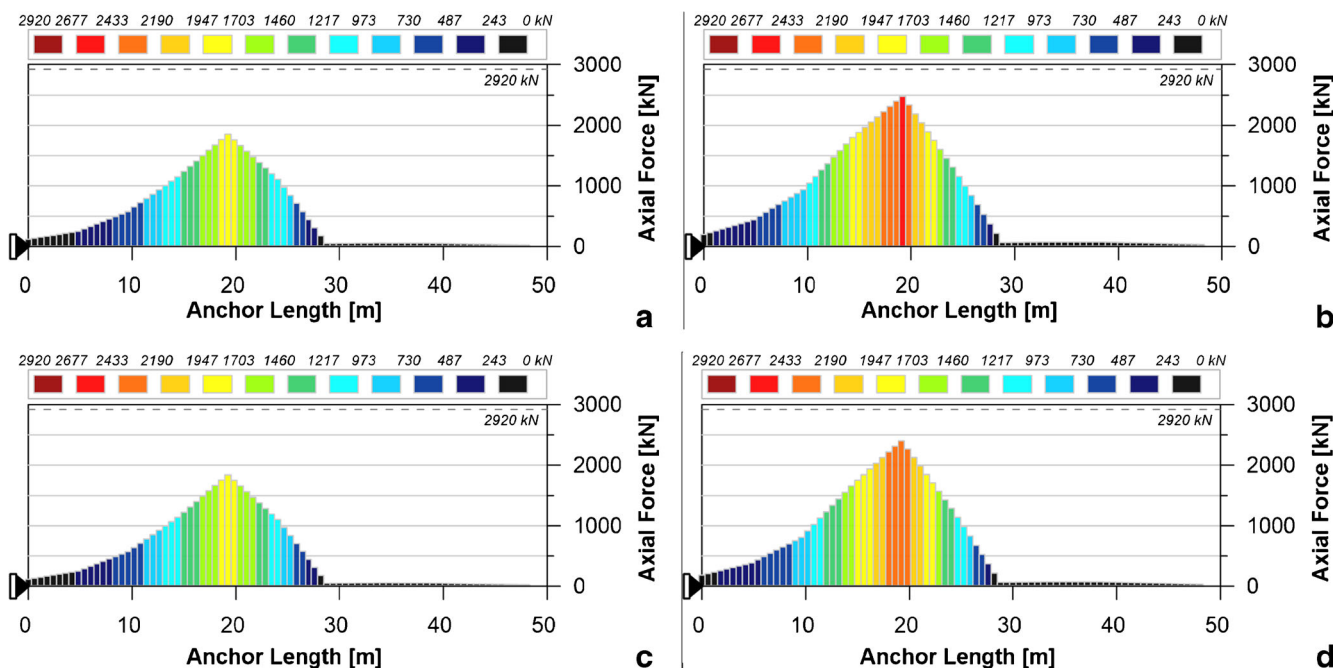
Fig. 16 Axial forces and bond stresses of anchor 14: (a) W.T. -12.5 m and (b) W.T. -7.5 m - case 2; (c) W.T. -12.5 m and (d) W.T. -7.5 m - case 3

The distribution of the axial forces along the anchors follows, in all cases, a pattern similar to those shown in Fig. 16; the stress is minimal in correspondence with the anchor plates and increases with depth in the "active" portion of the reinforcement (inside the moving mass). The maximum traction value is observed near the interface with the more rigid layer, represented by the sandstones, where the lateral shear stresses reverse the direction and the "passive" portion of the tie rod begins. In particular, Fig. 16 shows the axial forces along anchor no. 14 for two different water table levels and, respectively, for the situation with only the first group of reinforcements installed (case 2, Fig. 16a and b) and when both the groups are included (case 3, Fig. 16c and d). This anchor is located in the central portion of alignment B, exactly in the center of the instable body. Comparing Fig. 16a and 16b, it is evident that when the water table level moves from -12.5 to -7.5 m under the ground surface, the maximum axial force passes from 1917 to 2500 kN in case 2. The increase in the axial force is slightly reduced when all five anchor alignments are present: in this case, as Fig. 16d shows, the axial force of anchor no. 14 reaches the maximum value of 2478 kN. A less significant difference for the anchor axial force is observed between case 2 and case 3 when the water table is at -10 m or deeper. On the contrary, the effect of the floating anchors of alignments D and E becomes relevant when the instable mass begins to show increasing displacements.

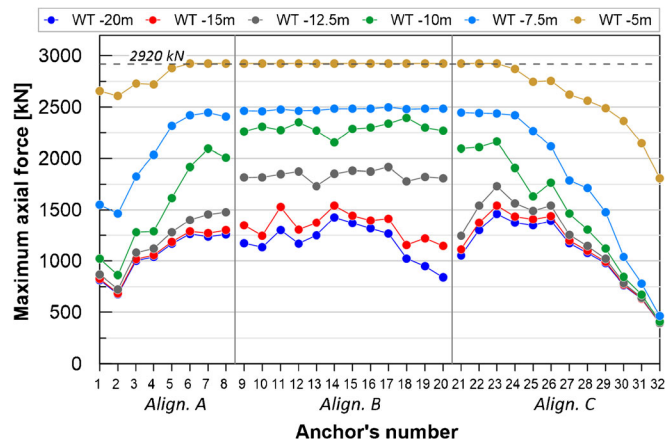
Fig. 17 Maximum axial forces on various anchors for different position of water table in case 2

when the WT reaches or exceeds the level of -10 m from the ground level. Figure 17 shows that the anchors reach the ultimate

tensile strength (2920 kN) when the water table is at -5 m from the slope level. This is evident for the anchors of alignment B, located

in the central portion of the landslide, while the more external reinforcements of alignments A and C still present a reserve of resistance, even if not very high.

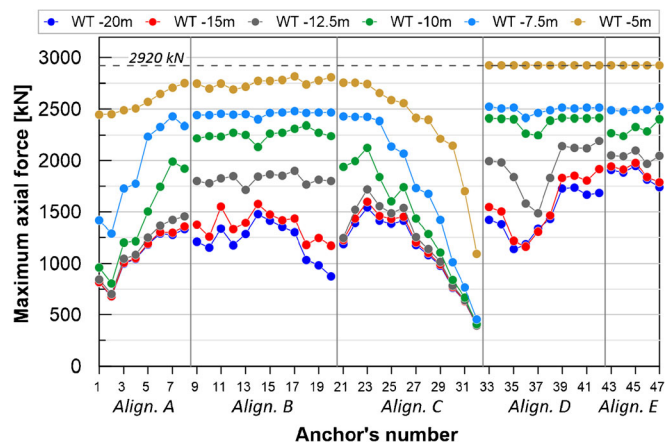
Fig. 18 Maximum axial forces on various anchors for different position of water table in case 3

As already observed, some anchors reach the ultimate tensile strength when the water table rises to -5 m, in particular, all the anchors of alignment B in case 2, and all those of alignments D and E in case 3. Figure 19a shows the axial force profile along anchor no. 14 in case 2, while Fig. 19b and 19c report the axial forces in anchors no. 36 and no. 45, in case 3. Note that all the plots are for WT at -5 from GL and that all the anchors reported here are close to the central section of the landslide, in alignments B, D, and E, respectively. It is observable that all these anchors reach the maximum axial force at the intersection with the interface, the layer in which the sliding occurs. Consequently, the anchor, reaching its ultimate limit, shows precisely the depth at which it encounters the interface, corresponding to the position where the axial force is the maximum. Clearly, this intersection takes place at different depths, depending on the position and inclination of each anchor: anchor no. 14 shows the peak around 20 m far from the external slab, while anchors no. 36 and no. 44 around 25 m and 13 m, respectively.

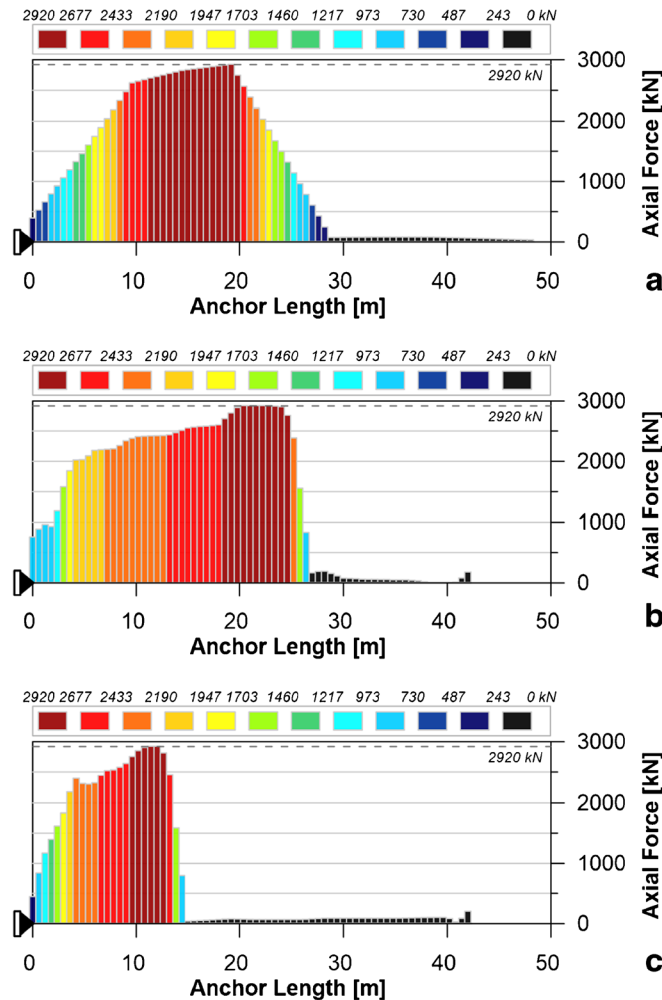
Fig. 19 Axial forces: (a) anchor nr 14, W.T. -5 m - case 2; (b) anchor nr 36, W.T. -5 m - case 3; (c) anchor nr 45, W.T. -5 - case 3

Once this limit is reached, the axial force inside the reinforcement cannot increase anymore. The consequent effect is a redistribution of the axial load along the length of the same anchor with a gradual increase of the anchor tension in a decreasing distribution moving from the peak towards the external end. The portion of anchors in the passive zone does not show evident variations, once the anchor has reached the ultimate limit. Moreover, if the pull-out resistance of the rock in the passive zone is very good, a portion of the anchors resulted unloaded. This behavior suggests that the anchorage has gradually more and more points in limit conditions in the active zone, while no great variations occur within the part included in the passive zone, a part that can therefore be reduced installing a shorter anchorage. In fact, it is evident that all the anchors shown in Fig. 19 have an oversized length, while they show acceptable behavior in terms of resistant strength, taking into account that the water table has never arrived at a level close to -5 m.
