Università degli Studi di Padova

Tesi di Dottorato

Influence of Grout Injection on the Dynamic Behaviour of Stone Masonry Buildings

Dottorando: Nicola Mazzon Supervisore: Maria Rosa Valluzzi

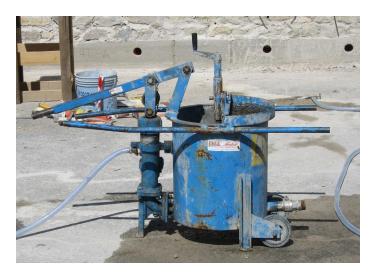
Figure 2.6: Hand pump for grout injection.

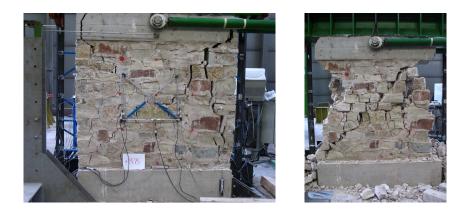
Figure 6.7: Specimen R2 at failure.

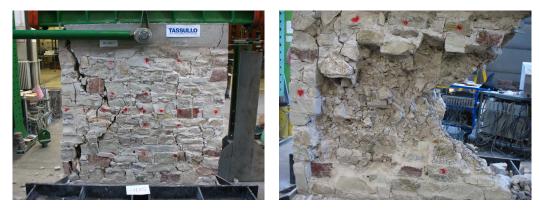
Figure 6.16: Specimen S2 at failure.

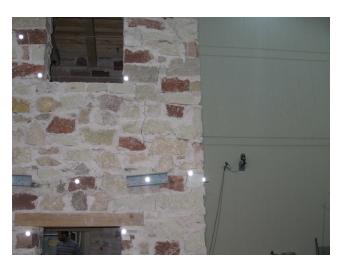
Figure A.4: URM model: detail of the damage at 0.45g.

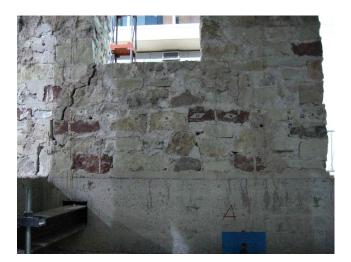
Figure A.10: RM model: a crack occurred at first floor level, internal view.

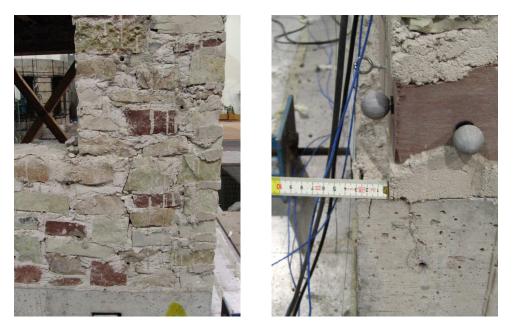
Figure A.13: SM model: detail of a crack occurred at the first floor level (right) and bottom displacement of a pier.

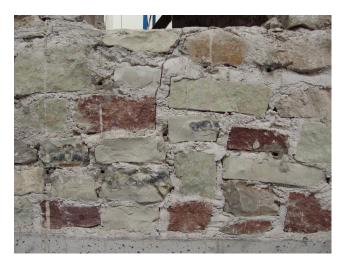
Figure A.16: SM model: detail of a crack occurred at the first floor level.
