The effect of heterogeneities and small cavities on levee failures: The case study of the Panaro levee breach (Italy) on 6 December 2020

Francesca Ceccato 💿 | Paolo Simonini

Department of Civil Environmental and Architectural Engineering (DICEA), University of Padua, Padua, Italy

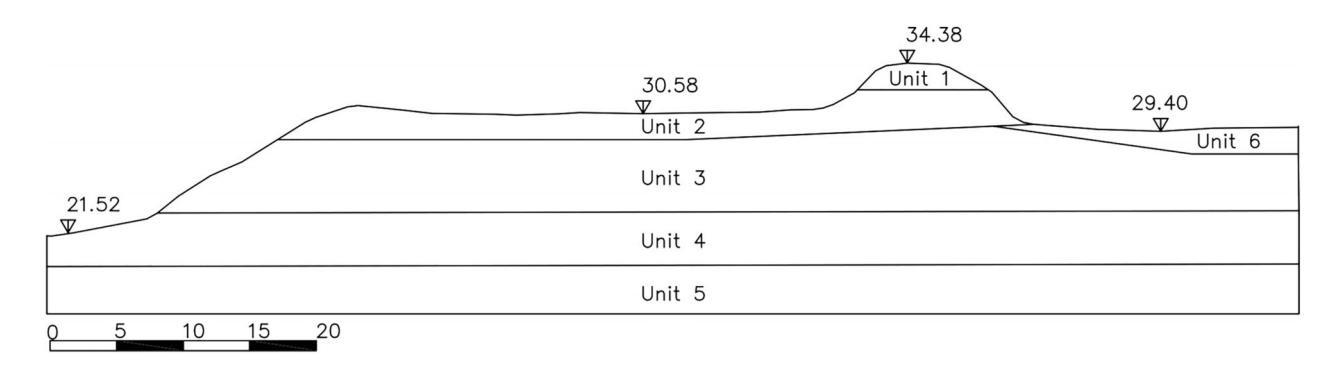
FIGURE 7 Geometry and stratigraphy of the levee (units are in meters, elevation is with respect to the m.s.l.).

A LiDAR survey carried out before the breach showed that in this location the slope is relatively steep, between 35° and 50° , the levee is 5-m high, 16 m-wide at the base, and the crest width is between 2 and 3.5 m.

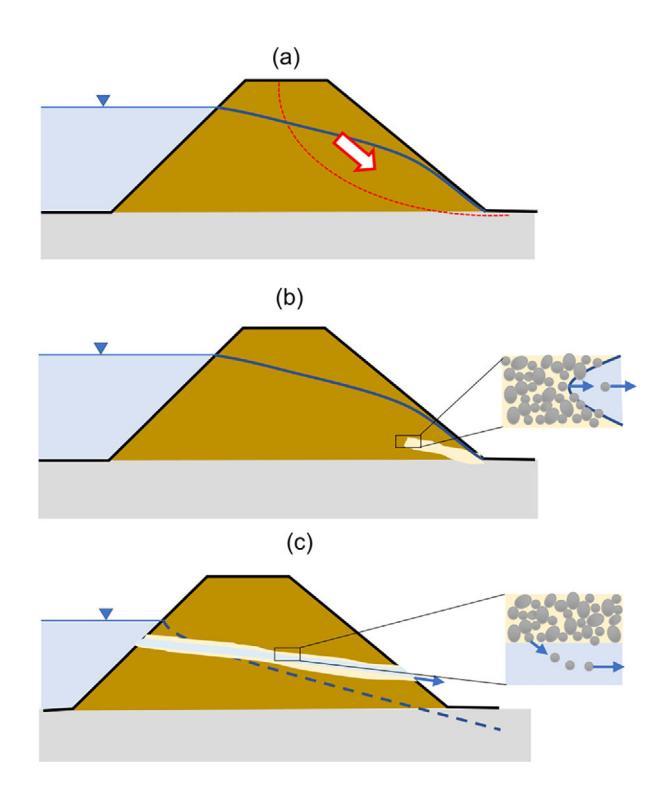
The failure mechanisms analyzed in this case study are (i) the macro-instability of the landside slope eventually involving also the foundation soil (Figure 10a), (ii) internal erosion in the foundation or in the levee body (backward erosion piping Figure 10b), and (iii) concentrated erosion at a pre-existing pipe (Figure 10c). Macroinstability is a global failure of the slope that, in this case, could have been triggered by the reduction of soil shear strength due to the increase of pore pressures during seepage. Backward erosion piping consists in the erosion of soil grains initially at the outer surface and the formation of a small pipe which can progress through or under the levee body, increasing its size and bringing the levee to failure. It is triggered when the saturation front reaches the outer surface and the local hydraulic gradient is larger than a critical hydraulic gradient. Piping manifests with sand boiling, it usually progresses relatively slowly and can be controlled with

FIGURE 10 Possible failure mechanisms: (a) global stability of the slope, (b) backward erosion piping, and (c) concentrated erosion

sandbags rings as occurred in 2019 (see Section 2.1 and Figure 3). Concentrated erosion occurs when there is a preferential flow path, such as a pipe or a crack, that connects the waterside and the landside. When the contact shear stress generated by the flow at the boundary of the conduct exceeds the critical soil shear stress, particles are eroded and the size of the pipe increases leading to failure. This mechanism can lead very rapidly to the opening of the breach.

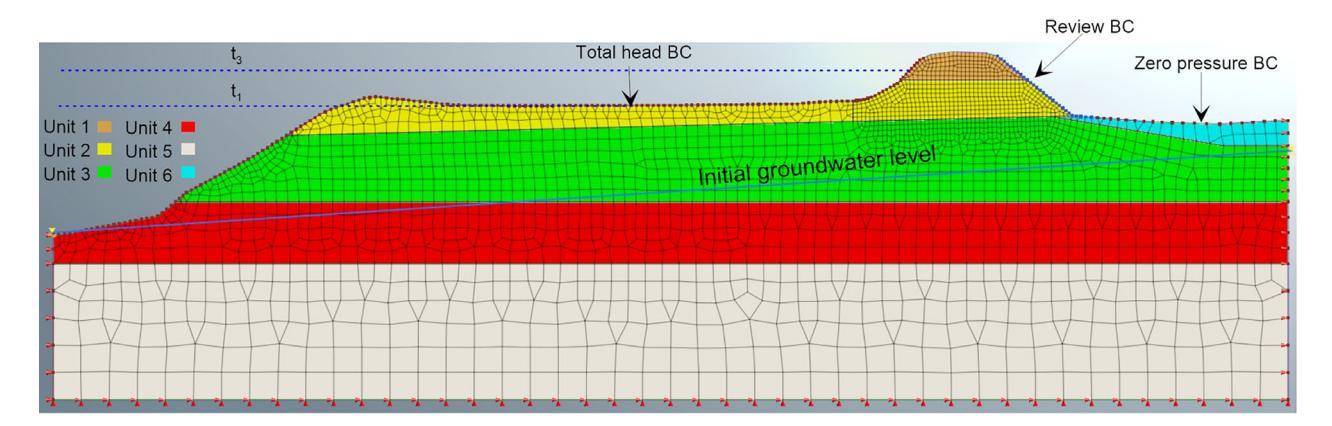
Stratigraphy, discretization, and boundary conditions (BC) are shown in Figure 11. Material parameters are listed in Table 3. Partially saturated effects are accounted for Units 1, 2, 3, and 6, and the Van Genuchten (1980) function is used for the soil–water retention curve (Equation 1) and hydraulic conductivity curve (Equation 2):

FIGURE 11 Discretization and boundary conditions of the numerical model.

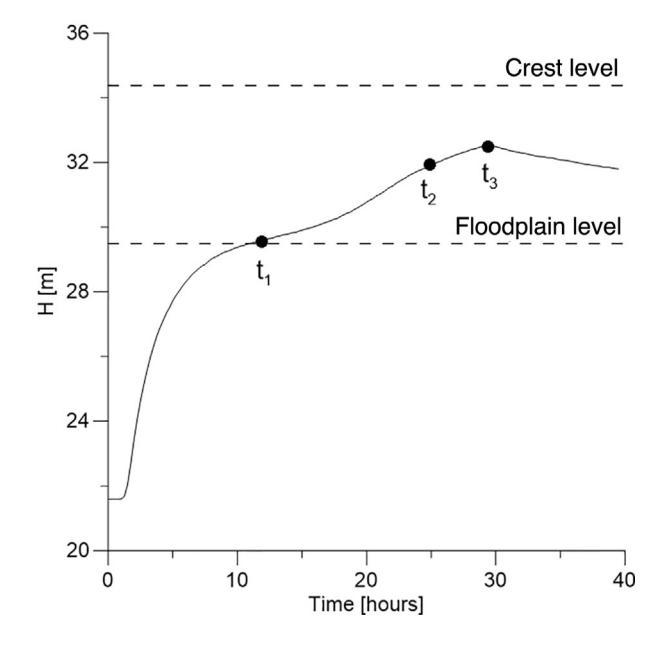
The hydraulic head corresponding to the river hydrograph is applied at the nodes of the waterside (*total head BC*). The hydrograph is shown in Figure 12; it was derived from the measured hydrometric level at the closest measuring station. Water level reached the level of the floodplain in 11 h (t_1) and the breach opened after about 29 h, at time (t_3). Note that the reference system of the model is the mean sea water level. The landside slope is a potential seepage face; in Midas GTS NX this boundary condition is called *review BC* (Figure 10). Zero pressure is applied at the toe of the levee on the landside

FIGURE 12 Hydrograph estimated at the breach section for the event of 6 December 2020.
