UNIVERSITÀ  
DEGLI STUDI  
DI PADOVA

**AN INTEGRATED APPROACH FOR RESTORATION AND  
CONSERVATION OF CULTURAL HERITAGE STRUCTURES: HISTORY,  
MATERIALS AND STRUCTURAL BEHAVIOUR. THE ARSENAL OF  
VENICE**

**Dottorando:** Giulia Bettiol

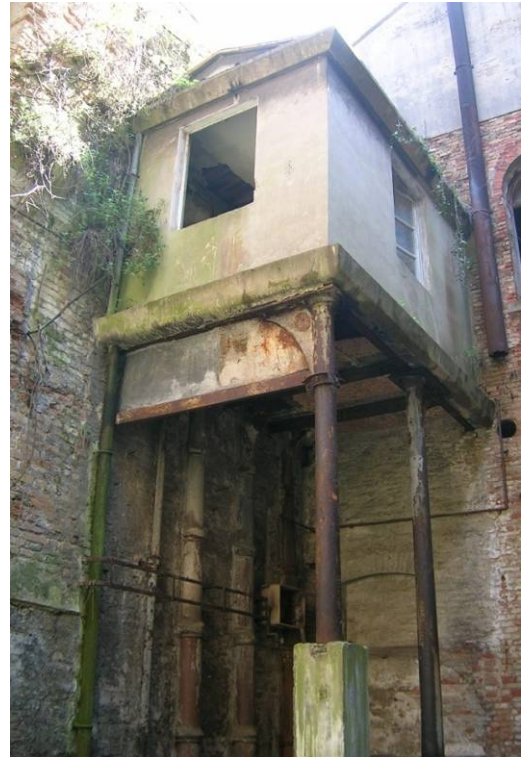
Fig. 4.3.16: Construction projecting supported by cast iron columns

from the first floor, likely added later to the the building (Fig. 4.3.16). On the first floor, two cast iron columns, nowadays collapsed, supported two wooden beams of the roof trusses, increasing their stability.

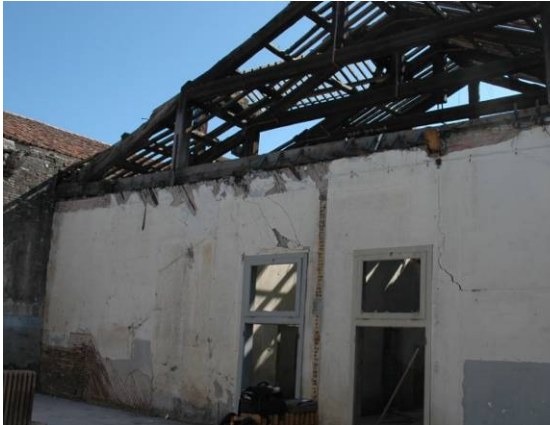
Fig. 4.3.17: Portion of the wooden partition covered by secondary beams nailed and plastered

In corrispondence of the connection of the two parts of the wall a supporting beam was made (Fig. 4.3.17). Fig. 4.3.18 shows the remaining part of the partition made on hollow bricks, collapsed with the roof.

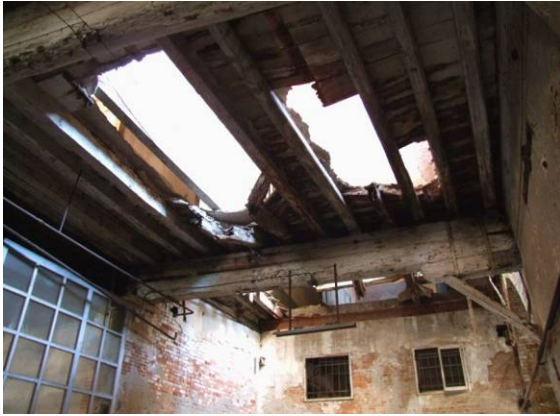
Fig. 4.3.19: A venetian traditional flooring emerged from the collapse of the wooden floor

The following figure (Fig. 4.3.19) shows the wooden floors collapsed. While they prevented from having access to some rooms on the first floor, thus limiting the information on the rooms, on the other hand, they made it possible to investigate the composition of the floor layer.

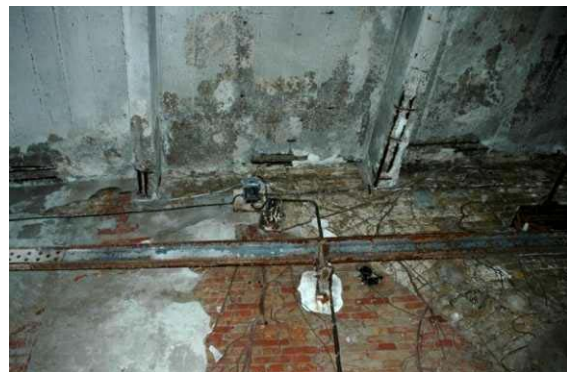
Fig. 4.3.22: Reinforced concrete floor with ribs and slab

The decay of the structure is underlined by the visibility of the ribs of the reinforcement, stirrups, longitudinal rods and slab, with a welded steel reinforcement mesh. On the intrados of the monolithic floor it is possible to see the marks of formwork used for the casting of the floor.

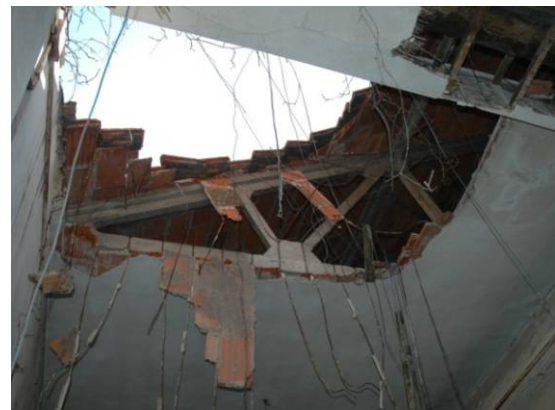
Fig. 4.3.24: Collapse of the "Perret" false ceiling, anchored at the reinforced concrete truss, as a consequence of the collapse of the tile roof

The floor casting is not so thick to form a slab, since it does not support any load. For this reason, the false ceiling was undergo a huge number of collapses that have occurred in correspondance of the collapses of the roof structure, as noted in Fig. 4.3.24.

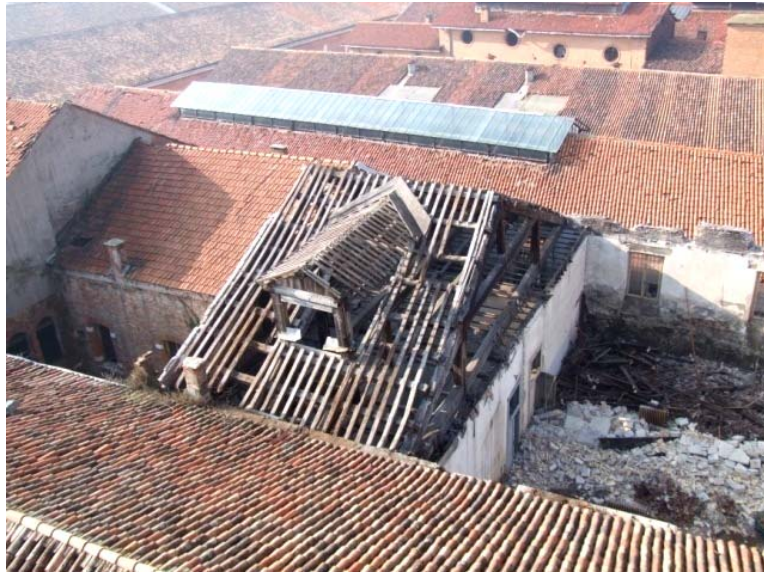
Fig. 4.3.25: View of the partially collapsed wooden roof

The wooden structure is located in the northern part of the building that overlooks the Darsena Nuova. It was partially affected in 2006 by a considerable collapse caused by the settlements of the supports of the trusses. It is the consequence of the poor state of preservation of the elements due to the moisture. The collapse has involved the wooden elements of the pavilion pitch and two trusses.

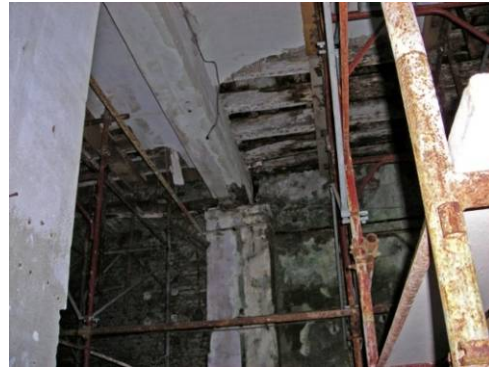
Fig. 4.4.6: Third span: decay of the end beam

In the third span of the beam is visible from all sides, plastered except for the flange next to the wall, where there are many plaster detachments (Fig. 4.4.6).

The edge of the beam restrained to the west wall has a plaster detachment due to the concentration of moisture rise in masonry and environmental humidity of the site. It helps, as it appears in this case, the attack of fungi.

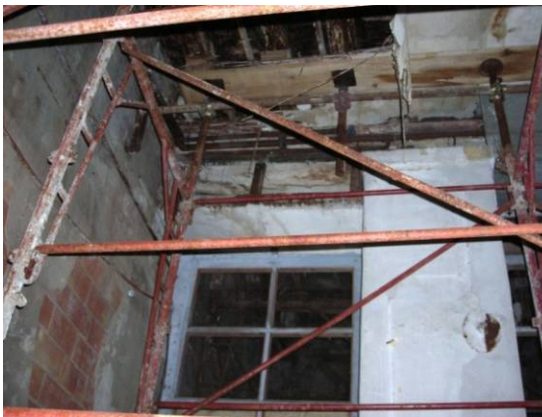
Fig. 4.4.9: Detail of the degradation of the end beam

It was observed no particular signs of decay, unless at the head of the beam restrained to the west wall, where it is clear that the connection was achieved without any special care. The risk is that settlement of the support could happen , considering also the height of the fourth span. It is true also that the presence of moisture has helped decreasing the loading edge capacity, to which any strengthening intervention were applied.

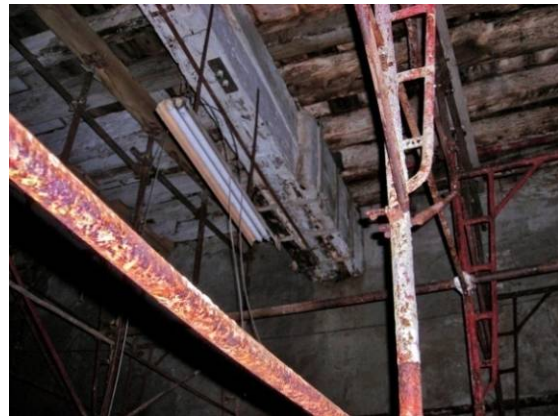
Fig. 4.4.12: Strengthening of one end of the beam through the application of side wooden planks connected to the original beams through metallic rods

two wooden overlapping beams. It is possible to observe the edge strengthening intervention by side tacking with wooden elements and metal stirrups (Fig. 4.4.12). It has been made in order to increase the supporting edge beam capacity, due to the height of the span.

It is possible to see the moisture attack to the wooden parts, used for tackling of the end of the beam. Again, the lack of attention to the connection beam-wall exposes the edge of the element to the danger of an attack by fungus and xylophagous insects.

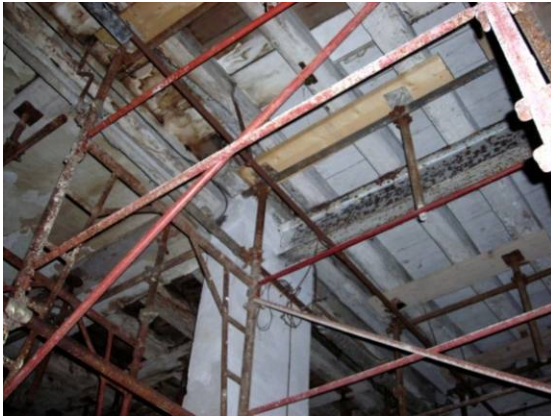
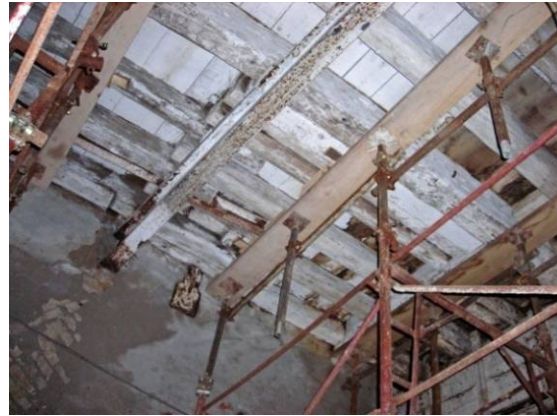
It is evident the rust on the whole surface of the steel element. Corrosion is the type wet for the heavy concentration of umidity in the air due to the environmental peculiarities of the site. This features are more visible at the end of the element fixed to the west wall.

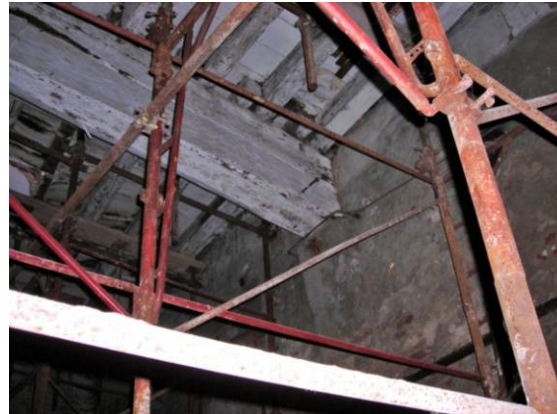
Fig. 4.4.16: End of the beam supported by masonry corbel

It is not possible to investigate on the beam-wall connection, but from the direct looking out the beam appears to be inserted in the partition without any device providing the necessary ventilation to the edge. This allows then to quantify the risk of edge decay with a consequent loss of load supporting-capacity due to the moisture rise, which can promote mycotic and xylophagous insects attack.

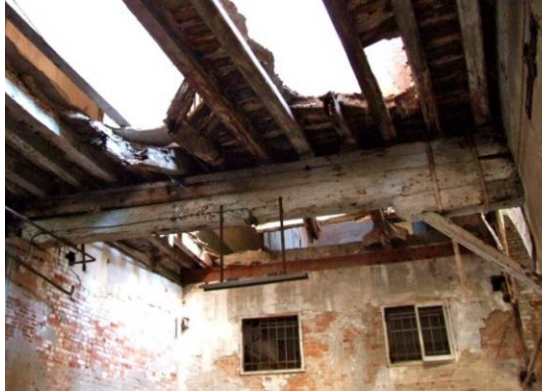
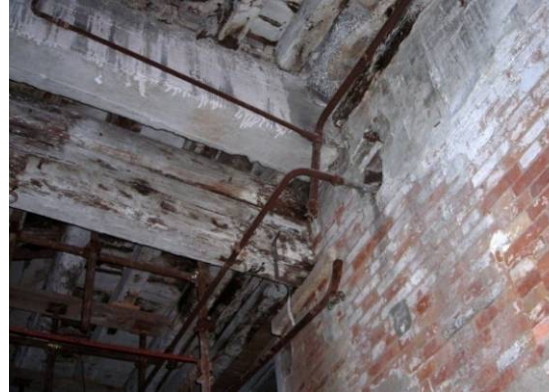
The material decay, caused by moisture rise, interest both ends of the beam due to the lacking of care in the realization of the connection beam-walls, and the ends resting on the pillar.

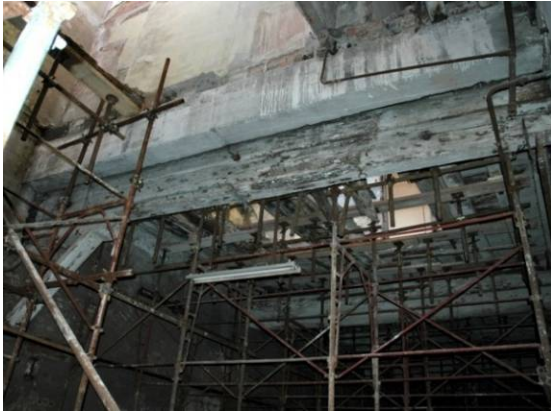
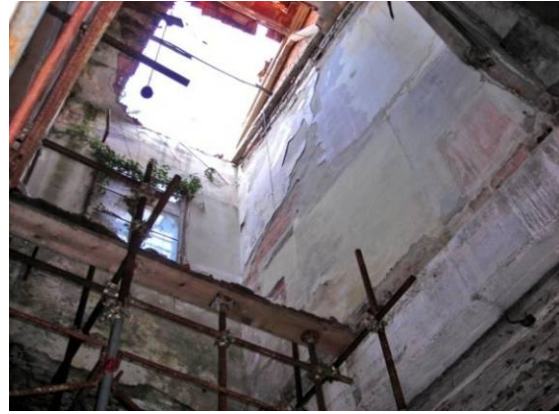
Compared to the above mentioned elements, the reinforced concrete beam has not a high level of decay. Detachments of material are visible on the element, caused by umidity.

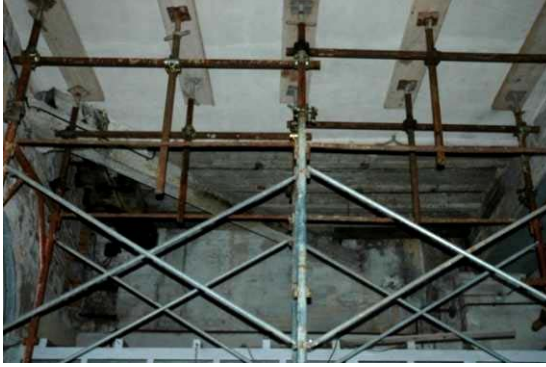
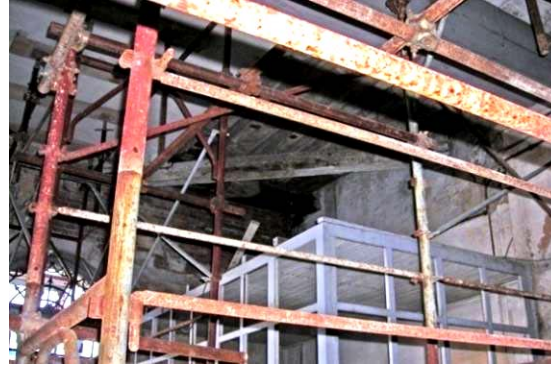
The decay of the material, caused by the moisture rise of the masonry element, involves visible edges of the purlins and edge element.

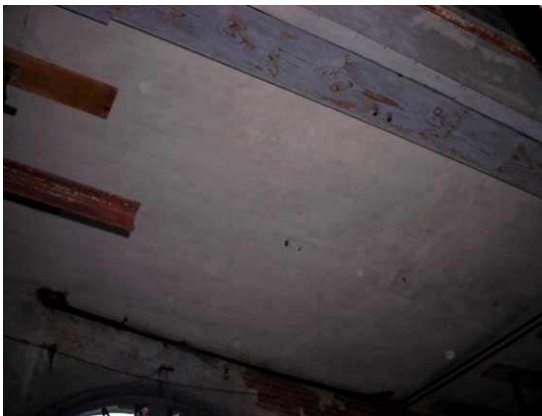
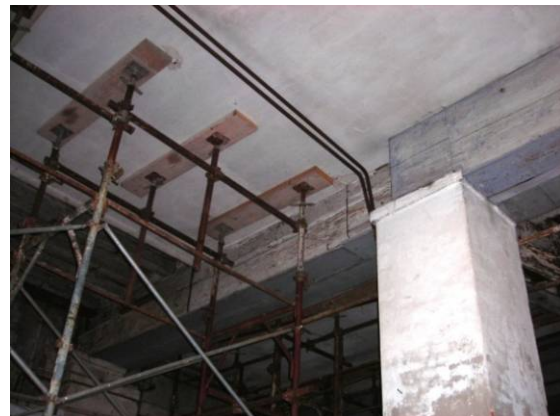
From the intrados the signs decay are not directly observable. Upstairs it is possible to detect a slight deflection of the ceramic floor tiles, the first symptom of the deformation of the purlins.

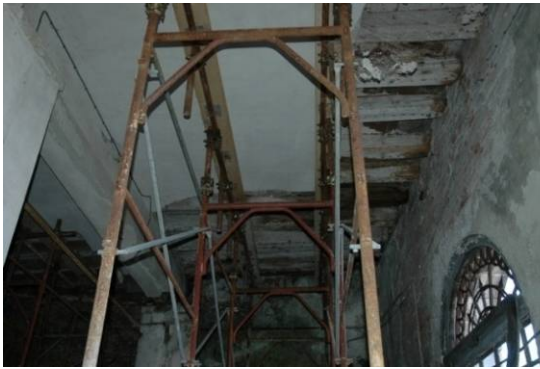
Fig. 4.4.26: Collapse of the false ceiling next to the masonry

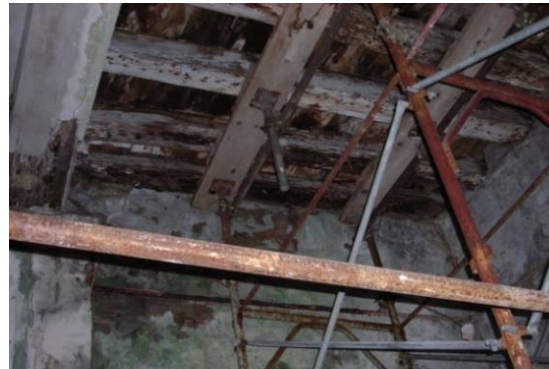
The material decay, due to the moisture rise of the masonry, concern with a large part of the purlins and their edges. The edge beam presents a clear reduction in section (Fig. 4.4.27). All the frame shows colours fading.

Fig. 4.4.27: Decay edge beam

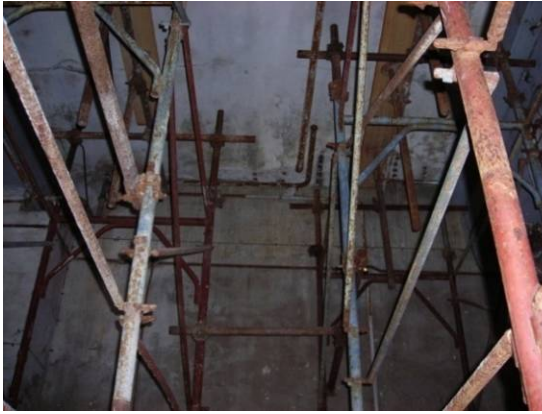
The observed decay of the plaster ceiling near the perimeter wall is caused by moisture rise, so it can be inferred that also the secondary frame of the floor is concerning with.

Fig. 4.4.28: View of the false ceiling where it is possible to see the metallic net

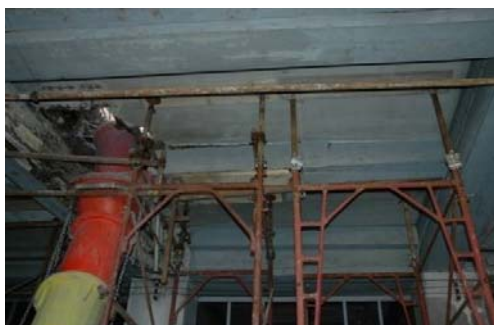
The collapse of the floor is caused by the settlement of supports of some purlins, as a result of increased vertical loads and therefore shear stresses.

Fig. 4.4.30: Collapse of the floor

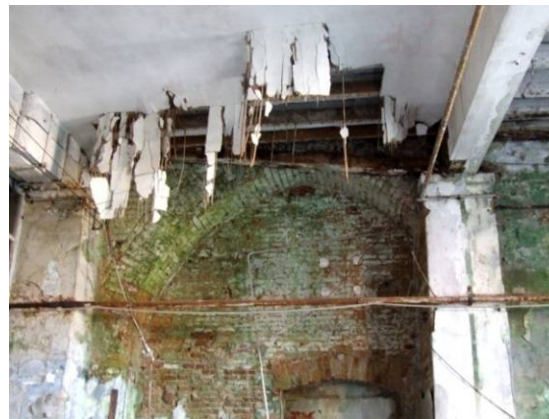
The edge beam shows the settlement of the support on the main beam 2, which is caused by decay which is affected the main beam edge. The deterioration of wood, caused from moisture rise of the masonry, has spread all over the visible frame and over the plank, presenting a chromatic change.

Fig. 4.4.33: Collapse of the support of the edge beam

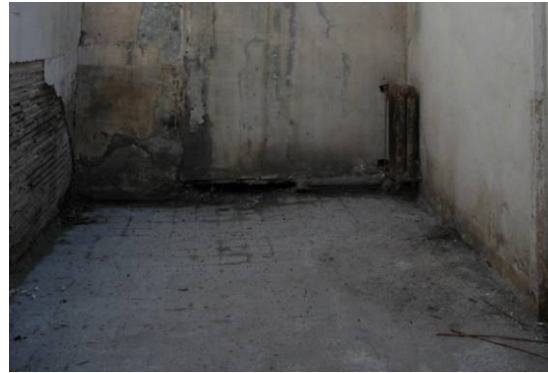
floor, there is the hollow of the floor along the perimeter wall (Fig. 4.4.35), that shows also a frame depression, resulting from the moisture.

Fig. 4.4.35: Depression of the floor

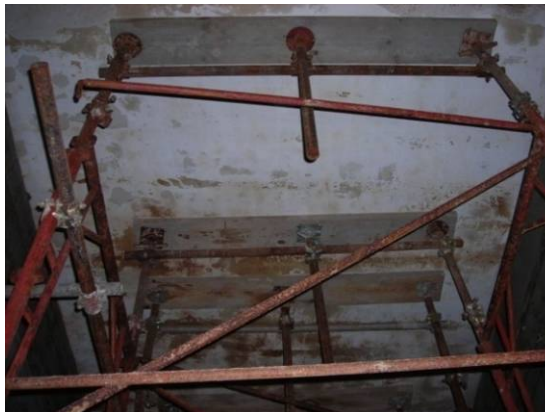
Fig. 4.4.36: False ceiling

The false ceiling hides the structure of the floor (Fig. 4.4.36). On the sides of the room, it is possible to see the paneling plank of two beams: the first, not directly visible, is arranged on the pillar 6 and 10, the second is placed on the pillars 7 and 11.

The false ceiling plaster has stains, symptoms of the presence of moisture. Walking on the extrados of the floor, it is possible to detect the depression of the tiles floor, due to frame-depression.

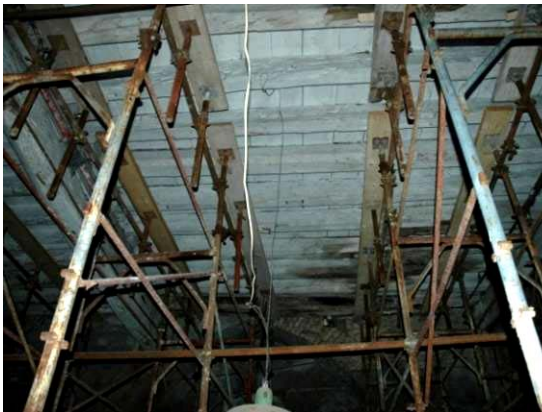
Fig. 4.4.38: Secondary frame of the floor

The false-ceiling is completely absent (Fig. 4.4.38). The purlins and the wooden plank are clearly visible. They load on main beams 2 and 3.

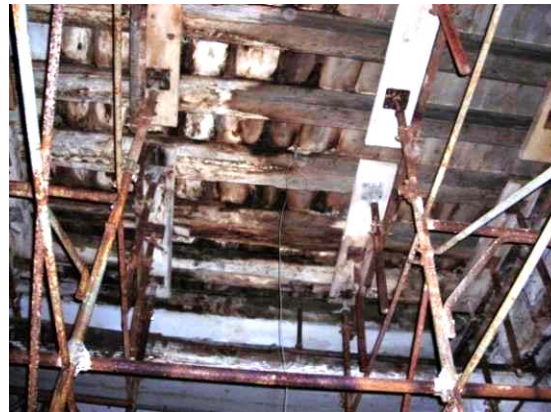
Fig. 4.4.39: Purlins and plank moisture

The decay of the material affects the whole frame, wooden plank included (Fig. 4.4.39).

The decay is very pronounced for the edge beam, that suffers particularly of moisture rise, because it is near the wall. The floor extrados shows a depression of the frame.

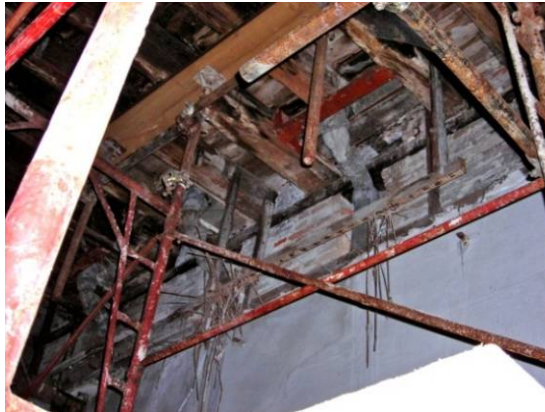
Fig. 4.4.40: Wooden joist used in the connection beam-wall

The room is bordered on two sides by wooden frames, one for the eastern perimeter wall and for the second from the wall that separates it from the small courtyard inside of the building. For the complete absence of the false-ceiling, it is possible to see the wooden plank and the wooden purlins of the floor. The frame is loading on the main beam 3 with one edge and on the wall for the other. The connection beam-wall that, from the height of purlins, presents a reduced wall thickness in order to create a shelf. Here is placed a wooden joist on which rest the edges of the purlins (Fig. 4.4.40).

The purlins and the wooden plank are affected by the deterioration of the material, presenting the chromatic change. The moisture rise is very deep.

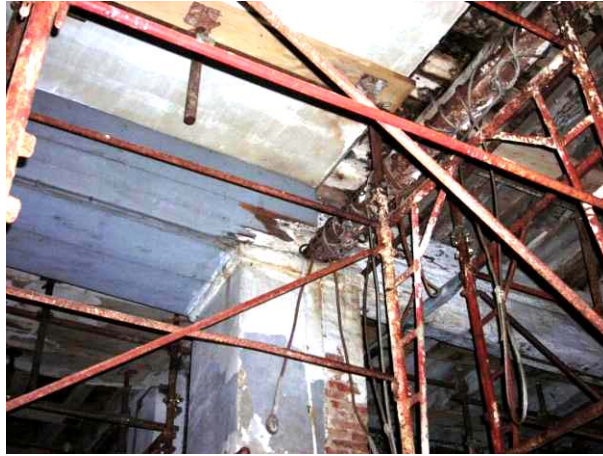
Fig. 4.4.42: Floor frame hidden among the false ceiling

The presence of the false-ceiling hides the structure of the floor (Fig. 4.4.42). It is reasonable to assume, for similarity to next rooms, that the purlins are loading on the main beams 3 and 4.

For the spots on the false-ceiling it can be assumed that the plank is affected by moisture. The top surface of the floor confirms this, showing floor deflection, a symptom of depression of the frame, caused by the deterioration of the material.

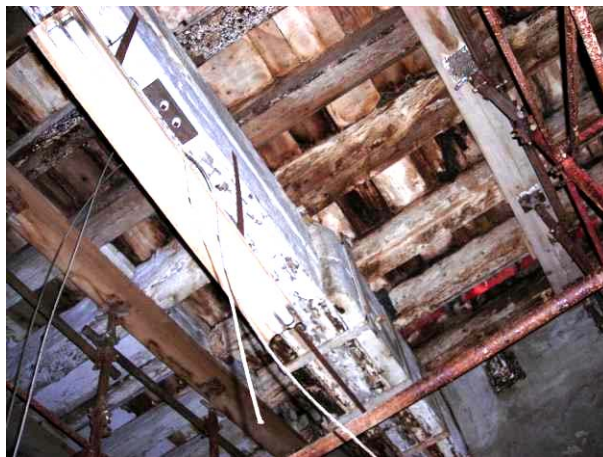
Fig. 4.4.43: Purlins supported by the main beam 5

The purlins and the plank are very deteriorated. Diffuse chromatics changes are observed all over the wooden plank. The floor of the extrados has some depressions near the wall, a sign that edge depression is more starting from the edge beam.

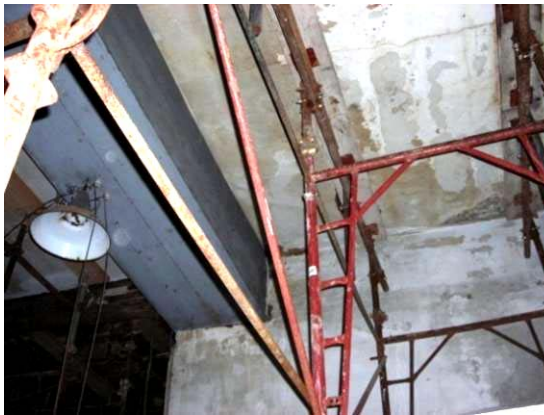
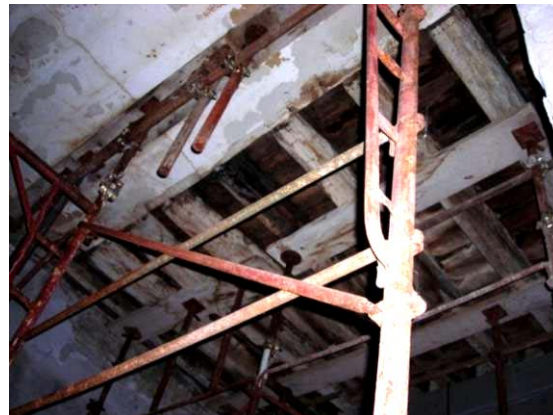
The room has a false-ceiling, only for half part, while in the other one it is possible to see the purlins and the wooden plank (Fig. 4.4.44, Fig. 4.4.45). The purlins rest on the main beams 4 and 6, placed at constant distance.

The moisture rise affects the frame, where chromatic change are observed, and the false-ceiling, where some marks are visible on the plaster. The edge beam is affected in particular way. Also on the extrados it is possible to observe that floor is subject to depression due to loss of strength of the purlins.

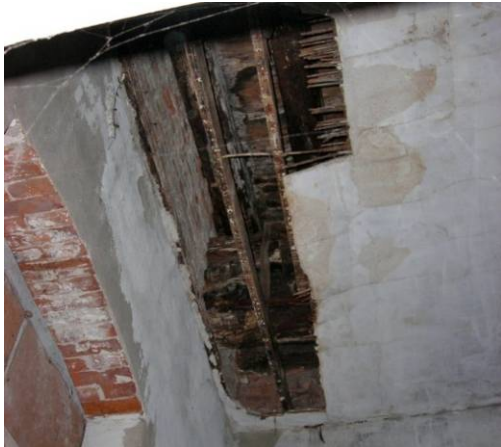
Fig. 4.4.52: Collapse of the false ceiling near the wall

The floor is almost completely hidden by the false ceiling made of plastered reed wattles. A partial collapse, however, close to the outside perimeter wall lets to see that the wall is connected to the main beam number 7, unlike from the other cases, by the wooden battens (Fig. 4.4.52). There are visible also the planks and the purlins that rest on the main beams 6 and 7.

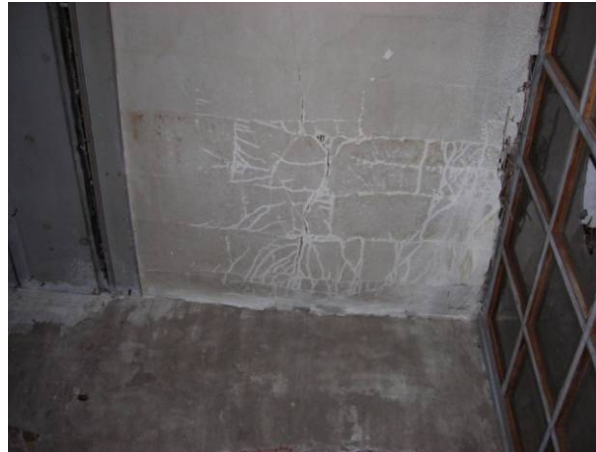
Fig. 4.4.53: Effects of the moisture rise in the false ceiling plastered

The collapse of the false-ceilings show the presence of moisture rise (Fig. 4.4.53) due to the closeness to the wall. This is also the cause of depression of the frame, visible from the floor on the extrados.

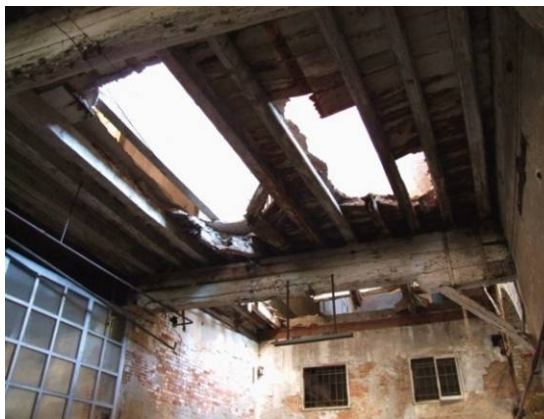
Fig. 4.4.54: Partial collapse of the floor

The floor upstairs is impassable for the suffered collapses (Fig. 4.4.54). This condition allows to investigate the composition of the layers above the plank. The Venetian traditional flooring can be observed. The purlins load on the main wooden beams 6 and 7.

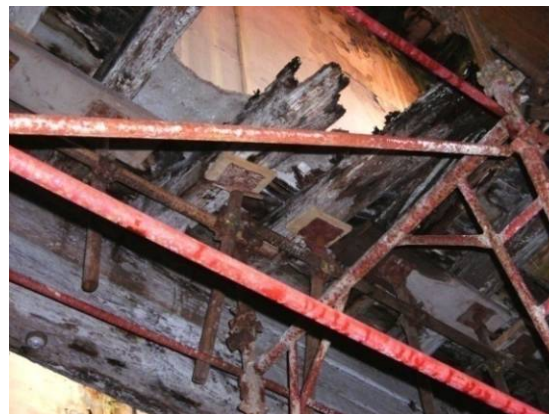
Fig. 4.4.55: Purlins and plank collapsed as a result of the material decay

The degradation of the material throughout all the frame and on the plank is caused by high presence of moisture (Fig. 4.4.55). The depression of the floor has reached the collapse due to the cracks on the beams.

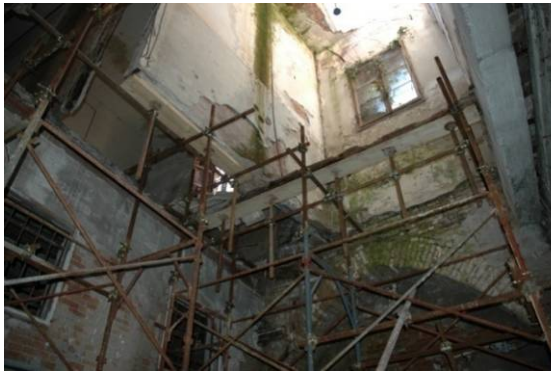
Fig. 4.4.56: Total collapse of the floor

The collapse of the floor is almost complete (Fig. 4.4.56). Only three wooden beams remain and almost no trace of the plank (Fig. 4.4.57). The frame of the floor loads on a masonry wall and on the concrete beam number 8. After the survey some walls on the upper floor without any support were found.

The collapse of the floor was caused by the high level of moisture, to which has been exposed, given the total absence of the upper floors. The collapsed material from the upper floors has also got worse the load on the frame already affected by depression of the purlins concerned by a reduced loading capacity.

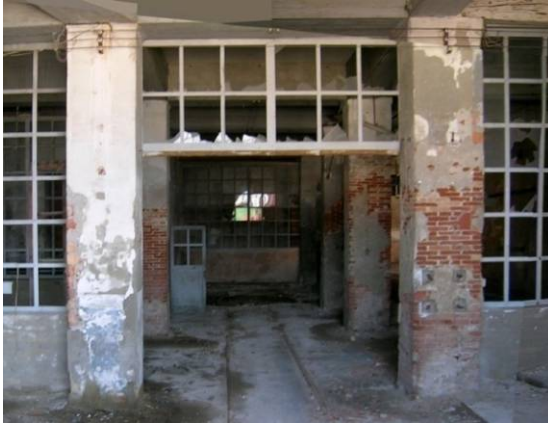
Fig. 4.4.63: Pillars 6 and 7 with diffuse detachments of plaster

Structural damages are not observed. The plaster shows many detachments, caused by moisture rise in the brickwork masonry.

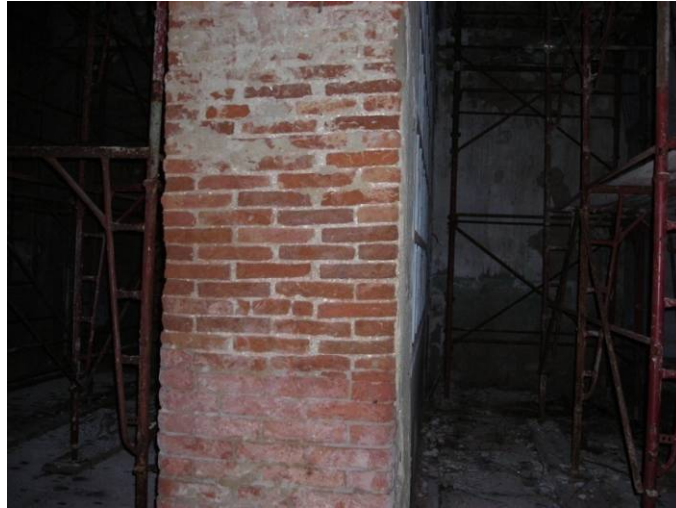
Due to the lacking of plaster, at the halfway up of the pillar 10, it is possible to see the slope of the rows of bricks, as a construction defect (Fig. 4.4.65).

There are no structural damages but large detachments of plaster, especially concentrated in the lower edge and caused by moisture rise. Powdery detachments of mortar are observed on the underside of the edges.

Fig. 4.4.65: Pillar 10 – inclination of the rows of bricks

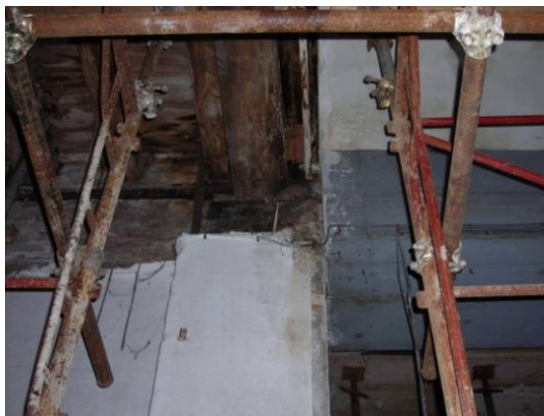
The pillar number 12, leaned against the wall, protruding out the edge of this wall for about 26 cm, as long as a length of the brick. Unlike other similar elements has no capital, nor the stone slab to support of the beam (Fig. 4.4.66).

There are not structural damages. The detachments of the plaster are caused by the presence of moisture rise.

Fig. 4.4.66: Pillar 12 – absence of the slab of stone for the connection beam-wall

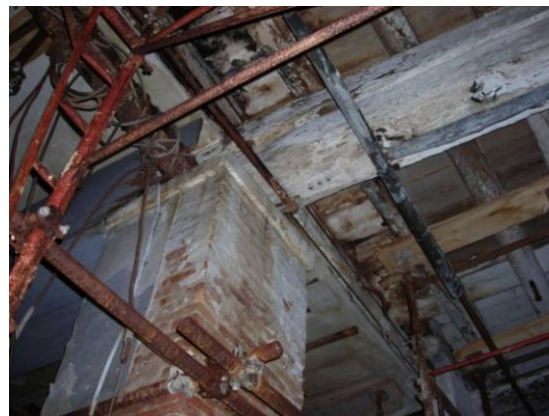
Fig. 4.4.67: Pillar 13 – presence of plaster in the upper part

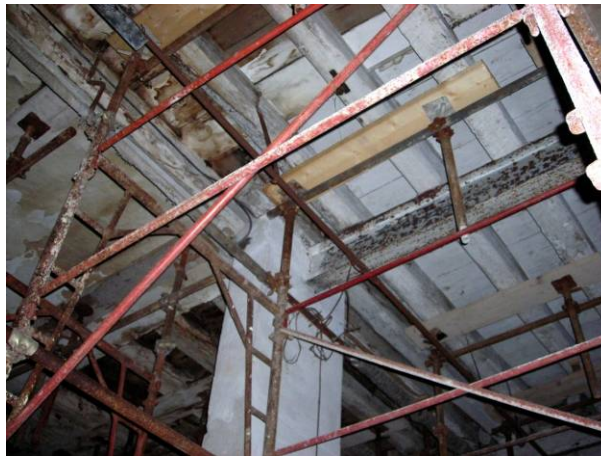
The wall has no structural damages. The cement plaster has some detachments due to moisture rise, concentrated on the lower part of the element.

Fig. 4.4.68: Iron beam restrained at the pillar

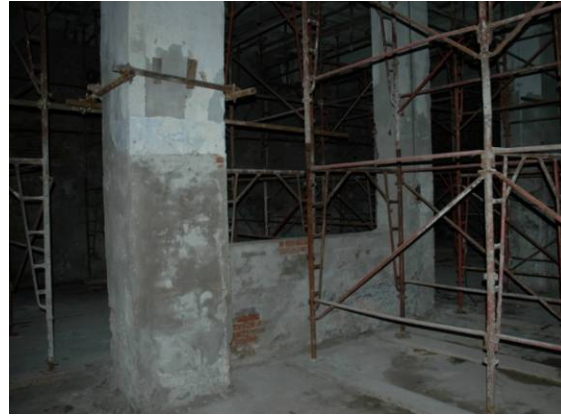
There are not structural damages. The plaster has concentrated detachments in the lower part of the element, due to the moisture rise, while it is in good condition in the upper part.

Fig. 4.4.70: Base of the pillar 15, connected with the pillar 14

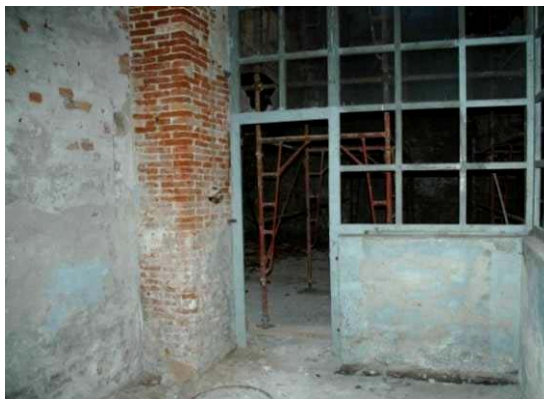
There are no structural damages in the pillar. The plaster has wide detachments caused by moisture on the wall.

Fig. 4.4.71: Masonry pillar against the wall

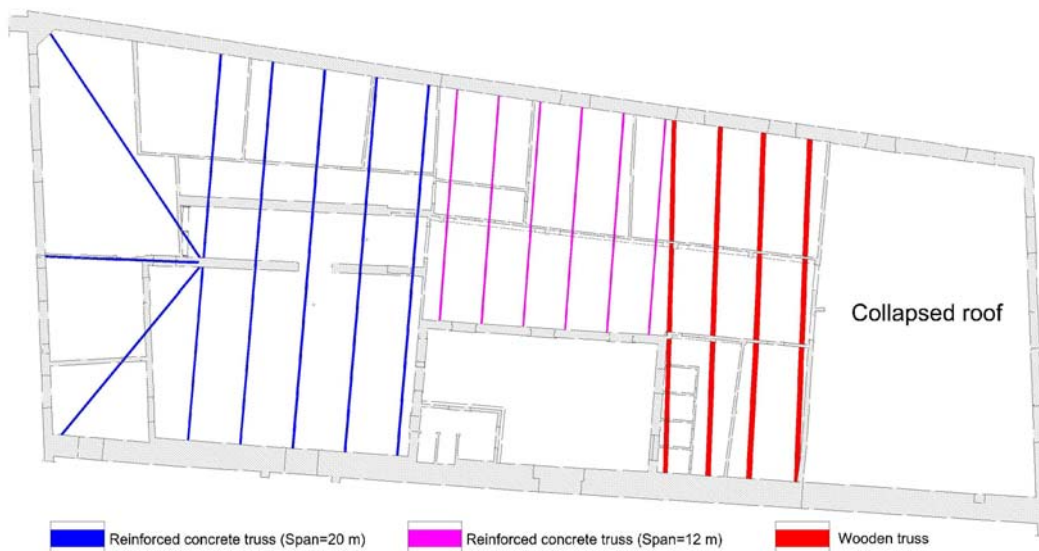
The roof of the area A is characterized by wooden trusses. As mentioned in the previous paragraph, a part of the roof has recently collapsed due to the decay of the structural wooden elements. In particular, there was a strong degradation at the ends of the beams. The state of neglect of the building and the non-maintenance of the roof have caused local collapse of the surface roof thus allowing the atmospheric agents to penetrate in the wooden elements up to cause the loss of the load bearing capacity.

Fig. 4.4.74: plan of the roof situation at the beginning of the investigation

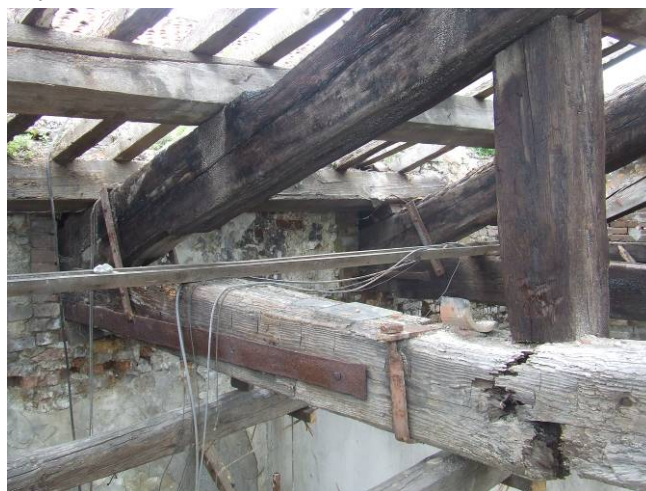
The not collapsed trusses have different and diffuse types of decay. The biotic degradation that involves the presence of insects and fungus, percolation from moisture and mechanical decay caused by cracking and breaking of the wooden elements (Fig. 4.4.79). The most diffuse damage is in the end of beams near the masonry interface, where there are high moisture zones (Fig. 4.4.80).

Fig. 4.4.79: Detail of a breaking in the tie beam near the joint with the post

Also, there is a degradation layer in correspondence to the joints (Fig. 4.4.81 e Fig. 4.4.82) between the wooden elements of the trusses. For this reason it will be necessary a redevelopment intervention to give back the load bearing capacity at the roof structure.

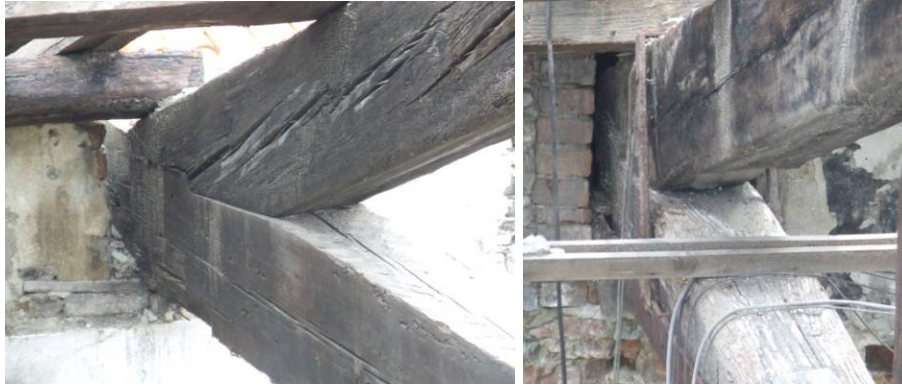
Fig. 4.4.80: Degradation at the ends of beams, near the anchorage

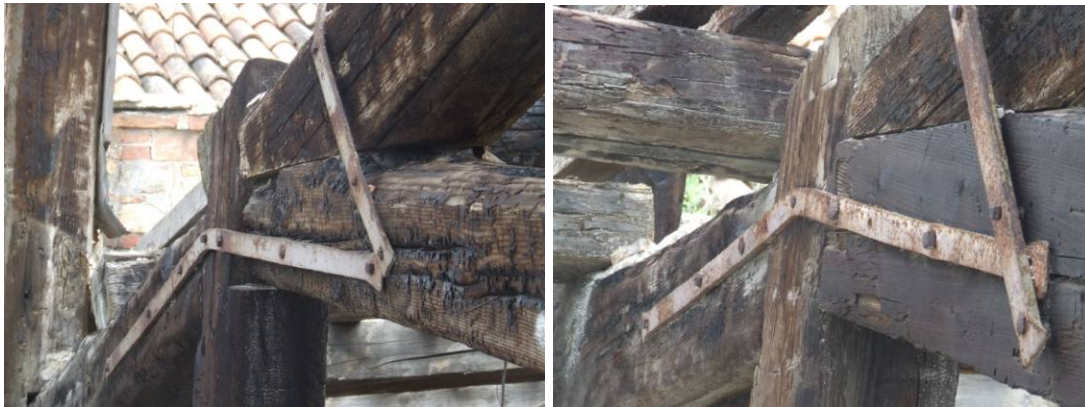
Fig. 4.4.81: Degradation of joints

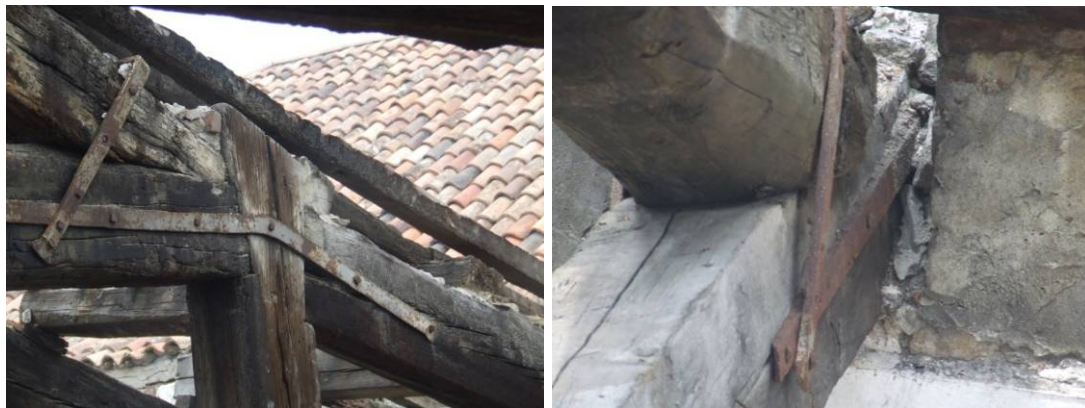
Fig. 4.4.82: Degradation of joints and of the connection between masonry wall and tie beam

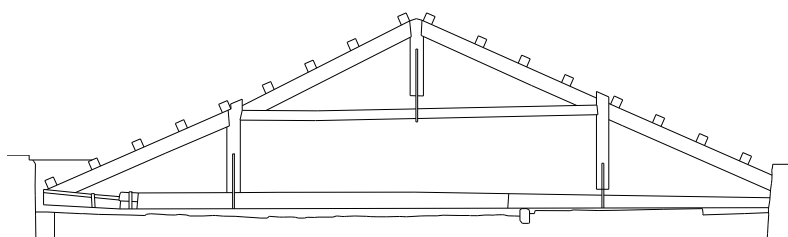
Below is reported the section of the present-day conditions of one of the 4 trusses. From the (Fig. 4.4.83), it is possible to see the considerable structural failures of tie beam, straining beam and the joints strut-tie beam. This section was made through a laser scanner survey.

Fig. 4.4.83: Section of the present-day conditions of the truss called A2

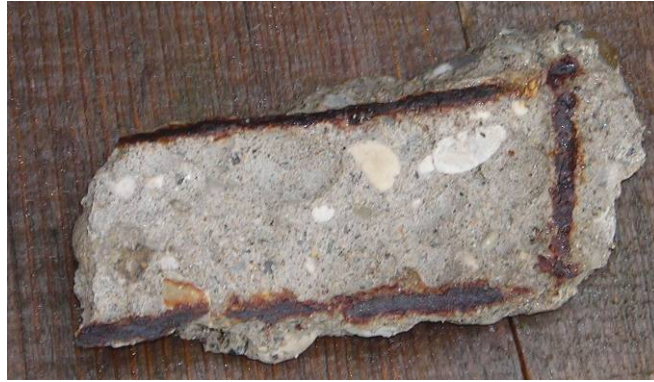
Fig. 4.4.98: Concrete specimen

The information obtained concern the aggregates, the binder and the concrete mixture of the specimen. The aggregates are sedimentary origin, sandstone, and have a granulometry composition predominantly fine, because their size do not exceed 4 mm. The angular shape of the inerts is indicative of its good bond with the cement paste that assure a greater tensile strength. The presence of the ferrous oxide with a percentage equal to the 3% is justified by the presence of rust due to the oxidation of the specimen surface, caused by the widespread carbonation.

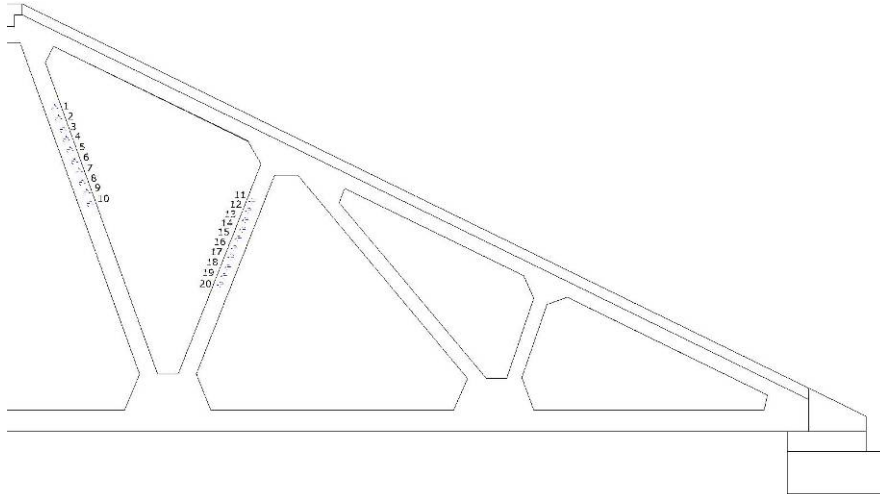
Fig. 4.4.99: Map of the points in which the Schmidt hammer test was made

Further to the processing data of the test with the Schmidt hammer it was possible to obtain the strength class of the concrete. It is included between 12 N/mm<sup>2</sup> and 16 N/mm<sup>2</sup>.

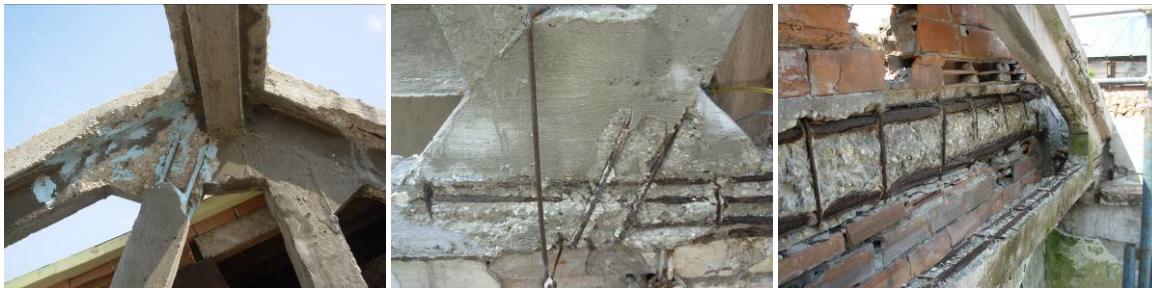
Fig. 4.4.102: Details of the actual conditions of the reinforced concrete trusses

Given the presence of spallings on the concrete trusses it was possible measure the diameter and the pitch of reinforcement bars and of stirrups on sight, with the use of the caliper. So, it was confirmed the position of reinforcement bars and stirrups measured by electromagnetic cover meter, thanks to the visual observations (Fig. 4.4.102).

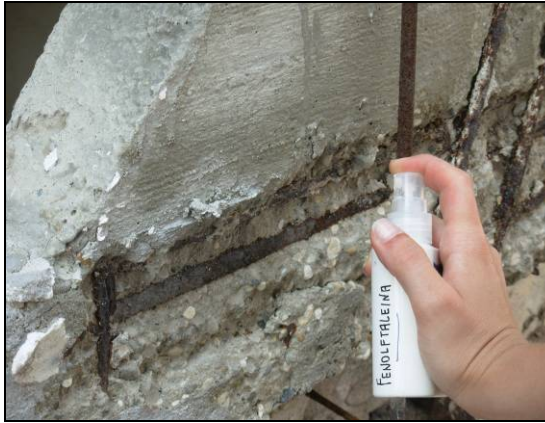
Fig. 4.4.106: Detail of the carbonation phenomenon in a joint of the r.c. truss of the area B

The building into consideration is located in a strongly saline environment and interested by an elevated percentage of moisture typical of the lagoonal ambient. These are the main causes of the diffused decay present in some parts of the r.c. trusses of the *Sala Maggiore*.

The structure is predominantly subjected at an elevated level of carbonation (Fig. 4.4.106) that, in some parts, it led to the spalling phenomenon (Fig. 4.4.107), that is the detachment of the concrete cover.

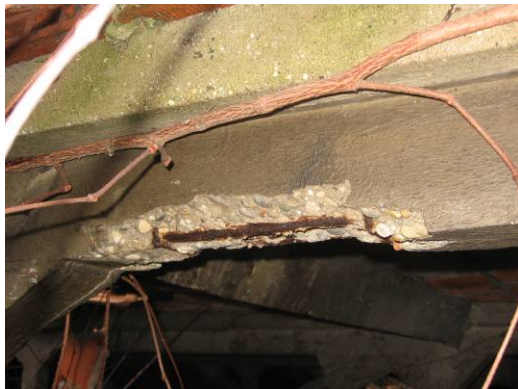
Fig. 4.4.108: Detail of a crack in a strut

- main and visible cracks in proximity of the parts where there are the detachments of the concrete cover (Fig. 4.4.108);
- poor concrete, especially in proximity of the joints (Fig. 4.4.109);
- concrete swelling that causing a superficial and localized raising of the material (Fig. 4.4.110);
- chemical attack due to algae patinas and mosses, identified by the presence of organic materials with a green colour (Fig. 4.4.111);
- presence of grout (Fig. 4.4.112);
- lacks that caused fall and loss of parts of material (Fig. 4.4.113).

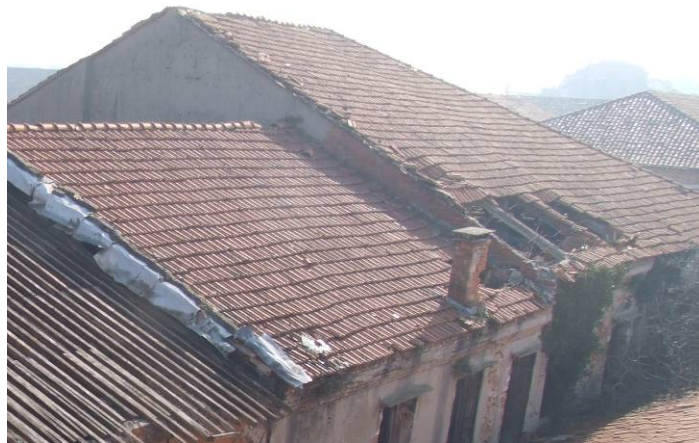
Fig. 4.4.127: View of the roof of the areas B and C

There are not information about the geometry of the support of the truss on the wall, schematized in Fig. 4.4.126 with the letter A. However, it is possible to understand the distribution of the elements considering some photos, as the Fig. 4.4.127. The support of trusses is at a higher level, compared with the one of the area B, of about 60 cm., as is reported in the longitudinal section in Fig. 4.4.128. Moreover, there is a masonry eaves as for the B zone. For this reason, the support of the trusses can be considered similar to the B, whose representation is reported in Fig. 4.4.97. The presence of the joist in not assured.

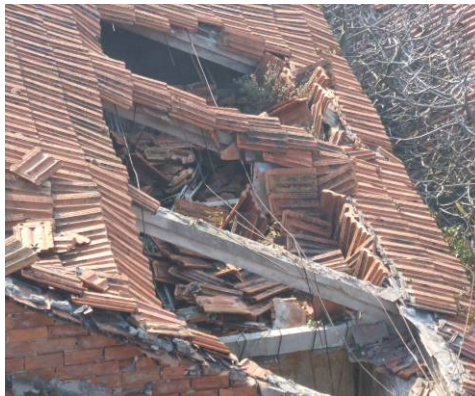
Fig. 4.4.129: View of the trusses C1 and C2

The main degradation of the trusses in the area C is in correspondence of the localized collapses of the roof structure. Below the numeration reported in Fig. 4.4.86, the trusses that present the most damage are: C1 and C2, where the decay is concentrated at the end of the west strut, and C6, C9, C11, C13 and C15, where the degradation implicates all the element. For the other trusses the view is not allowed due to the presence of the false ceiling, but it is possible to suppose that the decay is similar to the five trusses of the area B, not interested by a diffuse damages.

Fig. 4.4.129 shows the presence of vegetation and the collapse of part of the false ceiling. It is not possible define precisely if there are other type of damages, but given the exposure of the trusses to the atmospheric agents, probably the structure is interested by the carbonation phenomena.

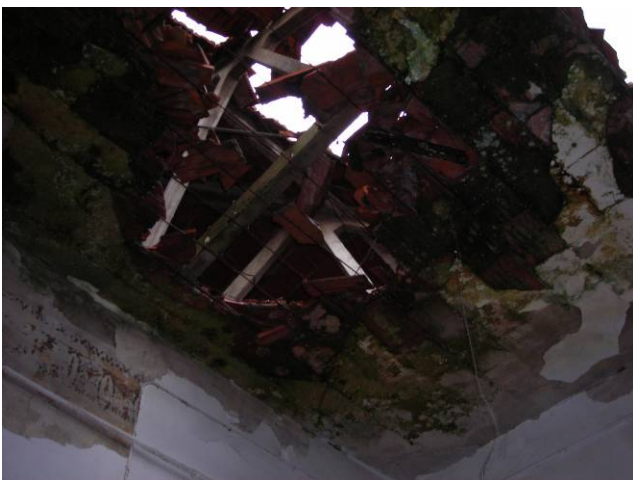
Fig. 4.4.130: View of the truss C9

In the south part of the roof, the trusses most degraded are the ones that form the pavilion pitch (C6, C9, C11, C13 e C15). The conditions of the beams were detected through a hole in the false ceiling, as reported in Fig. 4.4.130, that shows the presence of algae patinas in the tie beam. As in the previous cases, it is evident the poor concrete and the diffusion of carbonation attacks. In the struts there are sediments of tile roof, as showed in Fig. 4.4.131.

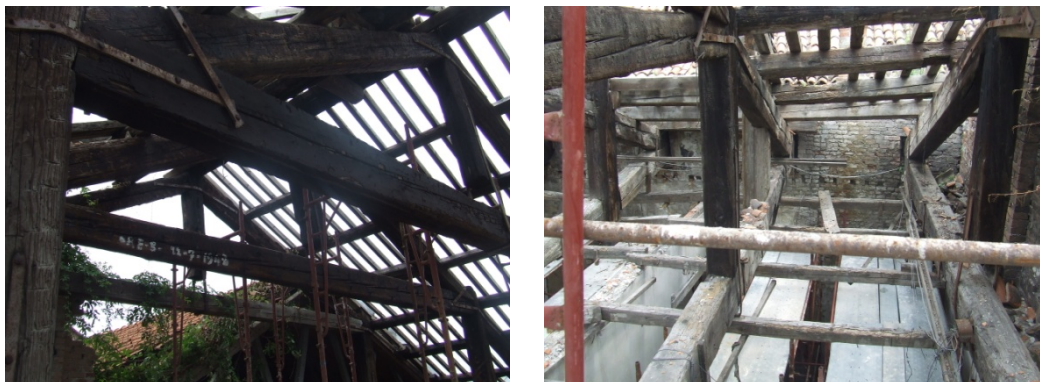
Fig. 4.6.12: Wooden trusses before the intervention of conservation

Also, have been made a series of inspections to assess the conservation status of wood trusses which have showed a diffuse decay, above all, at the end of the beams in correspondence of the strut-tie beam node (Fig. 4.6.12). Into the span width, in fact, the wood still appeared, in most cases, in good condition, while at the ends of the tie beams and strut, placed inside the perimeter wall of the building, appeared compromised by biological attacks. This degradation of the structures has significantly affected the stability of the entire structure.

The intervention project involved the reconstruction of the deteriorated parts of the trusses, by the insertion of special wooden implants, respecting as much as possible the original static scheme and aesthetic aspect of the structures, with attention to the mechanical characteristics of the wood. The intervention is designed to not undermine the resistance characteristics of the wooden parts giving an adequate assurance on the load-bearing capacity and durability of the restoration.

Therefore, was done the repair and replacement of the deteriorated ends of the struts and tie-beams with special wooden elements.

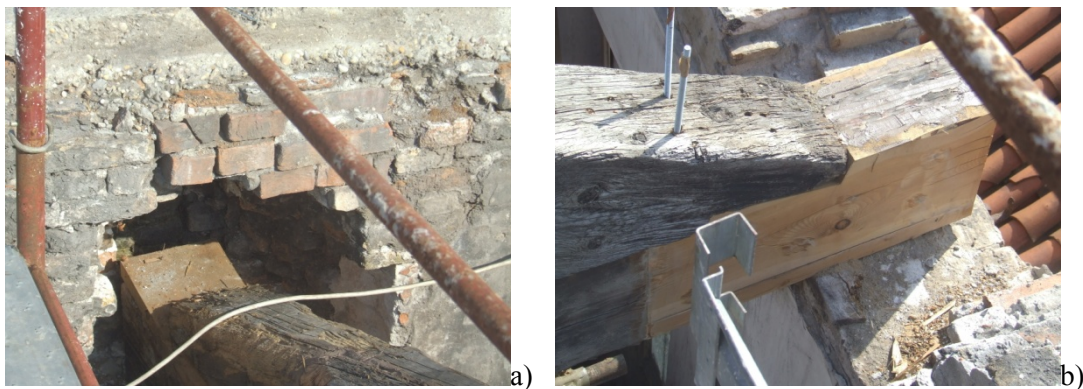
For the restoration of the truss has proceeded with the execution of building works involving the flaring and opening of the support seats of the trusses on the wall to allow the restoration and create adequate manoeuvre space for the removal of the wooden structures (Fig. 4.6.13).

Fig. 4.6.13: a) Inserting the edge of the beam inside the masonry wall; b) detail of the material substitution at the beam's end
