UNIVERSITÀ  
DEGLI STUDI  
DI PADOVA

**AN INTEGRATED APPROACH FOR RESTORATION AND  
CONSERVATION OF CULTURAL HERITAGE STRUCTURES: HISTORY,  
MATERIALS AND STRUCTURAL BEHAVIOUR. THE ARSENAL OF  
VENICE**

**Dottorando:** Giulia Bettiol

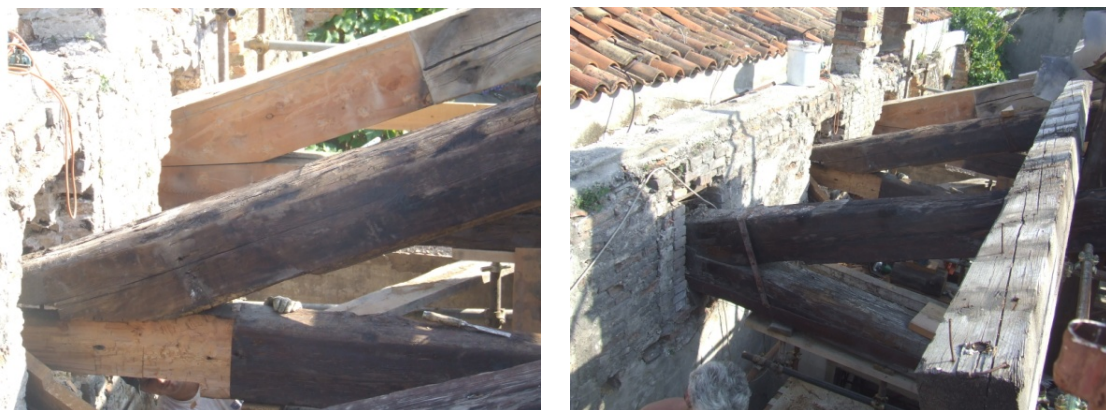
It was removed the metal bracket to release the node and allow the slight elevation of the strut than the tie-beam. Then, was performed resection of the terminal parts (Fig. 4.6.14) of the wooden truss needed to insert the new joints.

Fig. 4.6.14: Resection of the deteriorated sections

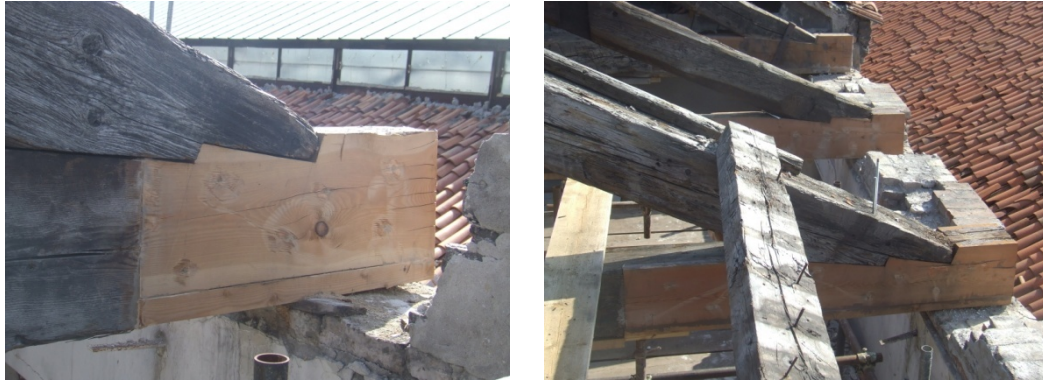
Fig. 4.6.15: Reconstruction of the tie beam-strut joint

The reconstruction of the truss was made with the gluing of wooden implants fixed on the stumps that had been previously profiled.

Also, were inserted the oak wedges and replaced the metal brackets previously removed to allow the execution of the restoration (Fig. 4.6.15 e Fig. 4.6.16).

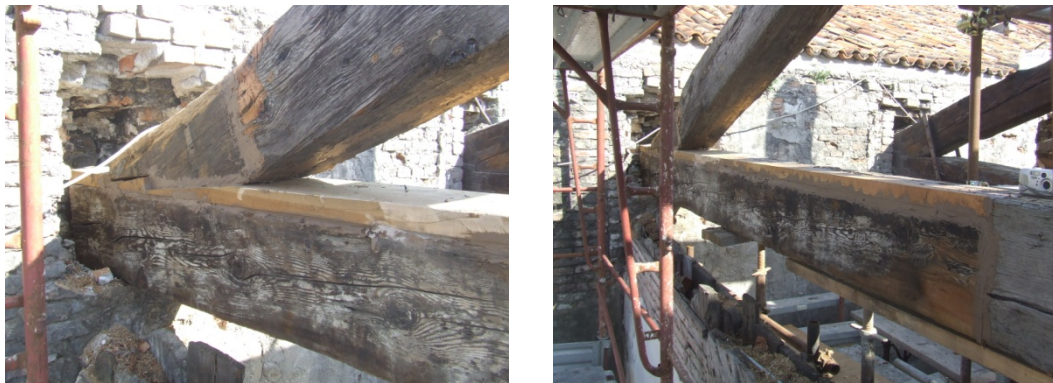
Fig. 4.6.16: Structural interventions, coupling of new and original materials

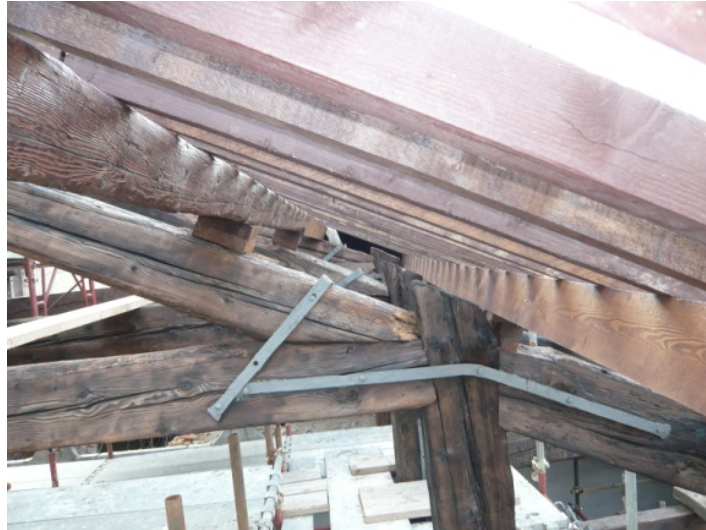
After completion of conservative restoration (Fig. 4.6.17) the trusses are able again to act as structural elements.

Fig. 4.6.17: Restored joints of the trusses of the area A

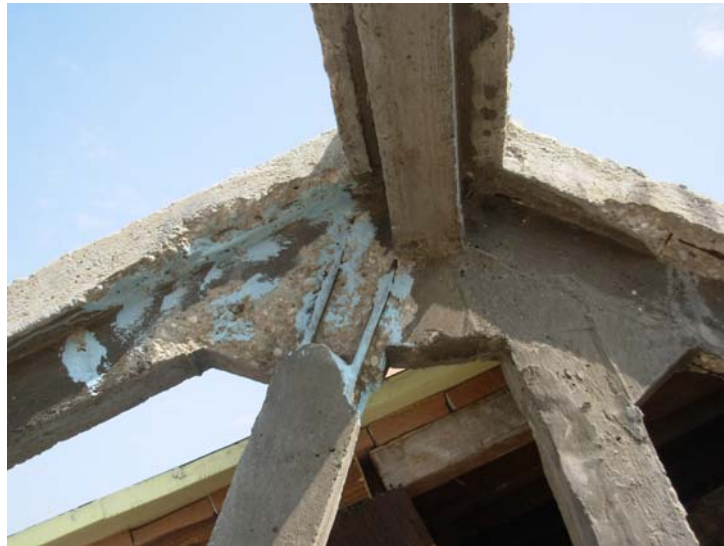
The verifications are not satisfied for the struts of the trusses called B4 and B5. Therefore, a strengthening intervention is needed. Since it was observed a diffuse spalling of concrete (Fig. 4.6.34), the same intervention was applied to all of the struts.

Fig. 4.6.34: Detail of the decay of the joint struts-secondary elements

The crack control of the beams truss is verified thanks to the low stresses . However, the actual situation of the structure presents a diffuse spalling of concrete and the corrosion of the reinforcement bars. Therefore, a recovery intervention of the concrete cover is needed.

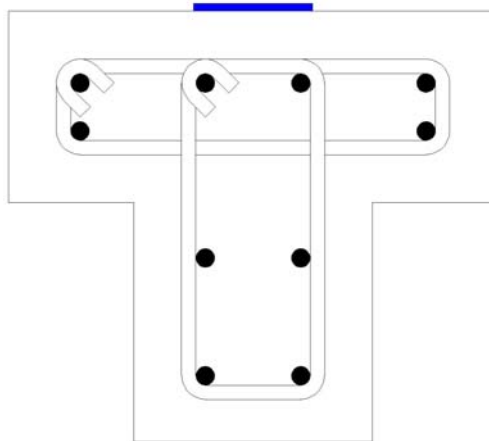
ELEMENT	$M_{Rd}$ (kN·m)	$M_{Ed}$ (kN·m)	VERIFICATION $M_{Rd} > M_{Ed}$
STRUT	-5,4550	-5,6398	Not verified

Fig. 4.6.35: Detail of distribution of FRP in the strut

The beams into consideration are in compression, therefore the fiber should be applied in the upper part of the struts, along the whole length of the element, as indicated in Fig. 4.6.35. The fiber must have a width of 50 mm and a equivalent dry thickness of 0,165 mm.

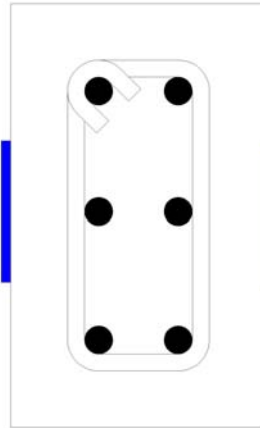
The design of resistance to bending and axial force for tie beams is not satisfied because reinforcement bars are insufficient. Therefore, since the beam is subjected to traction, it is necessary applied two layers of carbon fibers disposed parallel to the reinforcement bars (Fig. 4.6.36).

Fig. 4.6.36: Detail of distribution of FRP in the tie beam

The intervention consists in the application of two layer of carbon fiber with a thickness of 0,165 mm and a width of 50 mm. The fiber is distributed along the whole length of the element. To verify that the proposal intervention is sufficient, it was created a dominio M-N in which are calculated the minimum values of  $M_{Rd}$  and  $N_{Rd}$ . Successively it was verified if the maximum stresses calculated are internal at the range of the dominio M-N. Since fibers should be applied in the central section of tie beam the bending moment will not change.

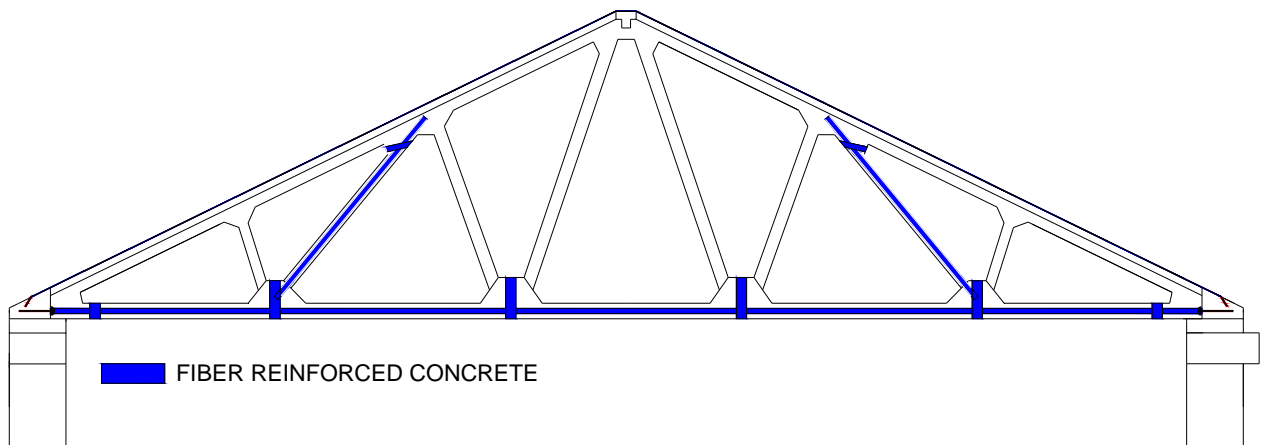
Fig. 4.6.40: Diagram of the distribution of FRP

Struts, tie beams and secondary elements in tension (5-15) of the trusses into consideration must be reinforced, according to the diagram reported in Fig. 4.6.40.

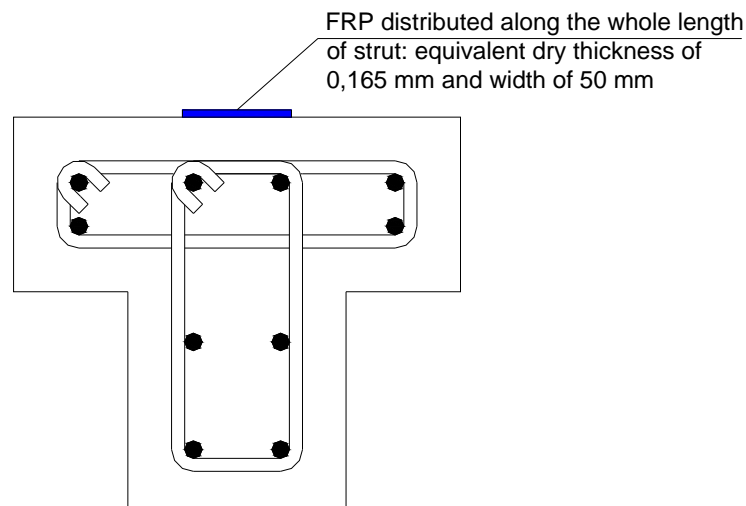
Fig. 4.6.41: Detail of the strut reinforced with FRP

The struts should be reinforced through a layout of FRP disposed in the upper part of the element. The minimum thickness of the layout is 0,0165 mm and the height equal to 50 mm (Fig. 4.6.41).

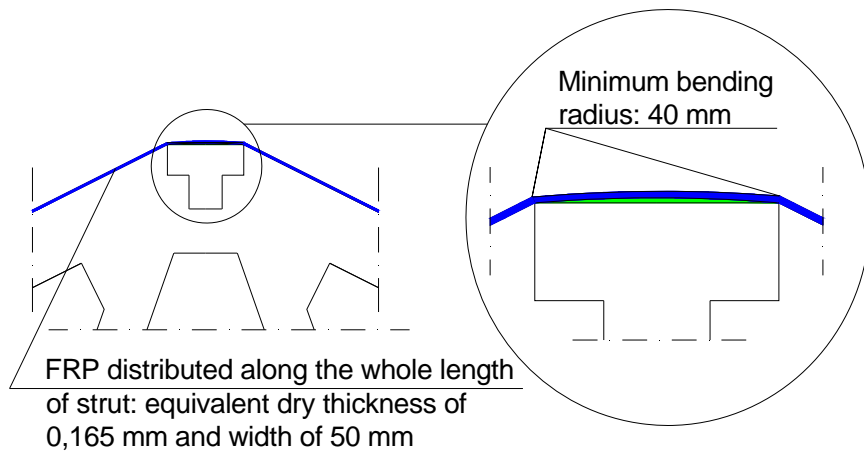
Fig. 4.6.42: Detail of the minimum bending radius (mm)

In the ridge joint, to prevent the indent of the fiber, is necessary to level the ridge beam and the struts in order to guarantee a minimum bending radius of 50 mm (Fig. 4.6.42)

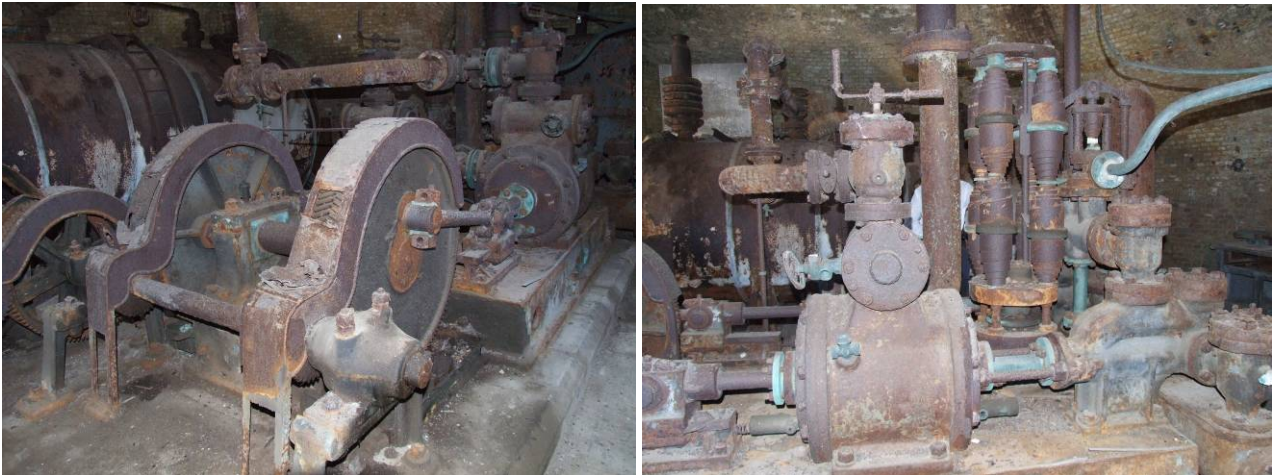
The adaptations of machine, switching from steam to electric motors, and the parts of it replaced are clearly recognizable (Fig. 5.3.6).

Fig. 5.3.6: The bronze parts replaced over time

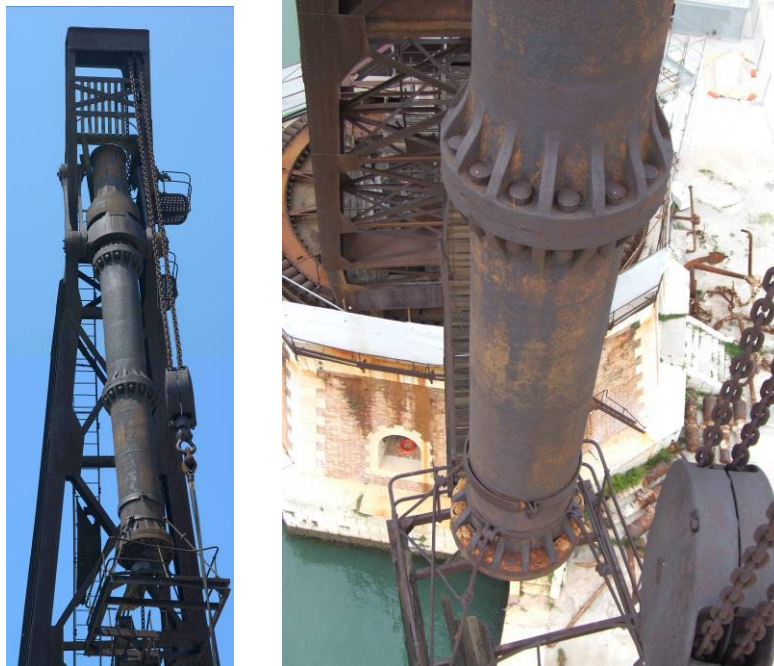
The cylinder of the lift system is still hanging in its proper position, but two important elements were lost: the two rigid pipes that fed the main cylinder, as well as most of the corner joints attached to the cylinder, and the lift rod of the cylinder, already absent in the photographs of the crane in 1916.

Fig. 5.3.23: The hydraulic cylinder

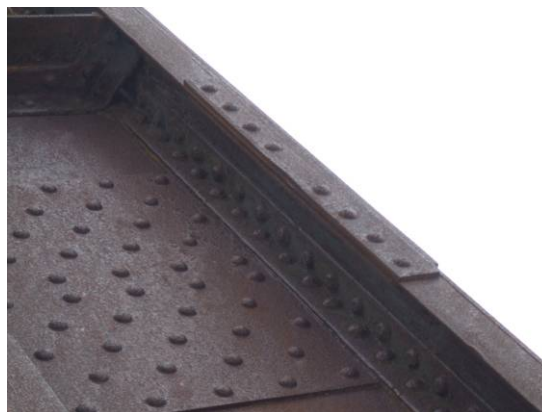
In order to define the geometry of the structure has been carefully surveyed the diameter and the interaction between the rivets on the surface of the crane. This verification was another important stage of the survey because it highlighted potential weaknesses in the structure due to a higher pitch (Fig. 5.4.4).

Fig. 5.4.4: Detail of the rivets pitch

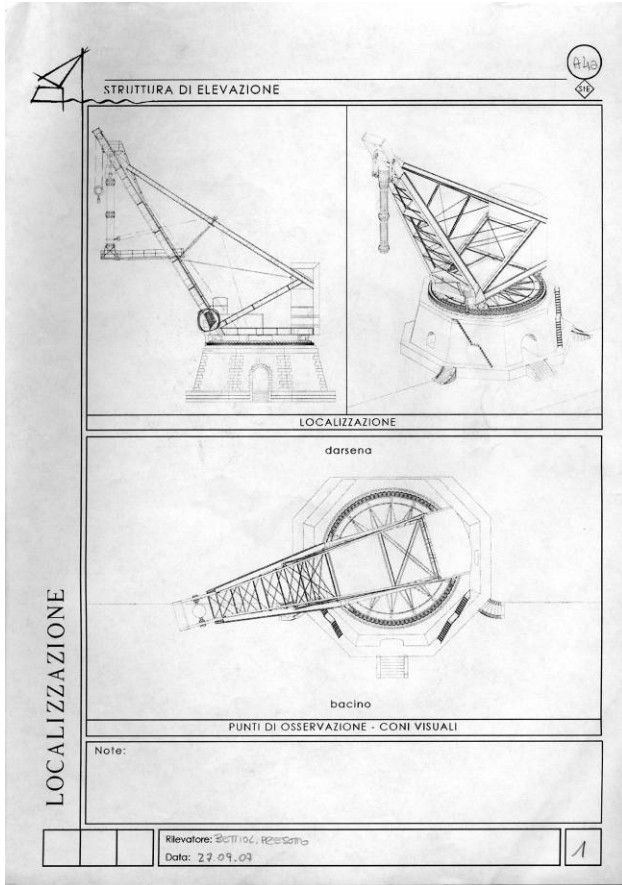
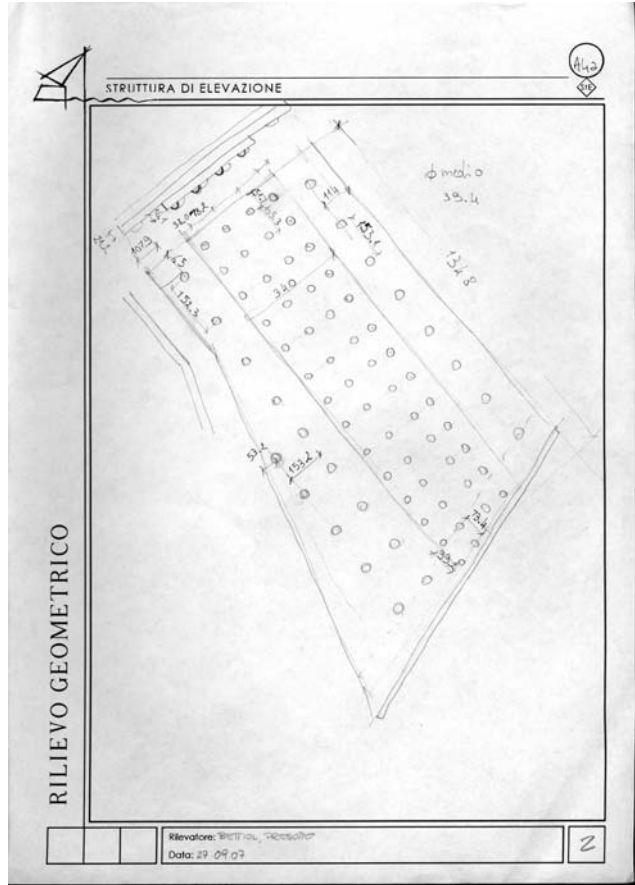
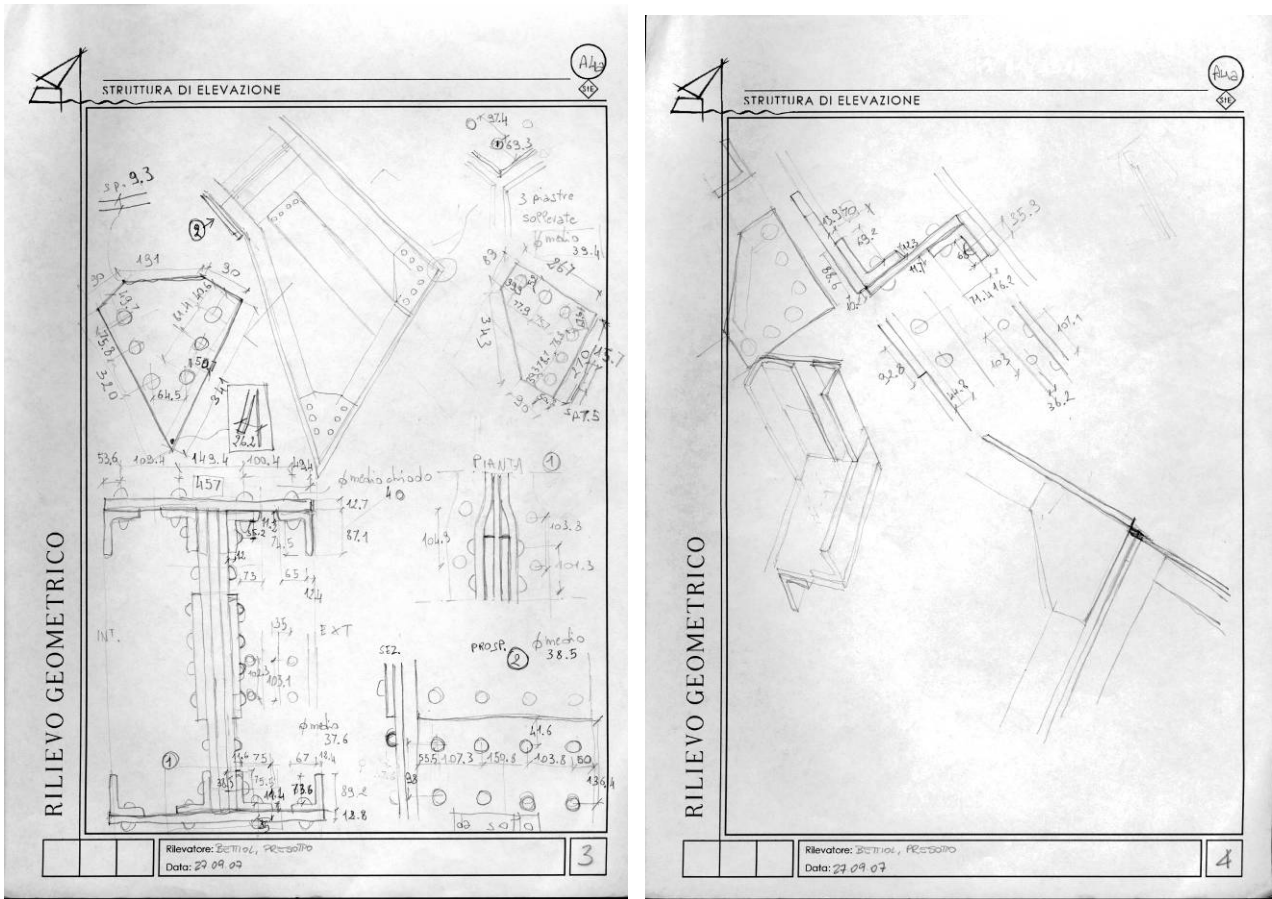
Fig. 5.4.5: Example of summarizing form of the on-site direct survey measuring

All the information observed and registered during the measurement campaigns have been carefully recorded and collected in the form of sketches, two-dimensional and three-dimensional ones, to give a better understanding, and descriptive notes of the degradation. Below an example is reported (Fig. 5.4.5).

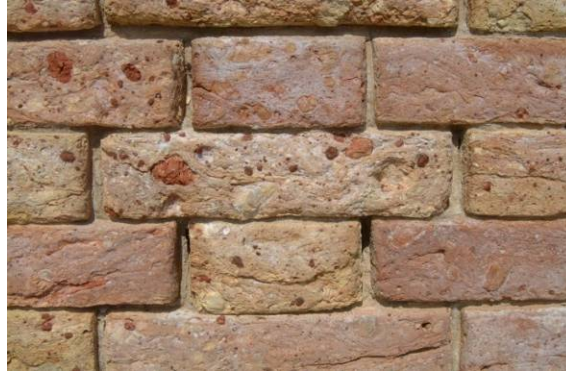
Bricks (Fig. 5.4.17) have a quite heterogeneous composition and so-called ARF (Argillaceous Rocks Fragments) are clearly visible: they are red-brown nodules due to the vitrification of calcium or iron (found as debris in the clay), during cooking. They form when the time needed to maturing phase is not granted. This phase is carried out by leaving the clay exposed outside for about a year so that is affected by phenomena of freeze-thaw and it homogenizes.

Fig. 5.4.17: ARF's details present in eroded bricks

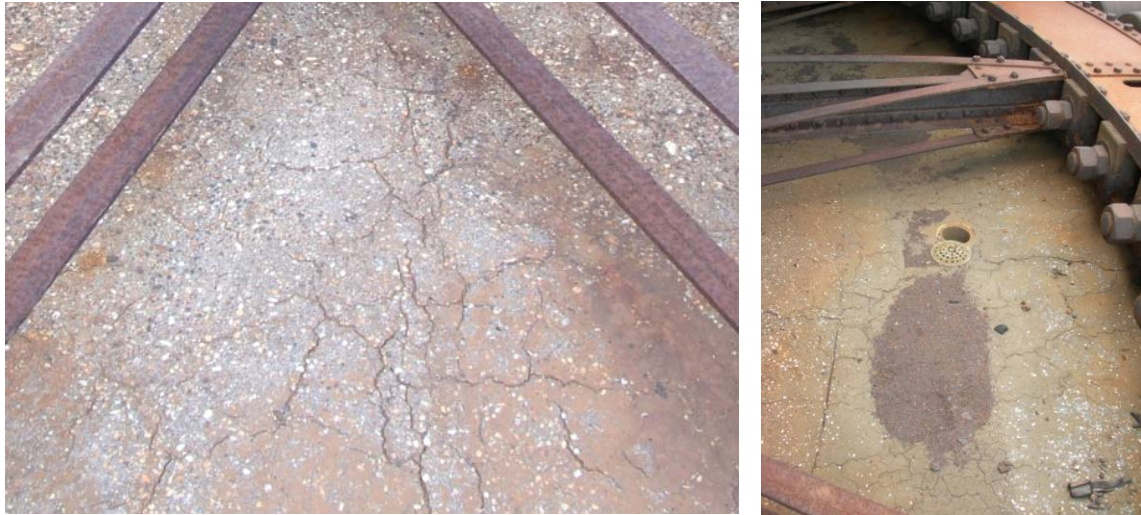
The concrete fills the basement and forms the upper platform (Fig. 5.4.21). It has a compact structure, the chemical binder has not been analyzed, the aggregates are very small particle size and the reddish color of the surface is given by the deposits of corrosion of the above metal components.

Fig. 5.4.21: Detail of the concrete layer

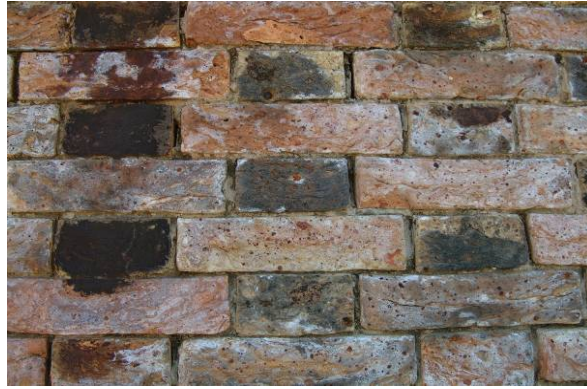
On the same faces efflorescence (Fig. 5.4.26) is located mostly in the lower part of the wall, up to the openings and in sporadic locations at the top. In some places its thickness reaches a few millimeters. The stone of Istria basement and its high elevation above the water, if compared to high tides, has provided a good defense against the possible capillary rise of sea water. Their presence is closely related to the continuous and substantial water-lifts and wet environment. As one can notice there is no efflorescence on the surface covered by corrosion results or stains, because the resulting compact layer does not allow combination with the salts present in the bricks and does not offer chemical elements to bind to.

Fig. 5.4.26: Masonry's detail showing that efflorescence is not present on the surfaces covered by corrosion's products and dark stains

Efflorescence phenomena is also undoubtedly due to the particular marine environment which presents an amount of sodium chloride (NaCl) in the air. These become hygroscopic salts when combined with other salts such as sulphates. In fact, chloride tends to crystallize in environmental conditions that can be defined as rare, that is at 25 ° C and 30% humidity, but they absorb a large amount of water and steam and keep them on the surface, so as to enable the solubilization of other salts.

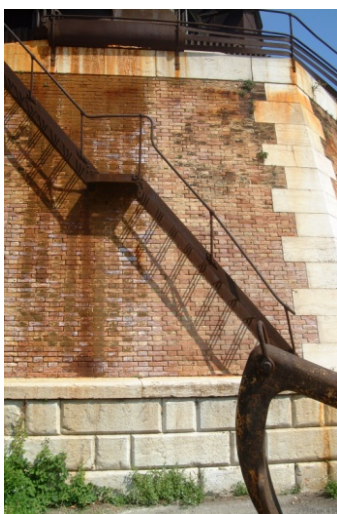
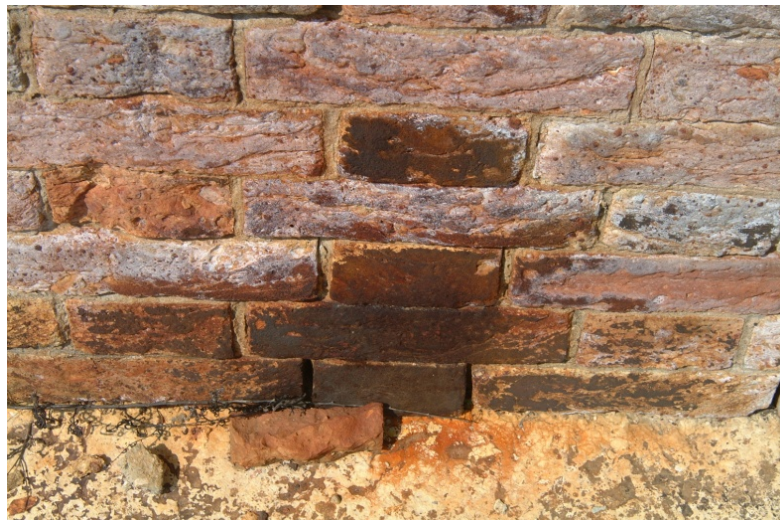
The stains of corrosion deposits (Fig. 5.4.27) cover almost 100% of the faces on the northeast and the upper part of the entire crown. This is due to leaching of the products of corrosion of the metal parts above.

Fig. 5.4.27: Corrosive deposits stains

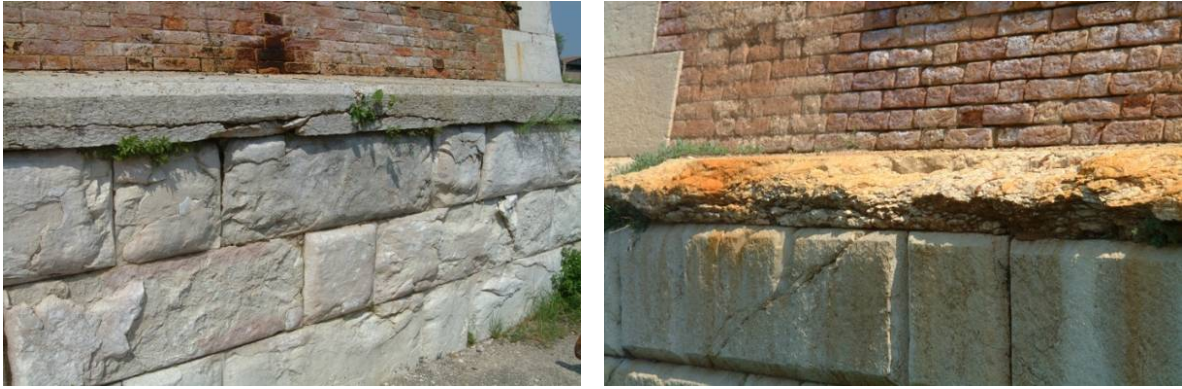
The diversified degradation on Istrian stone is due, external factors being equal, to the different installation against the plans of settling of the blocks and to their cutting in the quarry. One may notice in fact that only the blocks of the face on the right side of the entrance, having plans of settling parallel to the compressive stresses to which they are subject, present surfaces exfoliation, a degradation which led to high loss of material, favored by environmental phenomena. The exfoliation phenomenon (Fig. 5.4.30) is limited only to areas with the presence of faults and with a homogeneous structure.

Fig. 5.4.30: Exfoliation example

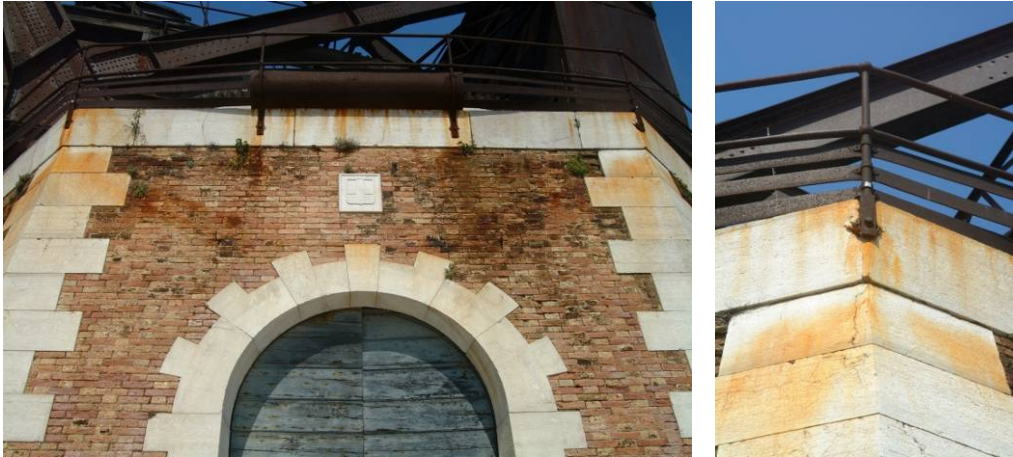
The fractures are quite superficial and may also be due to the processing they were finished with. The stains (Fig. 5.4.33) are the predominant degradation due to the formation of corrosion deposits.

Fig. 5.4.33: Corrosion deposits stains on Istria stone

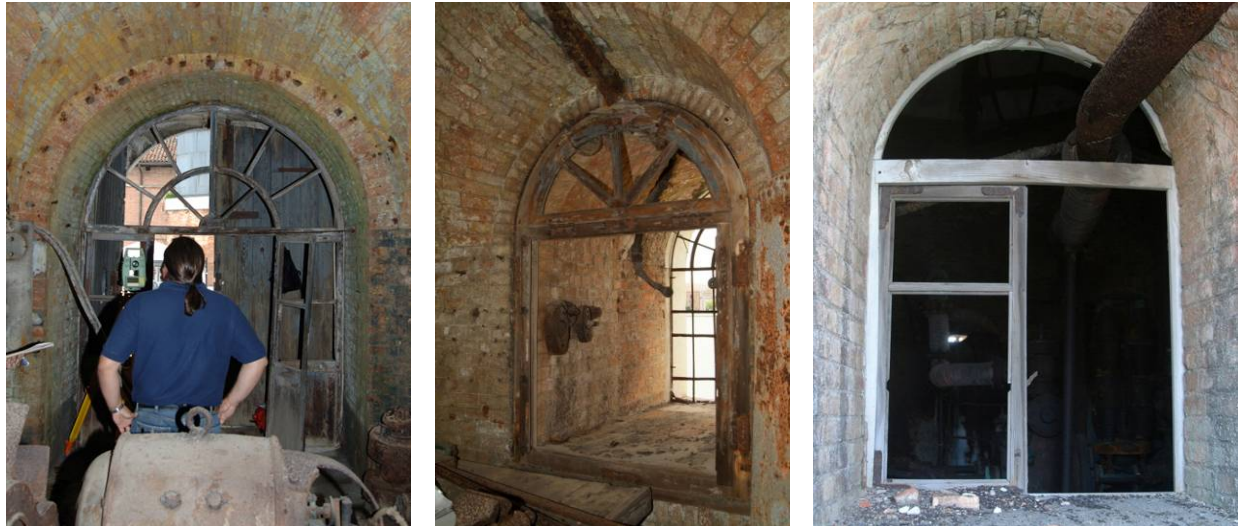
The basement has a wooden gate with two doors and a second door inside with a wooden frame with a fanlight divided into segments (Fig. 5.4.36). The gaps were filled with glass now no longer present. The frames of the windows have two doors too, with an upper fanlight.

Fig. 5.4.36: The wooden frames of the basement

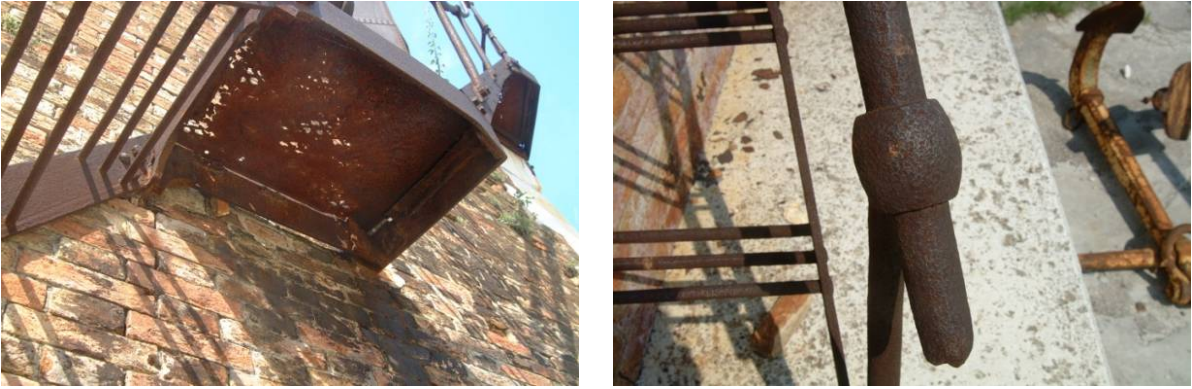
The iron stairs (Fig. 5.4.37), which leads up to the top of the basement, are affected by a degradation produced by localized corrosion. The entire surface is covered with cylindrical shaped craters having a uniform diameter of  $\pm 1\text{mm}$ . The same corrosion on the thin iron plates, covering the small landings, has resulted in their total loss.

Fig. 5.4.37: Iron stairs to reach the upper part of the basement

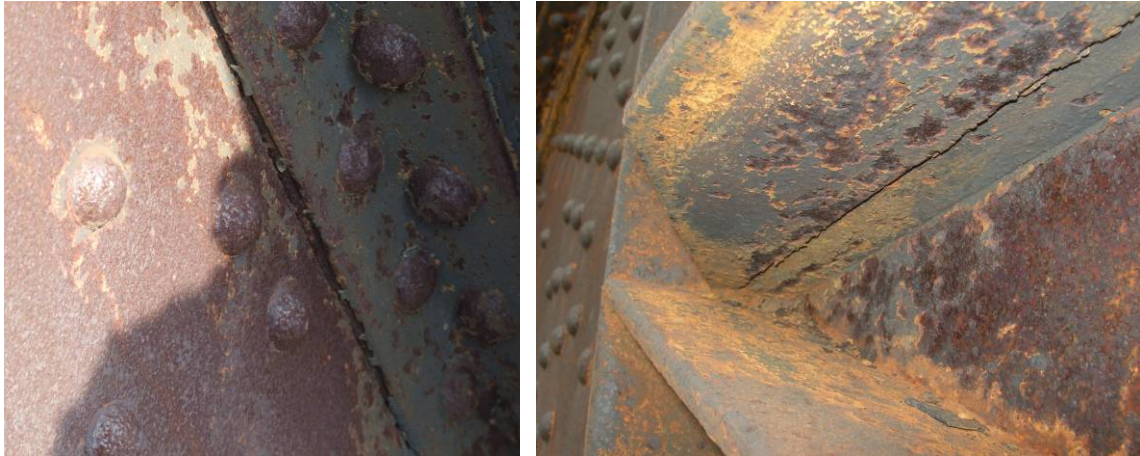
It's well known that the surface of these nineteenth century materials, unprotected, it's much more resistant to corrosion than the modern structural steels (Fig. 5.4.39).

Fig. 5.4.39: The protective layer placed on the surfaces and not yet present on some small areas

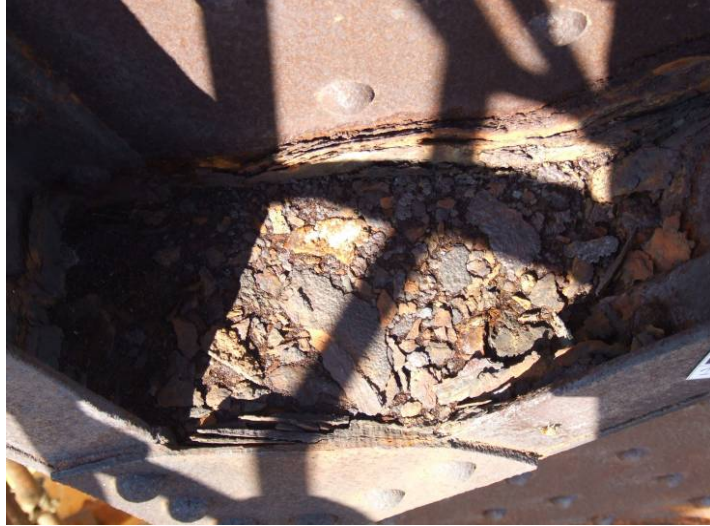
In other areas the corrosion is evident on localized spots of backwater, as on the water drains, present in the original project, but now obstructed by the corrosion products themselves because of lack of maintenance (Fig. 5.4.41).

Fig. 5.4.41: Drainage of the main ruster, blocked by the corrosion products.

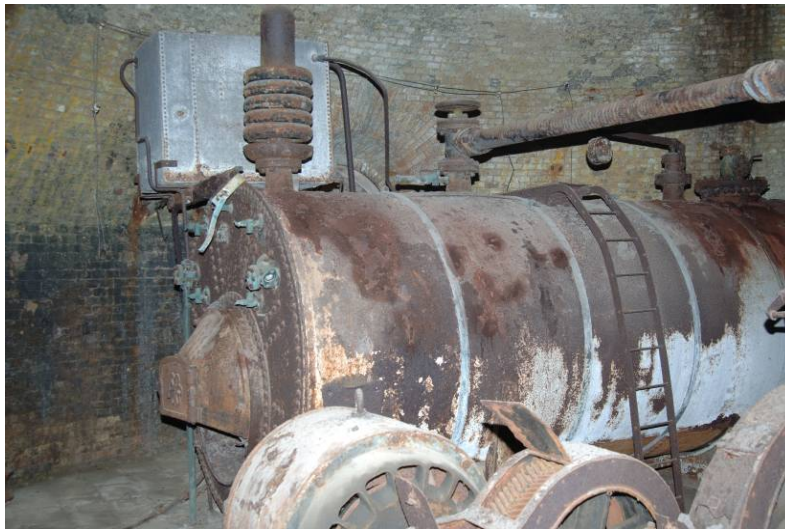
Visual examination of the driving machine shows that the components themselves are affected by the presence of exfoliation, even a deep one (Fig. 5.4.44).

Fig. 5.4.44: Engine room degradation

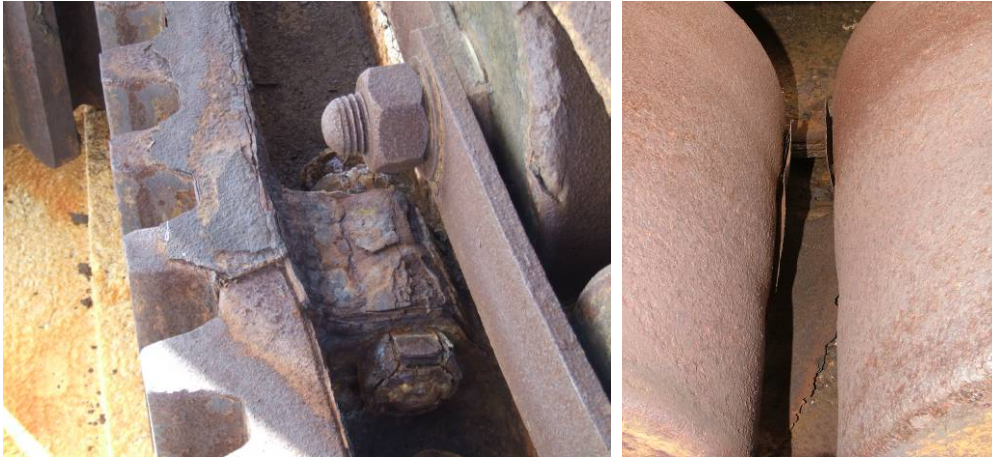
The cast iron rollers are severely corroded, mainly due to backwater that caused the corrosion of the rolling surface, which it's in direct contact with, and they present the most common degradation of this particular material, namely the exfoliation, on the bottom part which is constantly wet (Fig. 5.4.46).

Fig. 5.4.46: Rack's corrosion and rollers exfoliation

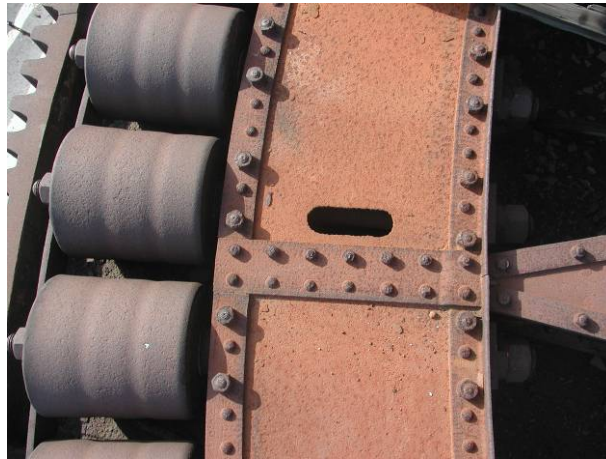
At the top of the rollers there is a wear along two intermediate layers, parallel to the sliding level, due to the rollers rubbing (Fig. 5.4.47).

Fig. 5.4.47: Ware due to rollers rubbing

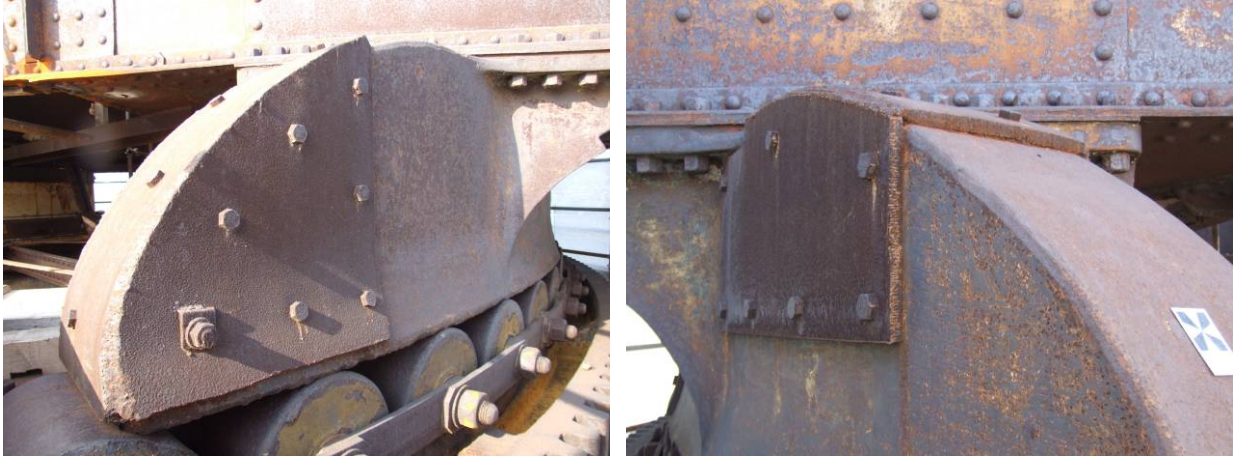
The four cast-iron sliding blocks, which support the platform and slid on rollers, have been hit by a high corrosive state, aggravated in a decisive way by the "fatigue" sustained over decades.

The sliding blocks are indeed the most stressed elements of the whole structure of the crane, being the elements of support of the lattice boom. The two rear sliding blocks, placed below the counterweight, have suffered the most heavy damage, highlighted by obvious cracks, some of which are passing. In the past they have been subject to maintenance through the use of steel jackets, presumably put to stop, or at least slow down, the cracks progress and keep the two sliding block parts connected, so as not to diminish the reagent section (Fig. 5.4.49).

Fig. 5.4.49: Sliding blocks reinforcements

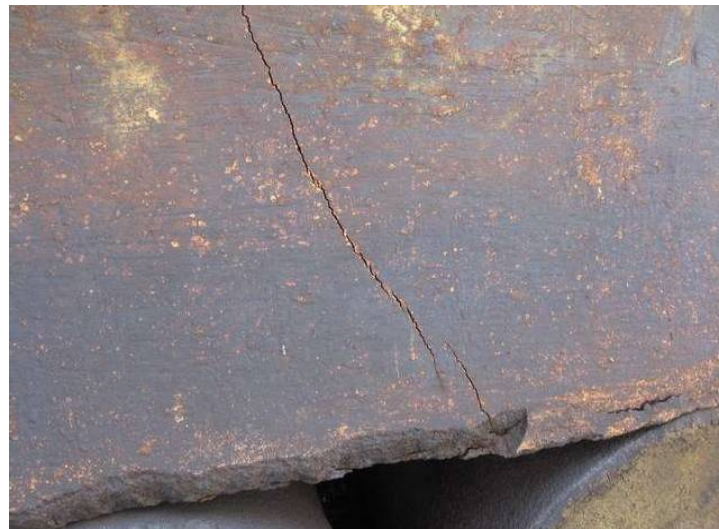
The condition of the sliding block placed under the counterweight is still critical because it is affected by a crack (Fig. 5.4.50).

Fig. 5.4.50: Crack on the sliding block below the counterweight

The results emerging from the general model of the crane together with the on site observations indicate the necessity of lightening the balance load, with the aim of reducing the stresses on the back sliding blocks, and consequently those on the masonry basement. A preliminary calculation was hence performed in order to evaluate the stability conditions of the upper part of the crane and of the mass to be removed to render equal the four vertical reactions at the sliding blocks. Verifications were performed by means of hand calculations and with the aid of the FE model.

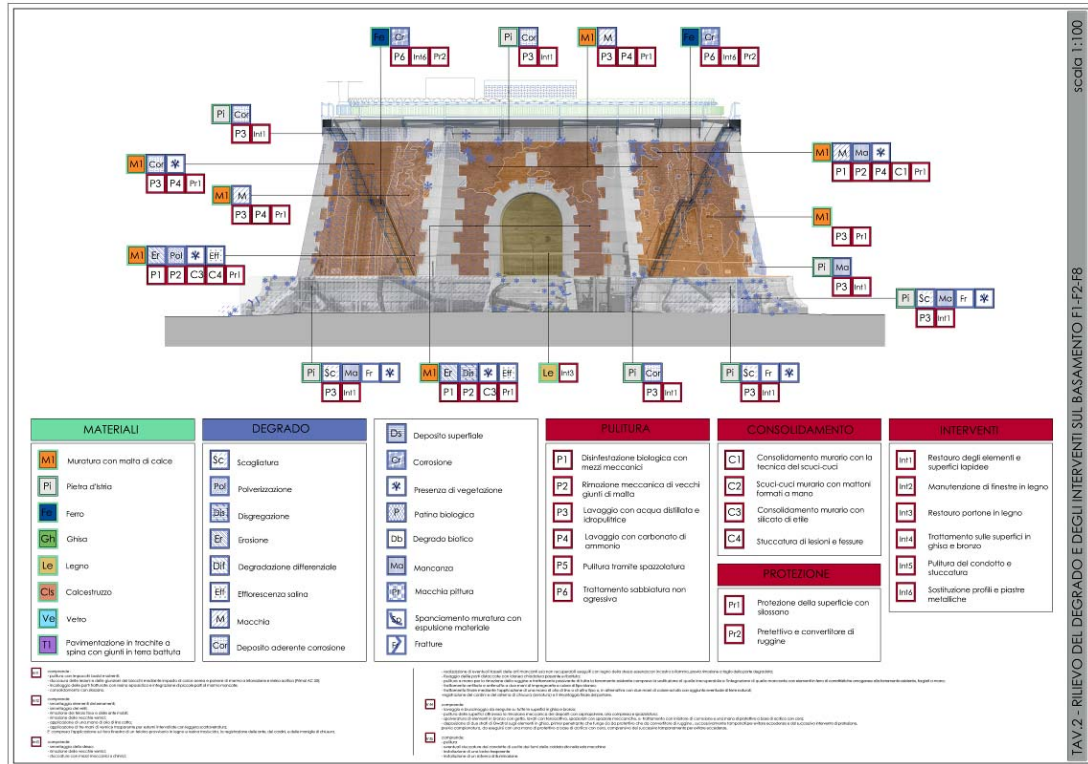
As for the bottom part, mainly built in masonry and Istrian stone, the degradation was shown in some graphic tables (Fig. 5.5.4) that contains the type of material, degradation and types of jobs to be performed for recovery and maintenance of the basement structure.

Fig. 5.5.4: Example of a graphical table concerning the degradation of the basement and the jobs to be performed for recovery

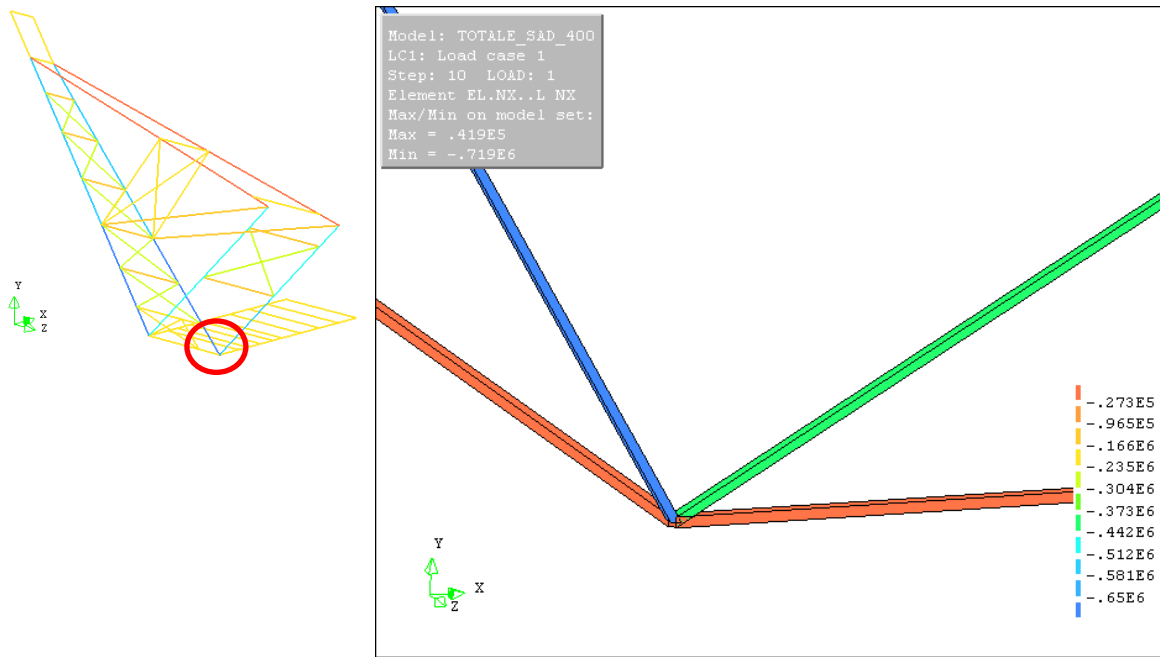
In particular, this truss is subjected to a gradually increasing load towards node named N1 (Fig. 5.6.14). Such node, also depending on the observed material deterioration, resulted the most critical area of the upper structure. This is due to the remarkable forces to whom the node is subjected, since it represents the converging point of three of the four principal beams of the crane.

Fig. 5.6.14: Detail, axial load converging to node N1 (N)

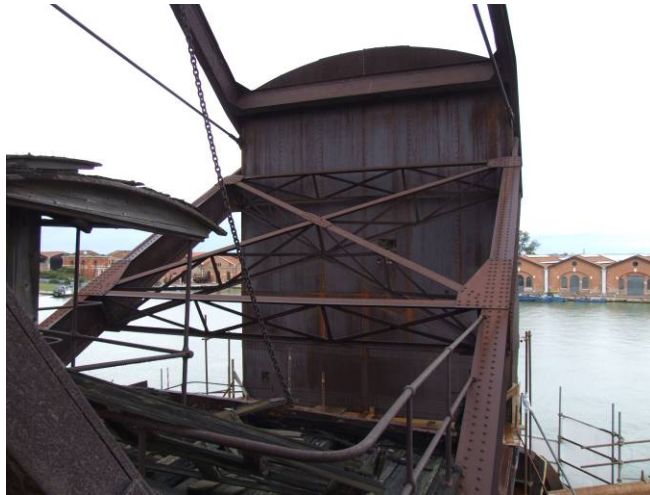
Fig. 5.7.4: Counterweight of the crane

The on-site survey has highlighted the presence of a diffuse degradations of the elements. For this reason, was decided the partial removing material inside the caisson (Fig. 5.7.4) to reduce the vertical reactions in the rear blocks.

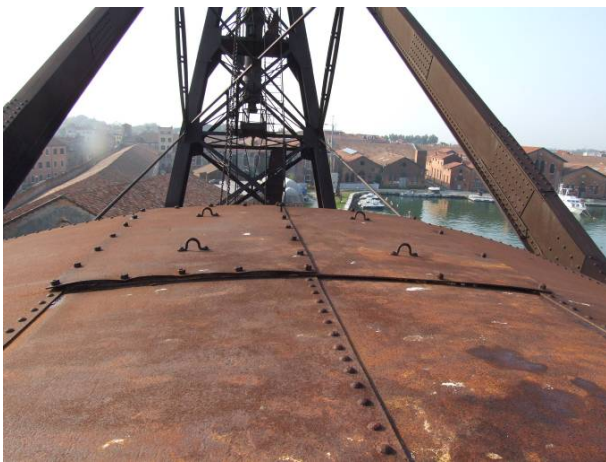
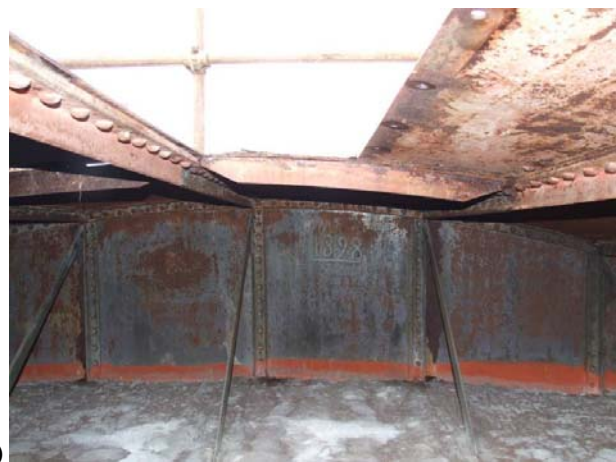
Fig. 5.7.5: (a) Manhole located at the top counterweight; (b) inside of the counterweight

The internal situation of the lateral surfaces of the caisson and of the bracing cross profiles shows a advanced decay conditions (Fig. 5.7.5) as well as the extended cracks, one higher than one meter (Fig. 5.7.6).

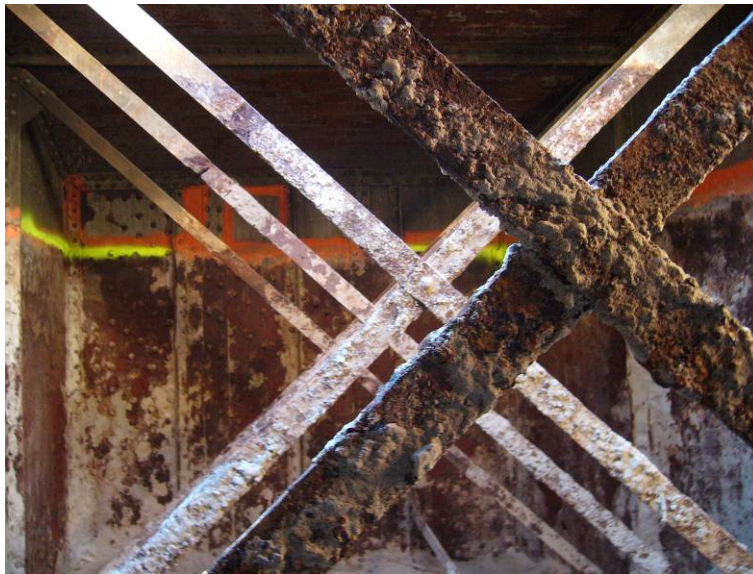
Fig. 5.7.9: Bracing system

As mentioned above, the infilling at the moment of the opening was empty for an heigth of 1,10 meters from the upper manhole. With the emptying of 100 tons of materials the heigth of the infilling has been fallen by an additional 2 meters. This has permitted to evaluate the damage situation of the internal bracing system (Fig. 5.7.9).

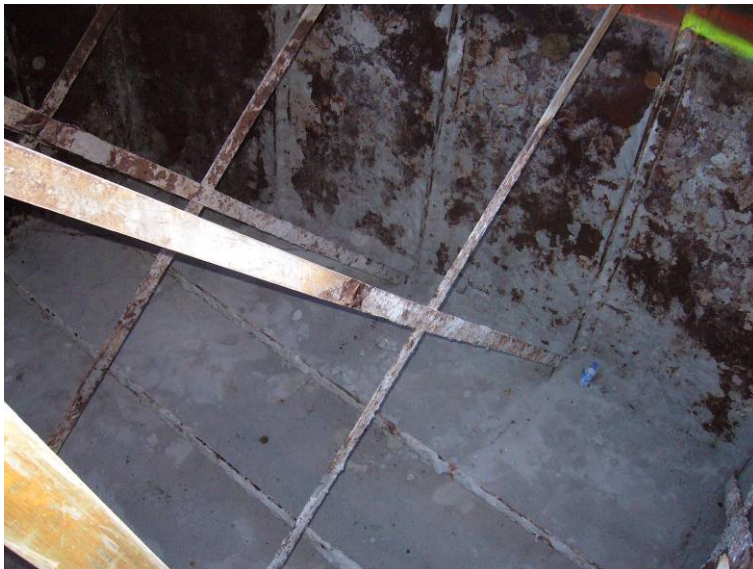
In the upper part of the caisson are present 5 bracing cross profiles. The central stiffening does not work any more in traction, due to a lateral breaking up of the two elements of the cross (Fig. 5.7.10).

Fig. 5.7.10: Central bracing cross profile

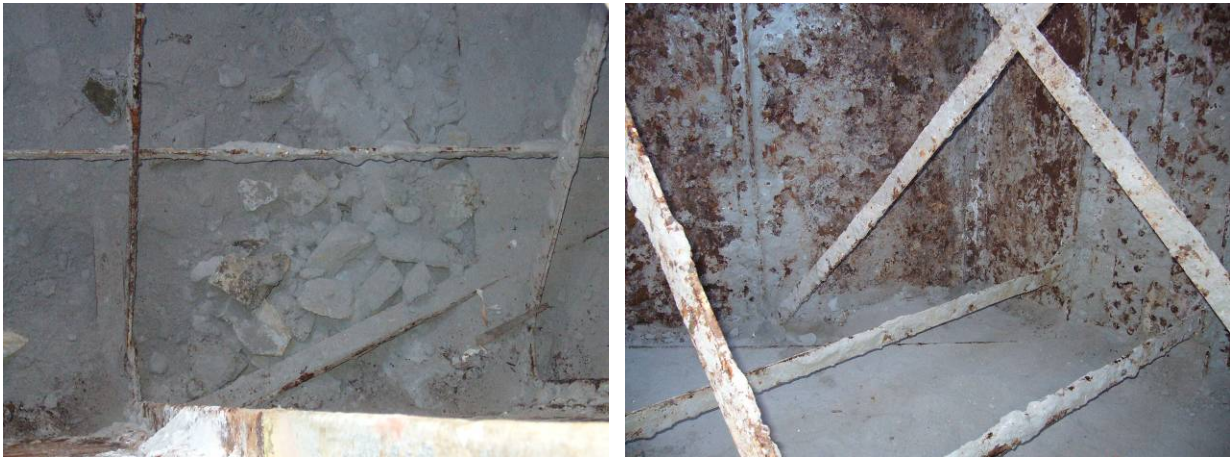
Fig. 5.7.12: Horizontal bracing

Finally, there are horizontal bracings and connection nodes between the horizontal and vertical profiles on the surfaces of the caisson in considerable state of deterioration, as reported in Fig. 5.7.12 e Fig. 5.7.13:

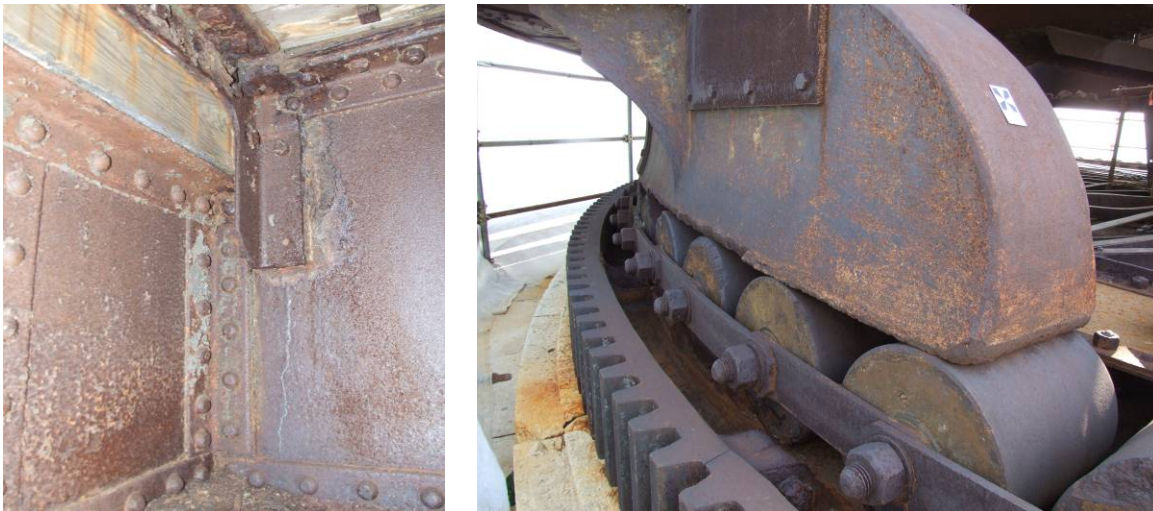
The tests on materials will just concern puddle iron and cast iron (Fig. 5.8.12).

Fig. 5.8.12: Details of iron and cast iron elements
