UNIVERSITÀ  
DEGLI STUDI  
DI PADOVA

**AN INTEGRATED APPROACH FOR RESTORATION AND  
CONSERVATION OF CULTURAL HERITAGE STRUCTURES: HISTORY,  
MATERIALS AND STRUCTURAL BEHAVIOUR. THE ARSENAL OF  
VENICE**

**Dottorando:** Giulia Bettiol

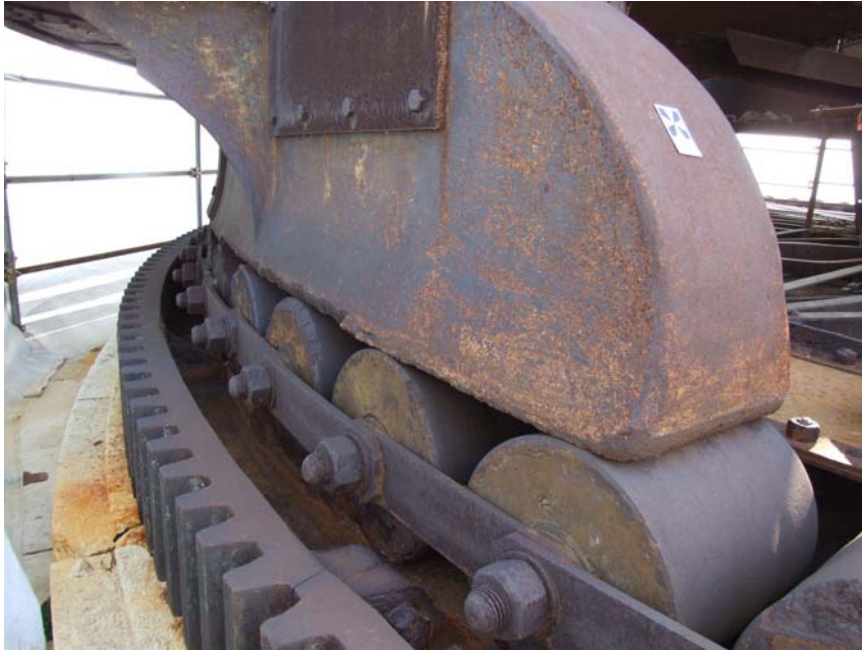
Some rollers (Fig. 5.8.15) of the training system serve as support for the four sliding blocks and are affected by heavy oxidation. The removal of one cast iron roller will be done in order to perform laboratory tests aimed to assess the strength, to assess if there are micro cracks inside and to write a recovery program of the slewing ring in the event of a future restore of the crane's operation.

Fig. 5.8.15: Detail of the rollers upon which one of the four sliding blocks lies

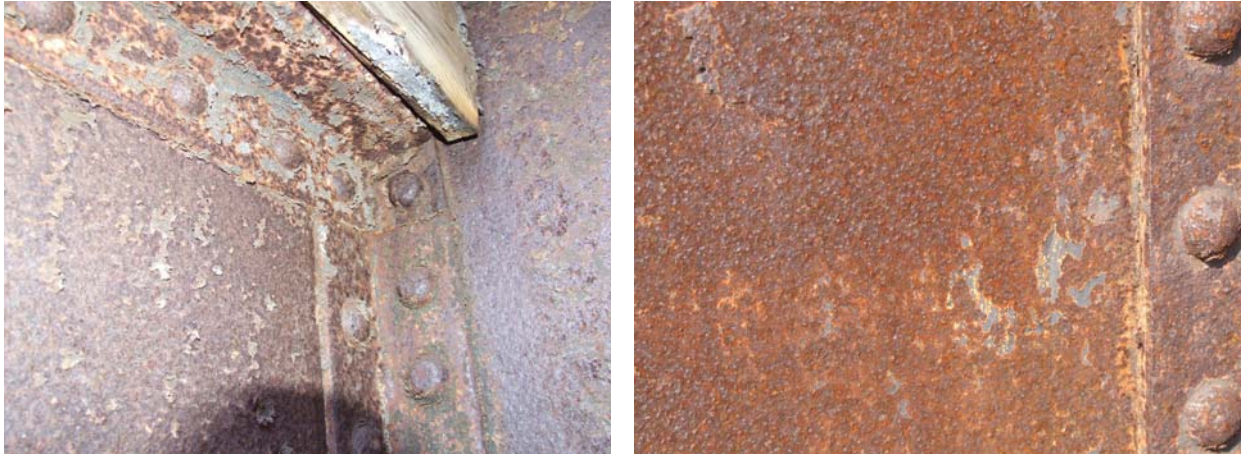
Fig. 5.8.16: Different layers of paintings

Therefore an intervention program was planned that includes the preliminary survey with overall cleaning by compressed air. This operation is aimed to assess the actual building's condition in each part, especially in the more recondite one (rolls, sliding blocks, and the bottom part of the boom of the crane), to identify the surfaces containing original layered paintings (Fig. 5.8.16), to map the degradation and to identify critical points where the degradation has produced the worst surface damage and / or structural damage.

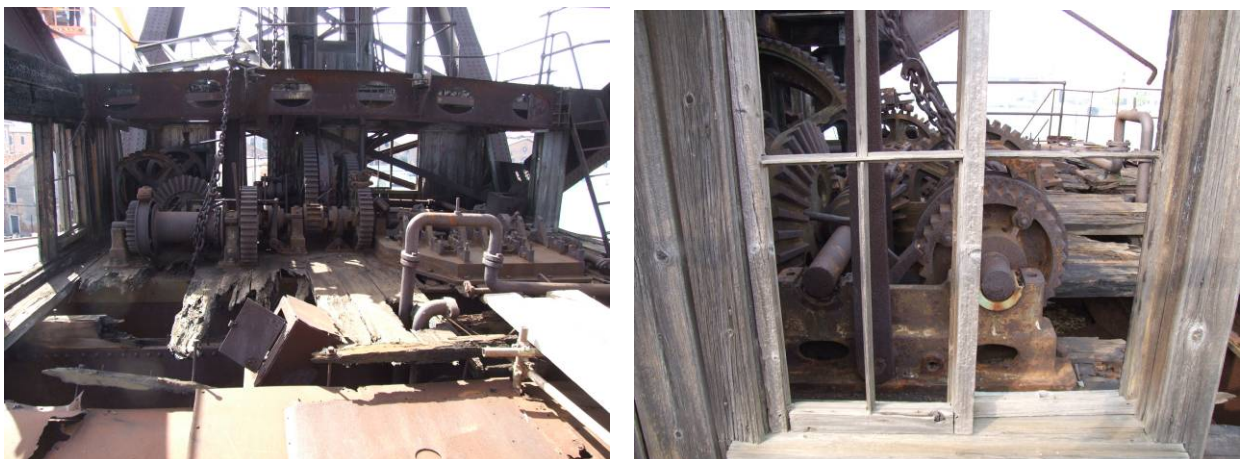
Currently the damaged material has been removed but the reconstruction is vital for the protection of the machinery (Fig. 5.8.21).

Fig. 5.8.21: Current condition of the engine room

The structure will be rebuilt following the original design (Fig. 5.8.22), but using a different type of timber to show that it is not the real one.

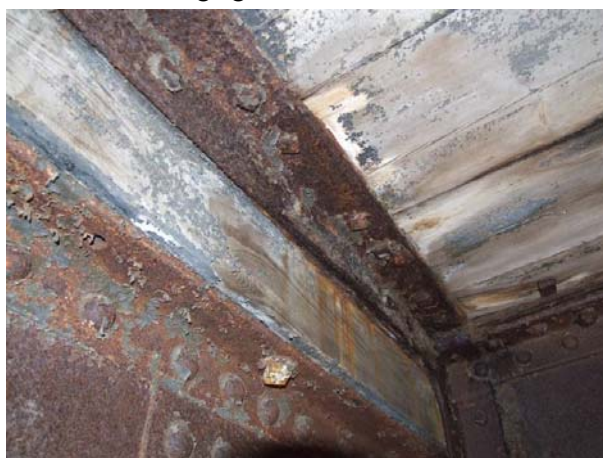
Fig. 5.8.23: Beam detail that needs cleaning and processing

Beams and timber in good condition (Fig. 5.8.23) will be cleaned and the wooden surfaces will be treated, by brushing and washing with a surface acting agent.

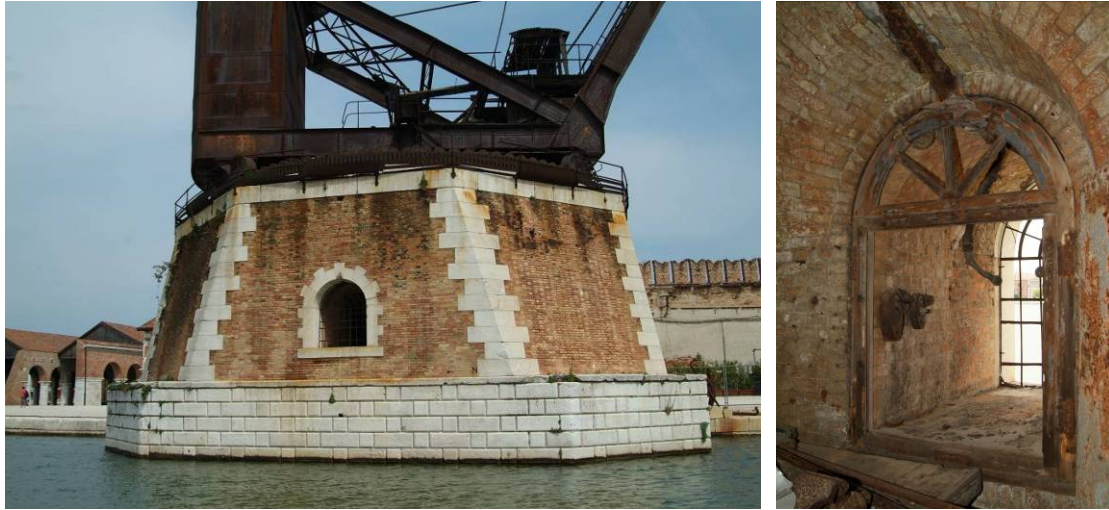
The crane's basement is built in masonry and Istrian stone. A visual analysis allowed to evaluate the level of degradation, which is superficial. On a structural level there aren't special and important issues, thanks to the skill in carrying out the work and to the thickness of the wall, that is more than 2.00 meters at the basement (Fig. 5.8.24).

Fig. 5.8.24: View of the basement and of the wall's thickness

The interventions for the recovery of the foundation are not invasive and involve only the superficial part of the basement.

The first thing to do is to wash the whole affected area. Following there is the removal of lichens and mosses to be carried out by mechanical instruments and subsequent dry or wet brushing. As for the bulging of the wall with ejection of material, a replacement of walls will be done using the unstitch-stitch technique. The joints between bricks should have the same characteristics as the existing ones. The new bricks to be used during the unstitch-stitch phase will need to have size, color, mixing and consistency similar to existing ones.

All lesions and cracks will be filled and the formation of a substrate is included, to be carried out with hydraulic white desalinated lime and inert materials having particle size, mechanical and colors similar to the existing mortar.

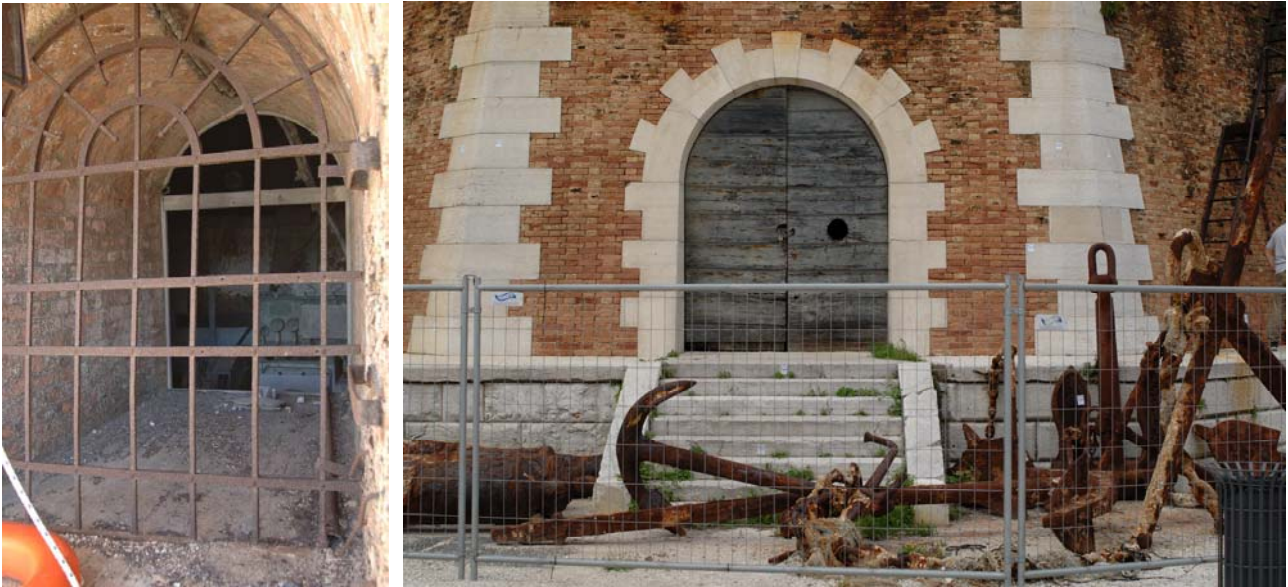
Fig. 5.8.25: Details of the windows and of the wooden door of the basement

Further steps that are required to maintain a good climate and a low level of moisture in the engine room, located inside the basement, consist in the maintenance of wooden windows and the restoration of the entrance door.

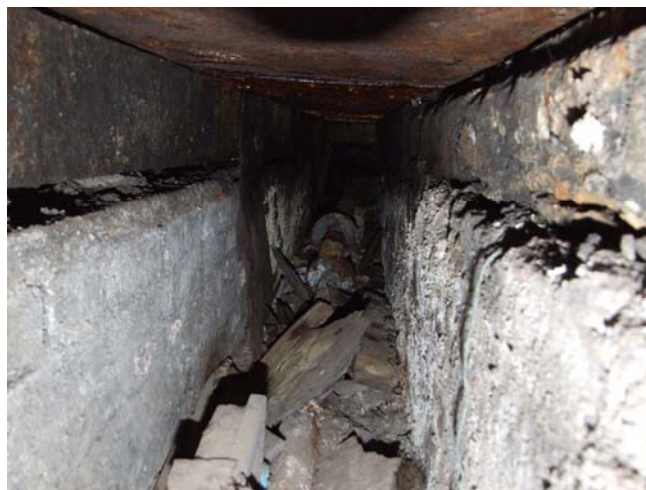
Fig. 5.8.26: Details of boiler's flue gas pipe

Another needed intervention is the cleanup and the eventual filling of the boiler's flue gas pipe (Fig. 5.8.26) located in the engine room and the subsequent installation of a transparent sheet and a lighting system to make it visible and inspectionable.

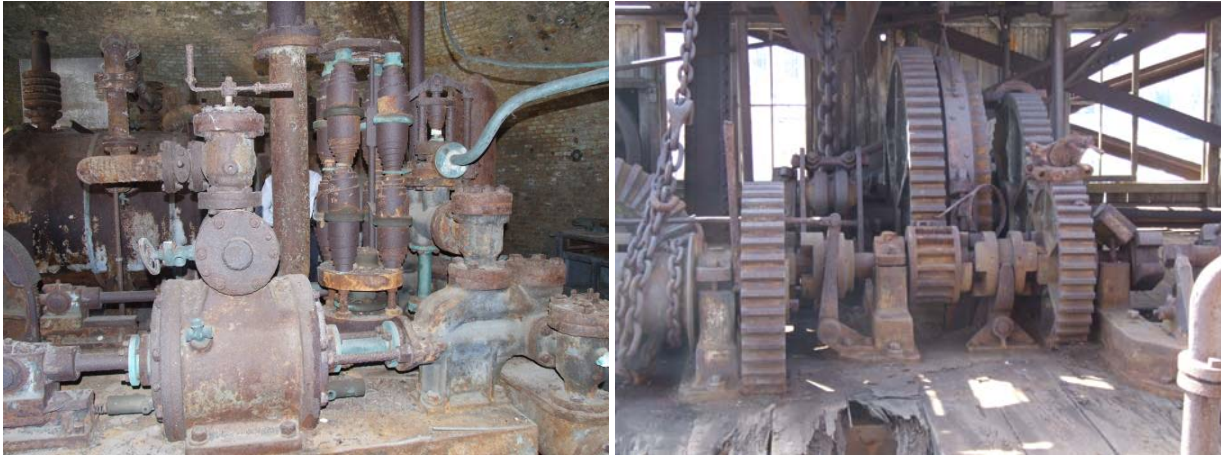
Fig. 5.8.27: Cast iron and bronze machinery

Currently they are in a remarkable state of degradation caused by lack of maintenance. The deterioration has so much altered the structure that is unthinkable for them to operate again. To keep alive the history of the crane and its operational techniques a treatment program is necessary. For both materials a surface cleaning by removal of deposits and a treatment with corrosion inhibitor and protective agent are expected.
