2nd International Conference on Structural Integrity, ICSI 2017, 4-7 September 2017, Funchal, Madeira, Portugal

Influence of corrosion morphology on the Fatigue strength of Bolted joints

This note summarizes some recent investigation results on the behavior of corroded steel bolted joints under uniaxial fatigue loading. Fatigue test specimens, were made up using S355 structural steel plates joined together with preloaded M12 bolts of class 10.9 with a geometry that corresponds to the $\Delta\sigma = 112$ MPa EC3 detail category.

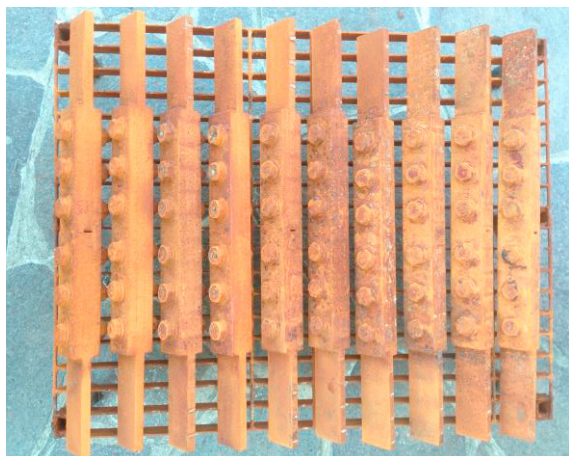
Fig. 3. a) Corroded specimens (672h); b) Mean mass losses interpolation of the corroded specimens (g/cm²).

In Figure 3, the curve resulting from the interpolation of the mean mass losses (g/cm²) measured every 168 hours is reported. As can be seen from the chart, the maximum mass loss at the end of the corrosion process is approximately equal to 0.06g/cm².
