# Debris-flow hazard assessment at the archaeological UNESCO world heritage site of Villa Romana del Casale (Sicily, Italy)

Archaeological sites are extremely vulnerable to the impacts of weather-related events, which may lead to irreparable damages to cultural heritage. Here an assessment of the debris-flow hazard for the UNESCO site of Roman Villa del Casale (Italy) is carried out, through a combination of historical analyses, field surveys, geomorphological and hydrological investigations and two-dimensional hydraulic numerical modelling, all performed at river catchment scale. Historical analyses reveal that the site has been hit by several landslides in the far and recent past. This is presently confirmed by the high level of exposure to the impact of rain-triggered debris-flow events, due to the position of the Villa at a closure section of the related river basin and to the hydro-geomorphological characteristics of the basin itself. By applying the proposed approach, a scenario analysis is carried out. Results allow one to highlight the dynamics of the impact of debris flows, thanks to space and time-dependent maps about deposition areas, water depth and speed values, and t

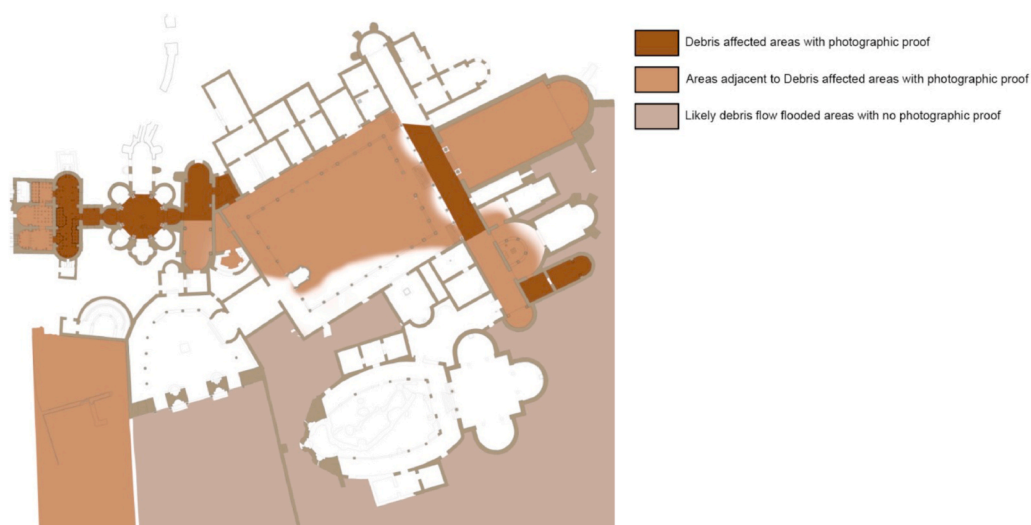
**Fig. 7.** Map of areas flooded in 1991. In dark brown areas with debris on the mosaics recorded through photos; in mid brown adjacent areas, which very likely have been invaded by debris, even if there are no photographs; in light brown areas likely invaded by debris, because of their geomorphological features.

affected for half of its extension, mosaics covered by debris. Major damages were: the detachment of mosaic tiles and fracture of decorations. Pictures in Fig. 6 show how areas at lower levels are easily flooded and are affected by high residence time, which increases damages to fragile decorative features, like mosaics and frescos, due to the prolonged exposure period to water or wet materials contact. Examining the photographs taken in 1991 after the debris flow event, it has been possible to deduce the areas that were hit and flooded by the flow, as shown in Fig. 7.

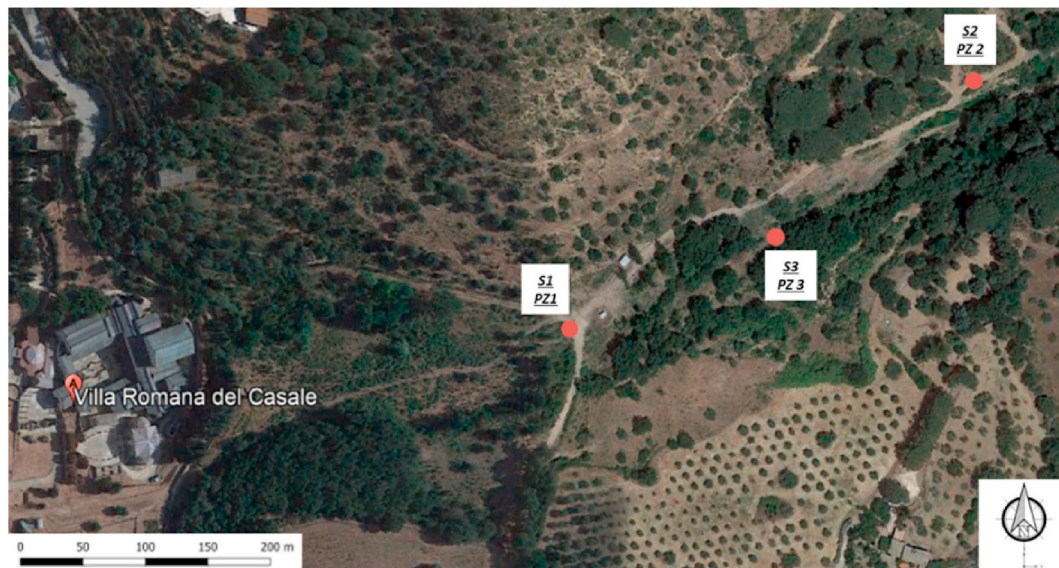
Fig. 19. Location of the three boreholes realized within the basin of the Villa Romana del Casale.
