Fatigue Behaviour of Steel Bridge Joints Strenghtened with FRP Laminates

Alessio Pipinato¹, Carlo Pellegrino¹ & Claudio Modena¹

¹ University of Padova, Padova, Italy

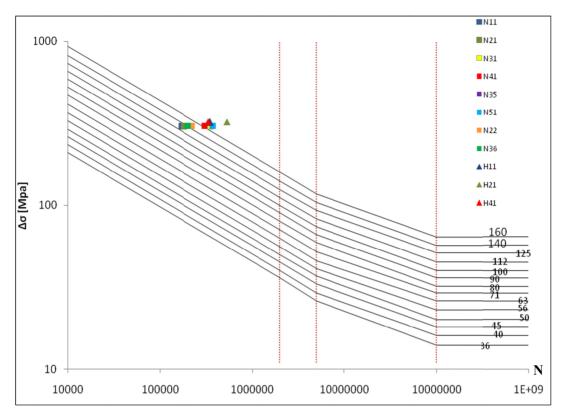
Figure 1. Fatigue failures of FRP reinforced steel plates subjected to tension forces

The first group of experimental tests investigated, is represented by FRP reinforced steel plates under tension forces (Figure 1) (Jones & Civjan, 2003). Examined details were notched (N) or hole (H) provided: N11 not reinforced; N21 is made of 4 Sika Wrapex 103C resin on one side; N31 is made of Sika Wrapex 103C resin on two sides, L=255 mm; N41 is made as N31 but with a smoothed resin layer; N35 is made as N31 but with an unbalanced resin mix; N51 is made as N31 but with L=380 mm; N22 is made as N21 but with MBRACE CF130; N36 is made as N31 is made as N21 but with MBRACE CF130; H11 is not reinforced; H21-22 is made of Sika Wraplex 103 C on two sides, L=255 mm; H41-42 as H21 but with Sika Carbodur. In this test the FRP application caused eccentricity causing bars curvature, and as a result the performance doesn't grow up if compared to the unreinforced test. Three types of CFRP have been used with diverse elasticity module, and varying thickness: from these tests it could be obtained that the best performance is obtained by using the CFRP with a lower E module (e.g. Sika WrapHex 103C). Moreover, from the obtained comparison on SN curves, an extended life has been obtained for: holed specimens, accurate preparation of the base layer, longer CFRP laminates. Category details, even if approximate, stands in the range C=140-160 for notched specimens, and on C=160 for holed specimens. A similar experimental testing has been provided as reported in Figure 2 (Monfared et al., 2008): in this test, similar specimens of the aforementioned test has been used. Variable parameters have

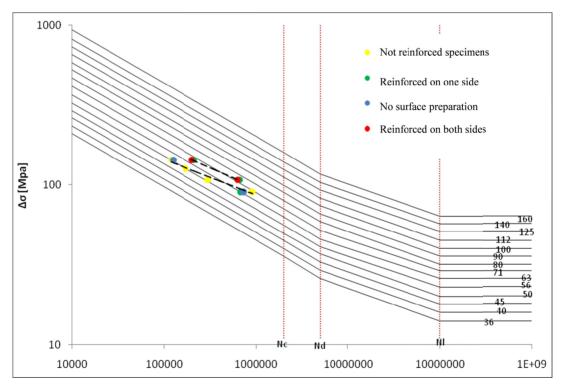
Figure 2. Fatigue failures and curve of FRP reinforced steel plates subjected to tension forces

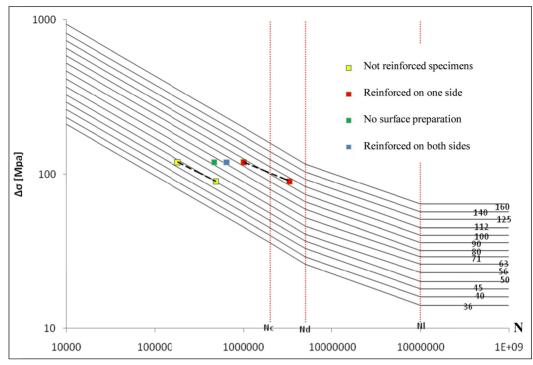
Figure 3. Fatigue failures and curve of FRP reinforced steel plates subjected to tension forces

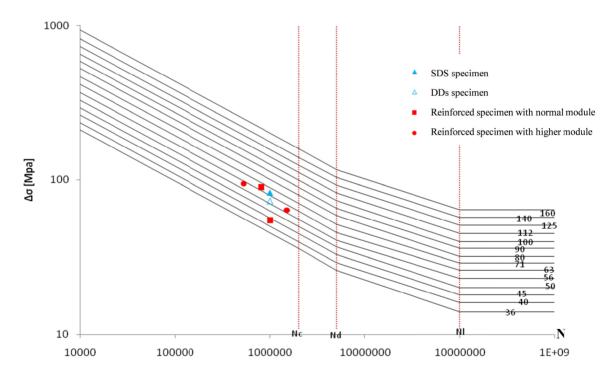
Figure 4. Fatigue failures of double strap FRP reinforced steel plates subjected to tension forces

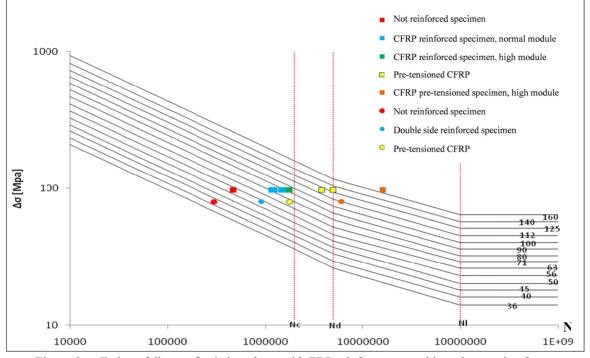
Figure 5. Fatigue failures of existing plates with FRP reinforcement subjected to tension forces

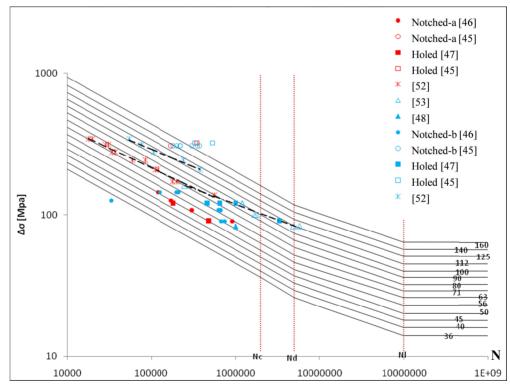
Figure 6. Fatigue failures and curves of different tests

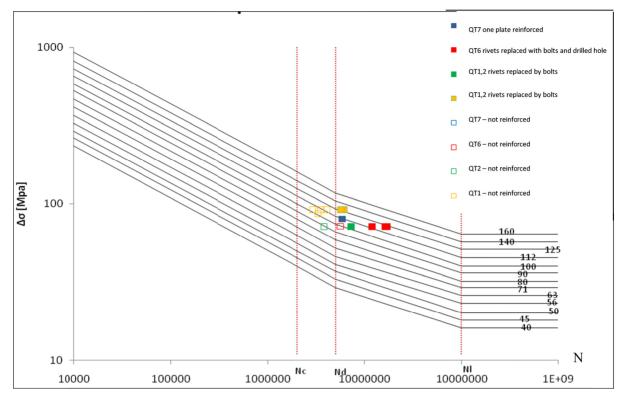
Figure 7. Fatigue failures of steel beam with traditional tecniques subjected to bending

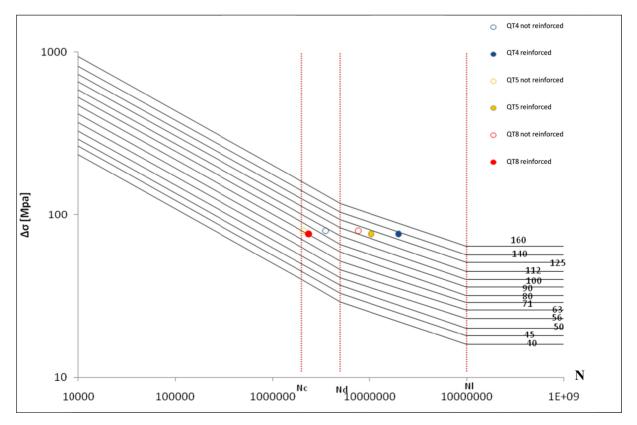
Figure 8. Fatigue failures of steel beam with CFRP reinforcing subjected to bending
